## Profile/Photo Observation Report

| Street: | <b>Capitol</b> | Flow Control: | <b>Not Controlled</b> |
| City: | <b>Hobart, IN</b> | Year Renewed: | |
| US MH: | <b>M-806-012</b> | DS MH: | <b>M-806-011</b> |

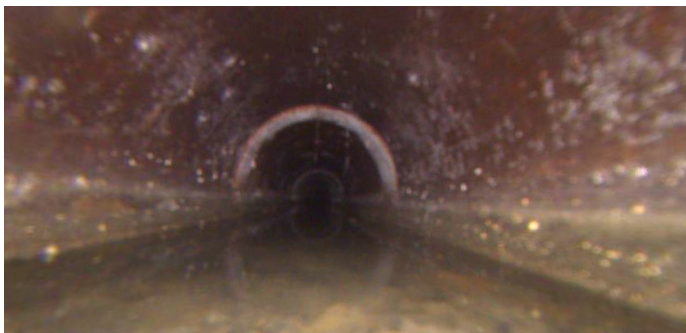
Code: **AMH**  
Description: **Manhole**

Distance (ft): **.0**  
Structural Grade: **0**  
O&M Grade: **0**  
Clock Start/From:  
Clock To:  
1st Value:  
2nd Value:  
Value Percent:  
Continuous Index:  
Within 8" of Joint: **NO**  
Remarks: **M-806-012**

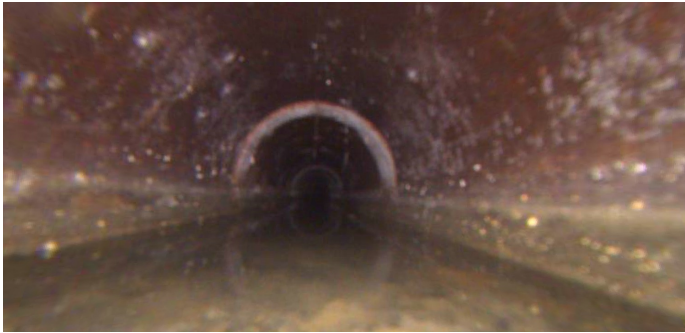
| Code: | <b>MWL</b> |
| Description: | <b>Water Level</b> |

| Value Percent: | <b>30.000</b> |

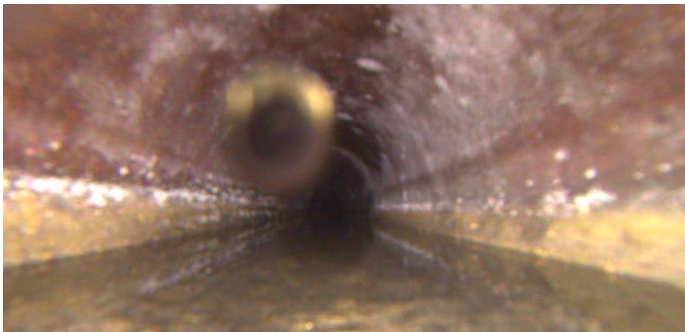
| Comment: | <b>heavy debris and sludge at 5'.</b> | | |

| Code: | <b>MSA</b> |
| Description: | <b>Abandoned Survey</b> |

| Distance (ft): | <b>6.2</b> |
| Remarks: | <b>debris under water</b> |
