## Profile/Photo Observation Report

Street:	<b>MEMORY LN</b>	Flow Control:	<b>Not Controlled</b>
City:	<b>Hobart, IN</b>	Year Renewed:	
Location:	<b>Ditch</b>	Tape/Media #:	
Purpose:	<b>Maintenance Related</b>	Dia/Height:	<b>10"</b>
Use:	<b>Sanitary</b>	Material:	<b>VCP</b>
Drain Area:	<b>NA</b>	Lining:	<b>Cured in Place</b>
Category:	<b>NA</b>		
Comment:	<b>heavy debris at 46'.</b>

Location Details:		Direction of Survey:	<b>Upstream</b>
US MH:	<b>M-806-013</b>	DS MH:	<b>M-806-012</b>
		Total Length Surveyed (ft):	<b>47.2</b>

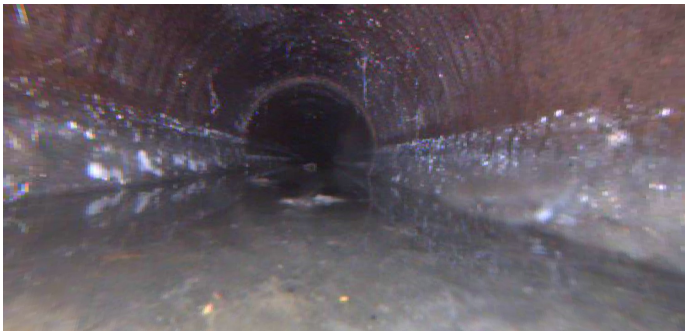
Code: **AMH**  
Description: **Manhole**

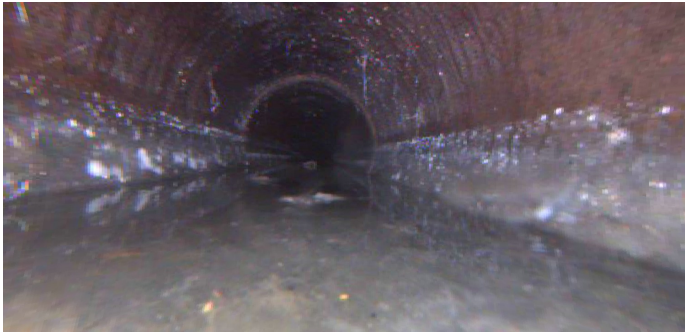
Code:	<b>MWL</b>
Description:	<b>Water Level</b>

Distance (ft):	<b>.0</b>
Structural Grade:	<b>0</b>
O&M Grade:	<b>0</b>
Clock Start/From:	
Clock To:	
1st Value:	
2nd Value:	
Value Percent:	<b>10.000</b>
Continuous Index:	
Within 8" of Joint:	<b>NO</b>
Remarks:

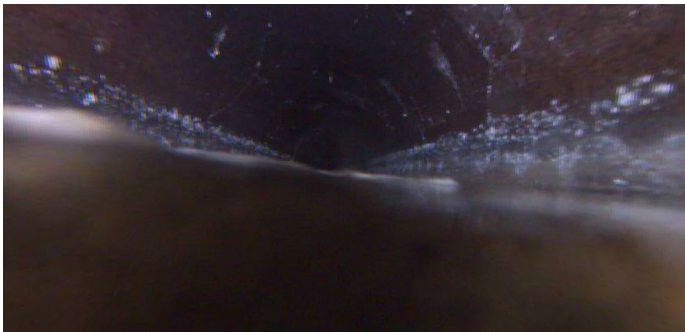
Code:	<b>MWLS</b>
Description:	<b>Water Level Sag</b>

Distance (ft):	<b>5.5</b>
Structural Grade:	<b>2</b>
O&M Grade:	<b>3</b>
Clock Start/From:	
Clock To:	
1st Value:	
2nd Value:	
Value Percent:	<b>10.000</b>
Continuous Index:	
Within 8" of Joint:	<b>NO</b>
Remarks:

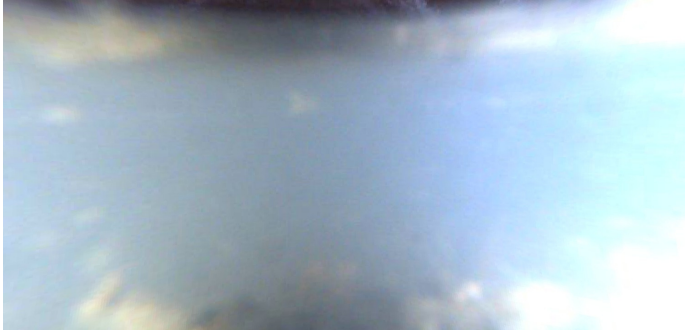
Code: **MCU**  
Description: **Camera Underwater**

Distance (ft): **33.8**  
Structural Grade: **0**  
O&M Grade: **4**  
Clock Start/From:  
Clock To:  
1st Value:  
2nd Value:  
Value Percent:  
Continuous Index:  
Within 8" of Joint: **NO**  
Remarks:

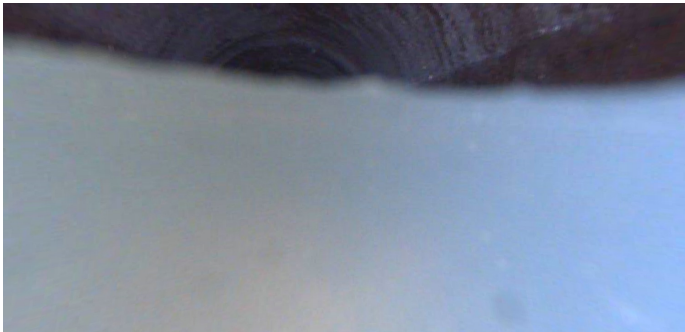
Code: **MCU**  
Description: **Camera Underwater**

Distance (ft): **43.4**  
Structural Grade: **0**  
O&M Grade: **4**  
Clock Start/From:  
Clock To:  
1st Value:  
2nd Value:  
Value Percent:  
Continuous Index: **S01**  
Within 8" of Joint: **NO**  
Remarks:
