Profile/Photo Observation Report

Date:	04/17/2018	Weather:		Coding:	PACP 6.0
Pipe Length (ft):	208.9	Owner:	NA	Pre Clean:	Not Known
P.O.#:		Surveyor:	Byrd Fitzgerald	PSR:	P-806-012-013
Customer:		Clean Date:	01/01/1900	Shape:	C

Street:	Capitol	Flow Control:	Not Controlled
City:	Hobart, IN	Year Renewed:	
Location:	Ditch	Tape/Media #:	
Purpose:	Maintenance Related	Dia/Height:	10"
Use:	Sanitary	Material:	VCP
Drain Area:	NA	Lining:	Cured in Place
Category:	NA		
Comment:	heavy debris at 46'.		
Location Details:		Direction of Survey:	Upstream
US MH:	M-806-013	DS MH:	M-806-012
		Total Length Surveyed (ft):	47.2

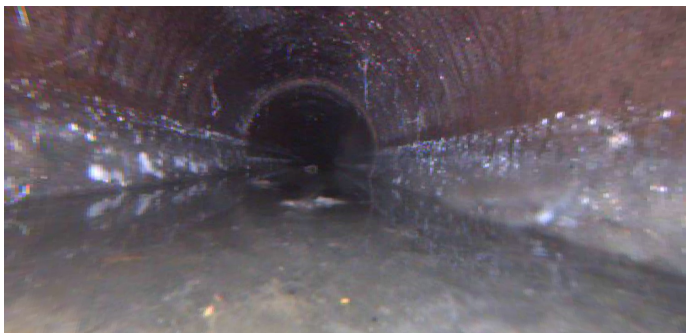
Code: **AMH**
Description: **Manhole**

Distance (ft): **.0**
Structural Grade: **0**
O&M Grade: **0**
Clock Start/From:
Clock To:
1st Value:
2nd Value:
Value Percent:
Continuous Index:
Within 8" of Joint: **NO**
Remarks: **M-806-012**

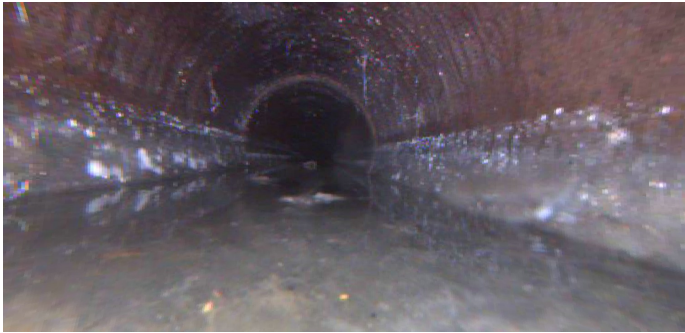
Code:	MWL
Description:	Water Level

Distance (ft):	.0
Structural Grade:	0
O&M Grade:	0
Clock Start/From:	
Clock To:	
1st Value:	
2nd Value:	
Value Percent:	10.000
Continuous Index:	
Within 8" of Joint:	NO
Remarks:

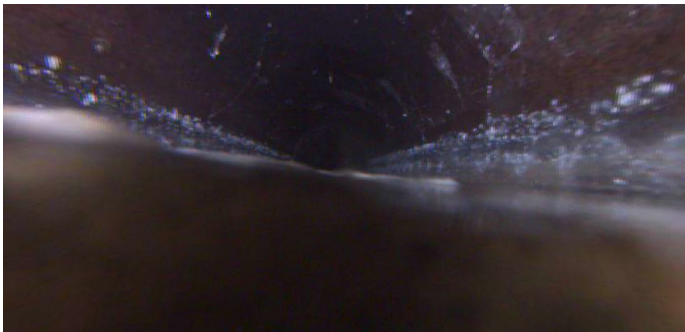
Code:	MWLS
Description:	Water Level Sag

Distance (ft):	5.5
Structural Grade:	2
O&M Grade:	3
Clock Start/From:	
Clock To:	
1st Value:	
2nd Value:	
Value Percent:	10.000
Continuous Index:	
Within 8" of Joint:	NO
Remarks:

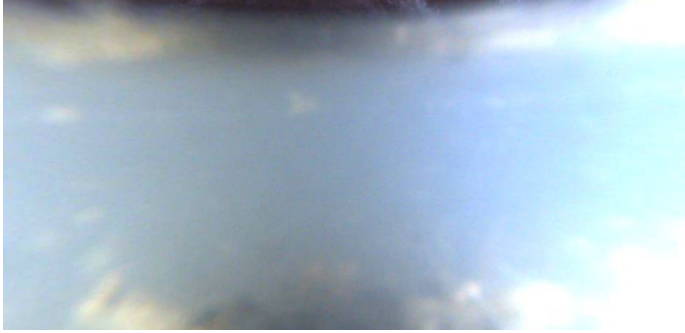
Code: **MCU**
Description: **Camera Underwater**

Distance (ft): **33.8**
Structural Grade: **0**
O&M Grade: **4**
Clock Start/From:
Clock To:
1st Value:
2nd Value:
Value Percent:
Continuous Index:
Within 8" of Joint: **NO**
Remarks:

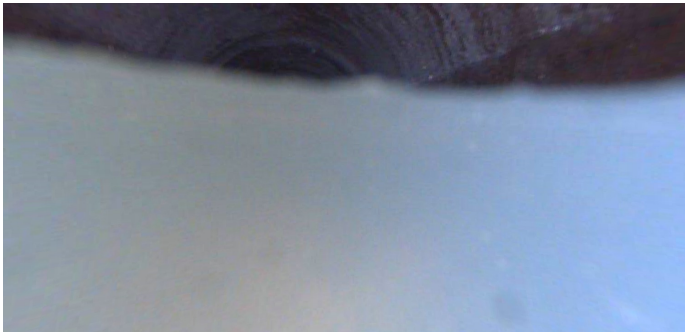
Code: **MCU**
Description: **Camera Underwater**

Distance (ft): **43.4**
Structural Grade: **0**
O&M Grade: **4**
Clock Start/From:
Clock To:
1st Value:
2nd Value:
Value Percent:
Continuous Index: **S01**
Within 8" of Joint: **NO**
Remarks:
