Profile/Photo Observation Report

Date:	04/17/2018	Weather:		Coding:	PACP 6.0
Pipe Length (ft):	198.8	Owner:	NA	Pre Clean:	Not Known
P.O.#:		Surveyor:	Byrd Fitzgerald	PSR:	P-806-013-014
Customer:		Clean Date:	01/01/1900	Shape:	C

Street:	MEMORY LN	Flow Control:	Not Controlled
City:	Hobart, IN	Year Renewed:	
Location:	Light Highway	Tape/Media #:	
Purpose:	Maintenance Related	Dia/Height:	10"
Use:	Sanitary	Material:	VCP
Drain Area:	NA	Lining:	Cured in Place
Category:	NA		
Comment:	heavy debris at 54'.		
Location Details:		Direction of Survey:	Upstream
US MH:	M-806-014	DS MH:	M-806-013
		Total Length Surveyed (ft):	55.4

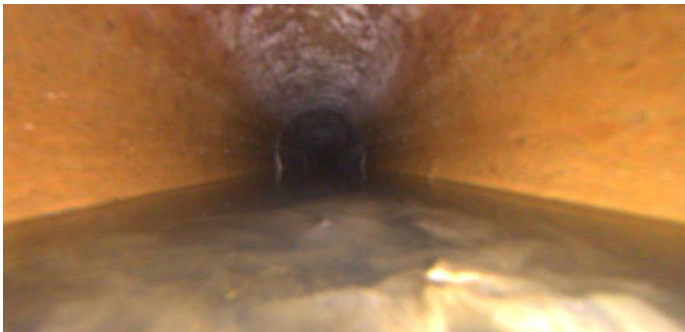
Code:	DSZ
Description:	Deposits Settled Other

Distance (ft):	23.4
Structural Grade:	0
O&M Grade:	2
Clock Start/From:	6
Clock To:	
1st Value:	
2nd Value:	
Value Percent:	5.000
Continuous Index:	S02
Within 8" of Joint:	NO
Remarks:	tissue

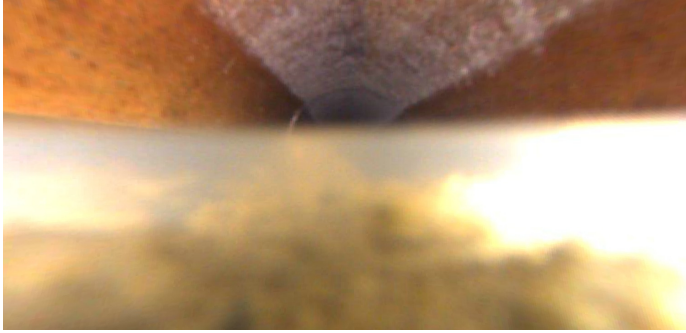
Code: **MWL**
Description: **Water Level**

Distance (ft): **48.8**
Structural Grade: **0**
O&M Grade: **0**
Clock Start/From:
Clock To:
1st Value:
2nd Value:
Value Percent: **55.000**
Continuous Index:
Within 8" of Joint: **NO**
Remarks:

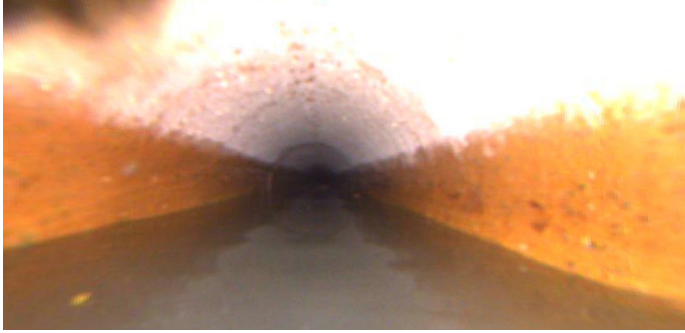
Code: **MCU**
Description: **Camera Underwater**

Distance (ft): **54.2**
Structural Grade: **0**
O&M Grade: **4**
Clock Start/From:
Clock To:
1st Value:
2nd Value:
Value Percent:
Continuous Index: **F01**
Within 8" of Joint: **NO**
Remarks:

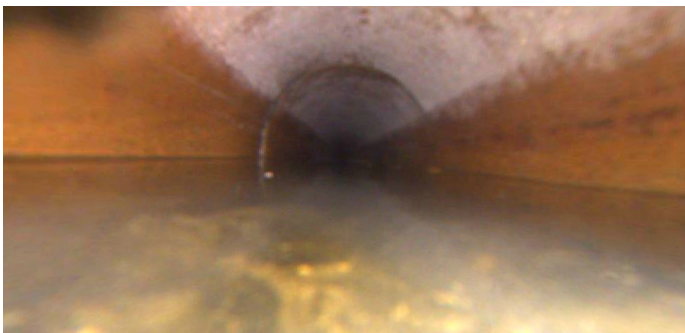
Code: **MSA**
Description: **Abandoned Survey**

Distance (ft): **55.4**
Structural Grade: **0**
O&M Grade: **0**
Clock Start/From:
Clock To:
1st Value:
2nd Value:
Value Percent:
Continuous Index:
Within 8" of Joint: **NO**
Remarks: **stopped by debris**

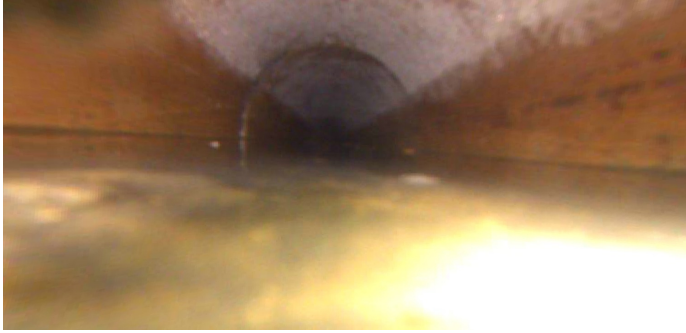
Code:	DSZ
Description:	Deposits Settled Other
Distance (ft):	55.4
Structural Grade:	0
O&M Grade:	2
Clock Start/From:	6
Clock To:	
1st Value:	
2nd Value:	
Value Percent:	5.000
Continuous Index:	F02
Within 8" of Joint:	NO
Remarks:	tissue
