Profile/Photo Observation Report

Date:	04/17/2018	Weather:		Coding:	PACP 6.0
Pipe Length (ft):	198.8	Owner:	NA	Pre Clean:	Not Known
P.O.#:		Surveyor:	Byrd Fitzgerald	PSR:	P-806-013-014
Customer:		Clean Date:	01/01/1900	Shape:	C

Location Details:		Direction of Survey:	Upstream
US MH:	M-806-014	DS MH:	M-806-013
		Total Length Surveyed (ft):	55.4

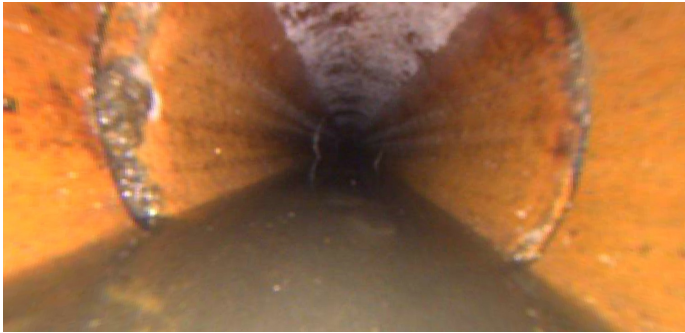
Code:	MWL
Description:	Water Level

Distance (ft):	.0
Structural Grade:	0
O&M Grade:	0
Clock Start/From:	
Clock To:	
1st Value:	
2nd Value:	
Value Percent:	5.000
Continuous Index:	
Within 8" of Joint:	NO
Remarks:

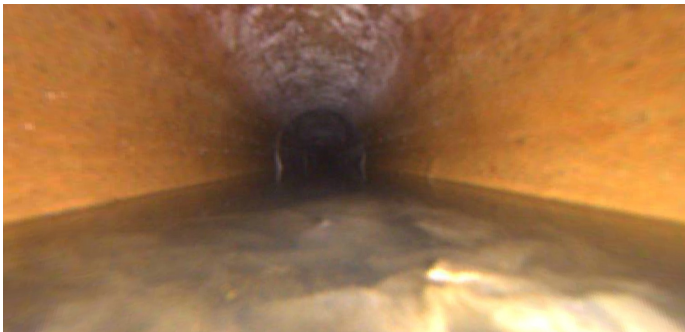
Code:	DSZ
Description:	Deposits Settled Other

Distance (ft):	23.4
Structural Grade:	0
O&M Grade:	2
Clock Start/From:	6
Clock To:	
1st Value:	
2nd Value:	
Value Percent:	5.000
Continuous Index:	S02
Within 8" of Joint:	NO
Remarks:	tissue

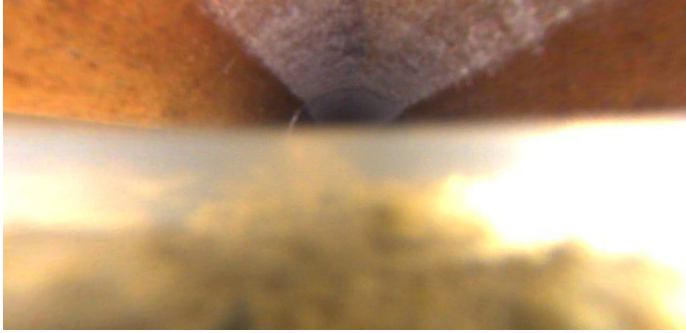
Code: **MWL**
Description: **Water Level**

Distance (ft): **48.8**
Structural Grade: **0**
O&M Grade: **0**
Clock Start/From:
Clock To:
1st Value:
2nd Value:
Value Percent: **55.000**
Continuous Index:
Within 8" of Joint: **NO**
Remarks:

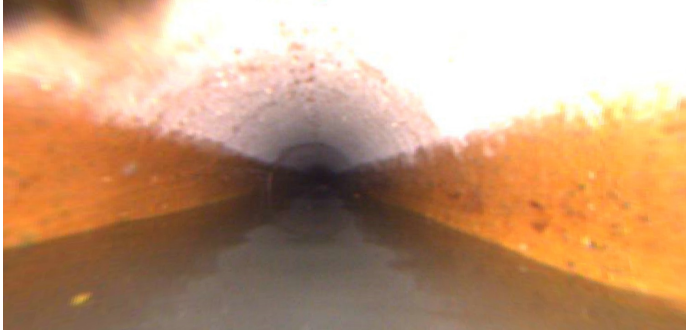
Code: **MCU**
Description: **Camera Underwater**

Distance (ft): **54.2**
Structural Grade: **0**
O&M Grade: **4**
Clock Start/From:
Clock To:
1st Value:
2nd Value:
Value Percent:
Continuous Index: **F01**
Within 8" of Joint: **NO**
Remarks:

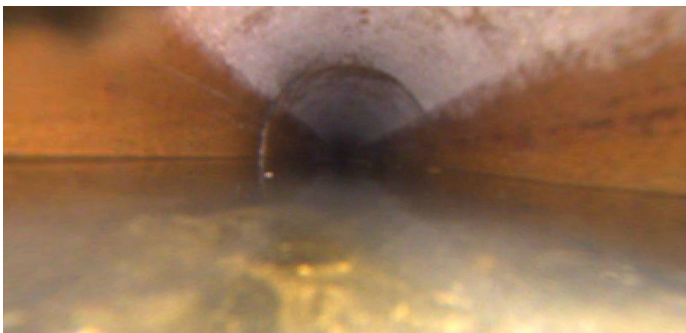
Code: **MSA**
Description: **Abandoned Survey**

Distance (ft): **55.4**
Structural Grade: **0**
O&M Grade: **0**
Clock Start/From:
Clock To:
1st Value:
2nd Value:
Value Percent:
Continuous Index:
Within 8" of Joint: **NO**
Remarks: **stopped by debris**

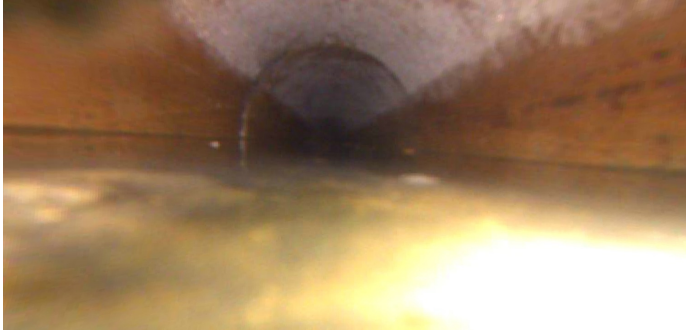
Code:	DSZ
Description:	Deposits Settled Other
Distance (ft):	55.4
Structural Grade:	0
O&M Grade:	2
Clock Start/From:	6
Clock To:	
1st Value:	
2nd Value:	
Value Percent:	5.000
Continuous Index:	F02
Within 8" of Joint:	NO
Remarks:	tissue
