Profile/Photo Observation Report

Date:	04/17/2018	Weather:		Coding:	PACP 6.0
Pipe Length (ft):	198.8	Owner:	NA	Pre Clean:	Not Known
P.O.#:		Surveyor:	Byrd Fitzgerald	PSR:	P-806-013-014
Customer:		Clean Date:	01/01/1900	Shape:	C

Street:	Capitol	Flow Control:	Not Controlled
City:	Hobart, IN	Year Renewed:	
Location:	Light Highway	Tape/Media #:	
Purpose:	Maintenance Related	Dia/Height:	10"
Use:	Sanitary	Material:	VCP
Drain Area:	NA	Lining:	Cured in Place
Category:	NA		
Comment:	Reverse setup. heavy debris at 58'.

Location Details:	Direction of Survey:	Downstream
US MH: M-806-014	DS MH: M-806-013	Total Length Surveyed (ft): 59.2

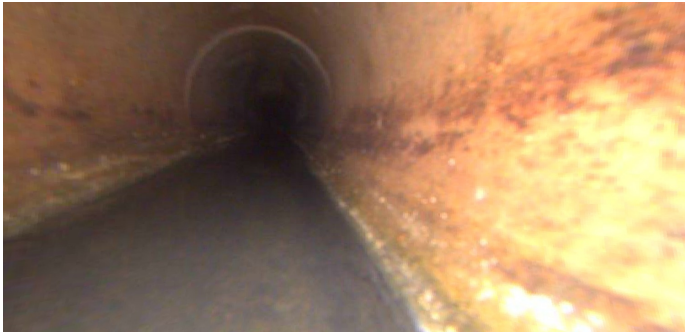
Code:	MWL
Description:	Water Level

Distance (ft):	.0
Structural Grade:	0
O&M Grade:	0
Clock Start/From:	
Clock To:	
1st Value:	
2nd Value:	
Value Percent:	5.000
Continuous Index:	
Within 8" of Joint:	NO
Remarks:

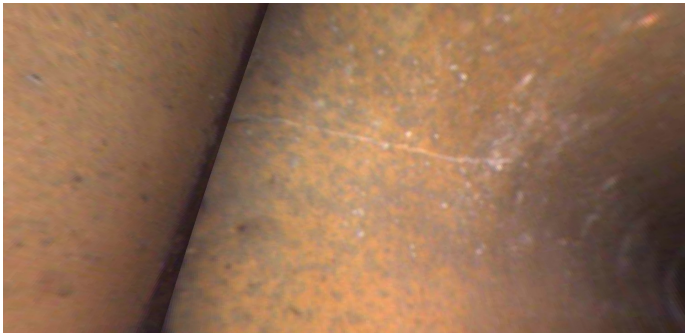
Code:	CL
Description:	Crack Longitudinal

Distance (ft):	2.3
Structural Grade:	2
O&M Grade:	0
Clock Start/From:	10
Clock To:	
1st Value:	
2nd Value:	
Value Percent:	
Continuous Index:	
Within 8" of Joint:	YES
Remarks:

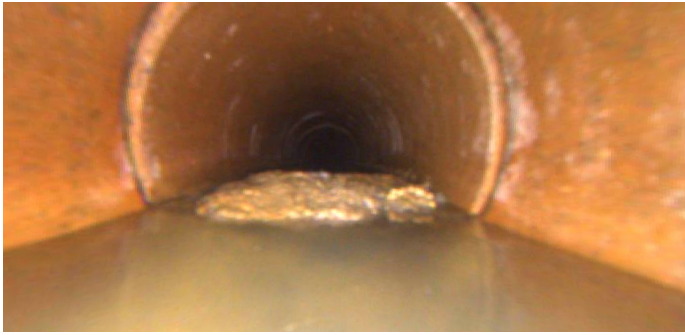
Code: **DSZ**
Description: **Deposits Settled Other**

Distance (ft): **19.9**
Structural Grade: **0**
O&M Grade: **2**
Clock Start/From: **6**
Clock To:
1st Value:
2nd Value:
Value Percent: **10.000**
Continuous Index: **S01**
Within 8" of Joint: **YES**
Remarks: **debris/gets stuck on camera**

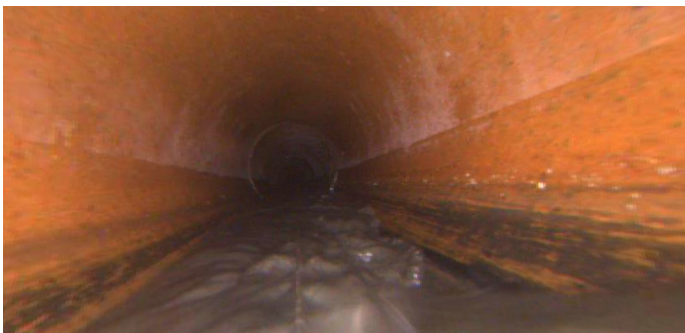
Code: **MGO**
Description: **General Observation**

Distance (ft): **44.9**
Structural Grade: **0**
O&M Grade: **0**
Clock Start/From:
Clock To:
1st Value:
2nd Value:
Value Percent:
Continuous Index:
Within 8" of Joint: **NO**
Remarks: **rear camera/lense covered**

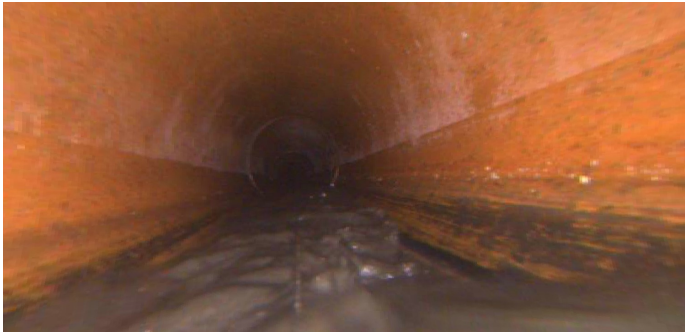
Code: **DSZ**
Description: **Deposits Settled Other**

Distance (ft): **44.9**
Structural Grade: **0**
O&M Grade: **2**
Clock Start/From: **6**
Clock To:
1st Value:
2nd Value:
Value Percent: **10.000**
Continuous Index: **F01**
Within 8" of Joint: **YES**
Remarks: **debris/gets stuck on camera**

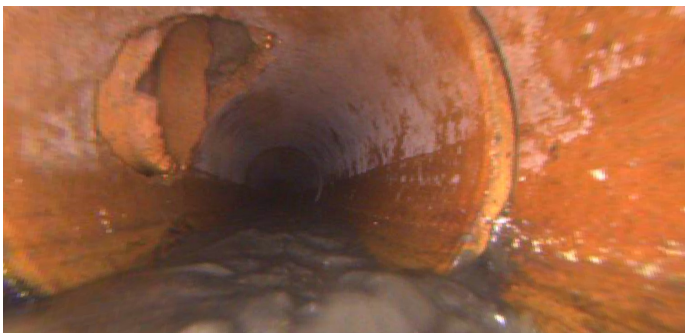
Code: **TB**
Description: **Tap Break-in**

Distance (ft): **54.8**
Structural Grade: **0**
O&M Grade: **0**
Clock Start/From: **2**
Clock To:
1st Value: **4.000**
2nd Value:
Value Percent:
Continuous Index:
Within 8" of Joint:
Remarks:
