Profile/Photo Observation Report

Date:	04/17/2018	Weather:		Coding:	PACP 6.0
Pipe Length (ft):	193.2	Owner:	NA	Pre Clean:	Not Known
P.O.#:		Surveyor:	Justin Gonzales	PSR:	P-806-014-015
Customer:		Clean Date:	01/01/1900	Shape:	C

Street:	E 8TH ST	Flow Control:	Not Controlled
City:	Hobart, IN	Year Renewed:	
Location:	Light Highway	Tape/Media #:	
Purpose:	Maintenance Related	Dia/Height:	10"
Use:	Sanitary	Material:	VCP
Drain Area:	NA	Lining:	Cured in Place
Category:	NA		
Comment:	mh confirmed at 193'.

Location Details:		Direction of Survey:	Upstream
US MH:	M-806-015	DS MH:	M-806-014
		Total Length Surveyed (ft):	194.7

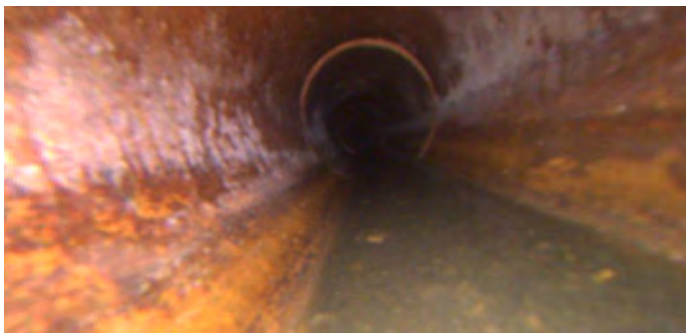
Code: **AMH**
Description: **Manhole**

Distance (ft): **.0**
Structural Grade: **0**
O&M Grade: **0**
Clock Start/From:
Clock To:
1st Value:
2nd Value:
Value Percent:
Continuous Index:
Within 8" of Joint: **NO**
Remarks: **M-806-014**

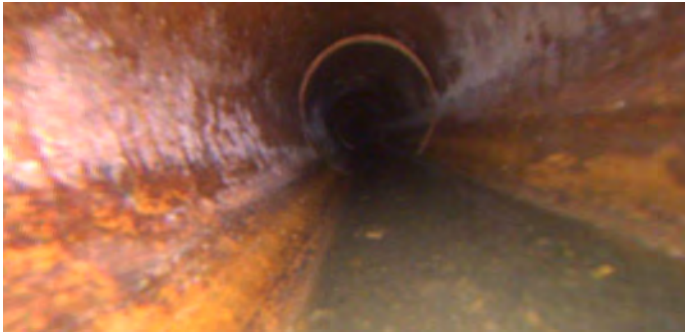
Code:	MWL
Description:	Water Level

Distance (ft):	.0
Structural Grade:	0
O&M Grade:	0
Clock Start/From:	
Clock To:	
1st Value:	
2nd Value:	
Value Percent:	5.000
Continuous Index:	
Within 8" of Joint:	NO
Remarks:

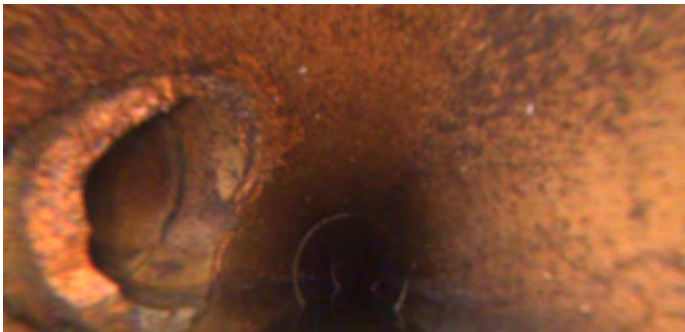
Code:	TBI
Description:	Tap Break-in Intruding

Distance (ft):	18.9
Structural Grade:	0
O&M Grade:	2
Clock Start/From:	9
Clock To:	
1st Value:	4.000
2nd Value:	1.000
Value Percent:	
Continuous Index:	
Within 8" of Joint:	
Remarks:

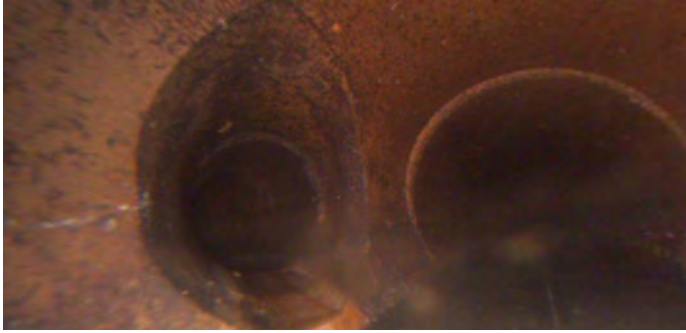
Code: **TFA**
Description: **Tap Factory Active**

Distance (ft): **19.3**
Structural Grade: **0**
O&M Grade: **0**
Clock Start/From: **3**
Clock To:
1st Value: **4.000**
2nd Value:
Value Percent:
Continuous Index:
Within 8" of Joint:
Remarks:

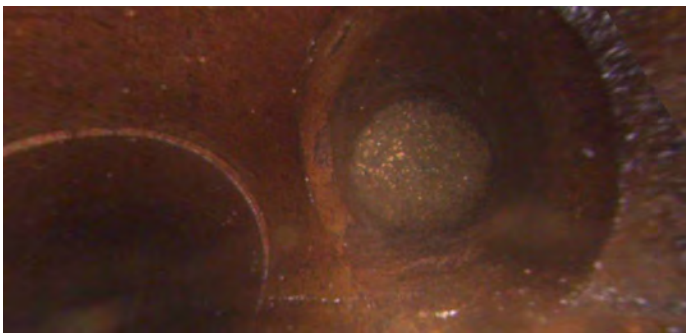
Code: **TFC**
Description: **Tap Factory Capped**

Distance (ft): **25.4**
Structural Grade: **0**
O&M Grade: **0**
Clock Start/From: **9**
Clock To:
1st Value: **4.000**
2nd Value:
Value Percent:
Continuous Index:
Within 8" of Joint:
Remarks:

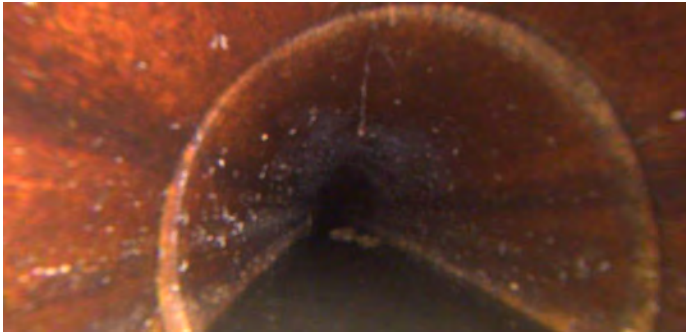
Code: **RFJ**
Description: **Roots Fine Joint**

Distance (ft): **72.6**
Structural Grade: **0**
O&M Grade: **1**
Clock Start/From: **12**
Clock To:
1st Value:
2nd Value:
Value Percent:
Continuous Index:
Within 8" of Joint: **YES**
Remarks:

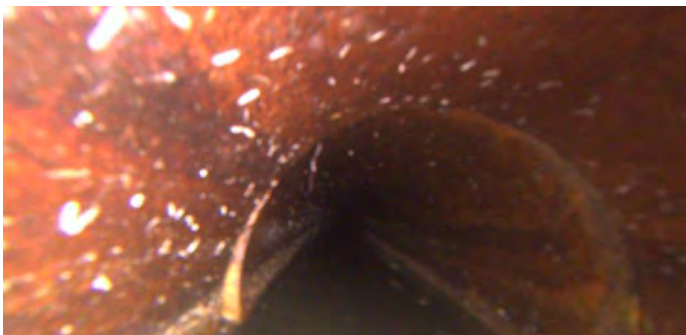
Code: **RFJ**
Description: **Roots Fine Joint**

Distance (ft): **75.5**
Structural Grade: **0**
O&M Grade: **1**
Clock Start/From: **11**
Clock To:
1st Value:
2nd Value:
Value Percent:
Continuous Index:
Within 8" of Joint: **YES**
Remarks:

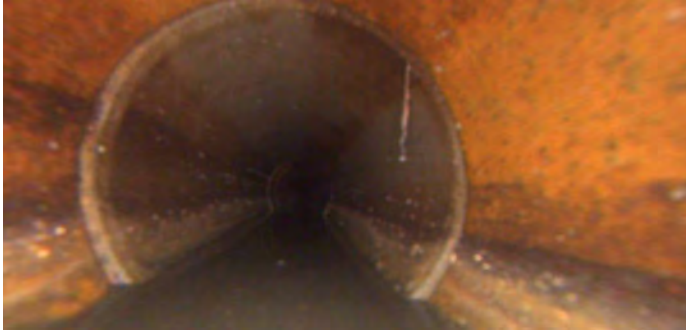
Code: **RFJ**
Description: **Roots Fine Joint**

Distance (ft): **96.9**
Structural Grade: **0**
O&M Grade: **1**
Clock Start/From: **2**
Clock To:
1st Value:
2nd Value:
Value Percent:
Continuous Index:
Within 8" of Joint: **YES**
Remarks:

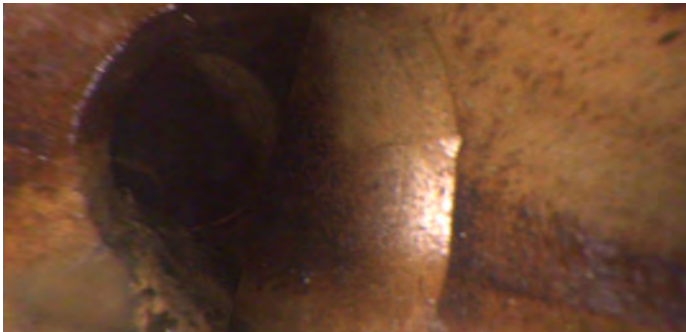
Code: **TF**
Description: **Tap Factory**

Distance (ft): **101.3**
Structural Grade: **0**
O&M Grade: **0**
Clock Start/From: **9**
Clock To:
1st Value: **4.000**
2nd Value:
Value Percent:
Continuous Index:
Within 8" of Joint:
Remarks:

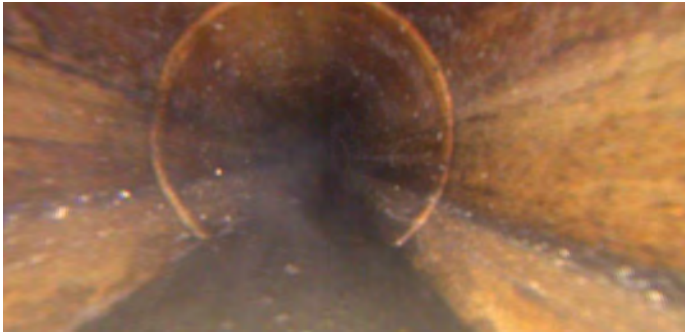
Code: **MGO**
Description: **General Observation**

Distance (ft): **102.9**
Structural Grade: **0**
O&M Grade: **0**
Clock Start/From:
Clock To:
1st Value:
2nd Value:
Value Percent:
Continuous Index:
Within 8" of Joint: **NO**
Remarks: **SLIGHT FOG**

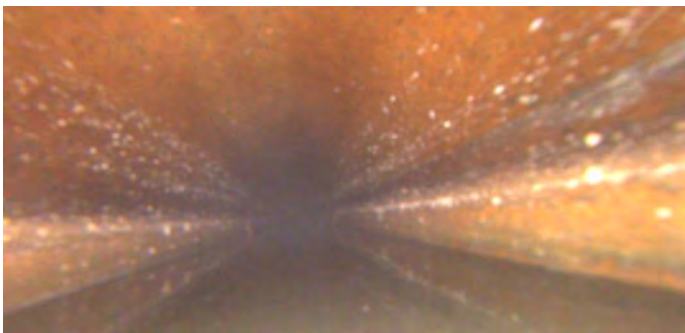
Code: **MWL**
Description: **Water Level**

Distance (ft): **122.2**
Structural Grade: **0**
O&M Grade: **0**
Clock Start/From:
Clock To:
1st Value:
2nd Value:
Value Percent: **30.000**
Continuous Index:
Within 8" of Joint: **NO**
Remarks:

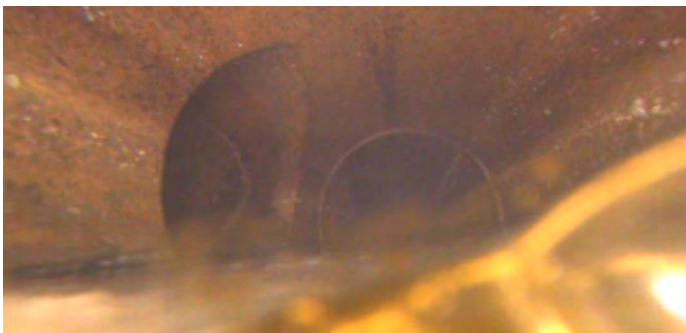
Code: **TF**
Description: **Tap Factory**

Distance (ft): **141.9**
Structural Grade: **0**
O&M Grade: **0**
Clock Start/From: **3**
Clock To:
1st Value: **4.000**
2nd Value:
Value Percent:
Continuous Index:
Within 8" of Joint:
Remarks:
