Profile/Photo Observation Report

Date:	04/17/2018	Weather:		Coding:	PACP 6.0
Pipe Length (ft):	193.2	Owner:	NA	Pre Clean:	Not Known
P.O.#:		Surveyor:	Justin Gonzales	PSR:	P-806-014-015
Customer:		Clean Date:	01/01/1900	Shape:	C

Street:	Capitol	Flow Control:	Not Controlled
City:	Hobart, IN	Year Renewed:	
Location:	Light Highway	Tape/Media #:	
Purpose:	Maintenance Related	Dia/Height:	10"
Use:	Sanitary	Material:	VCP
Drain Area:	NA	Lining:	Cured in Place
Category:	NA		
Comment:	mh confirmed at 193'.

Location Details:		Direction of Survey:	Upstream
US MH:	M-806-015	DS MH:	M-806-014
		Total Length Surveyed (ft):	194.7

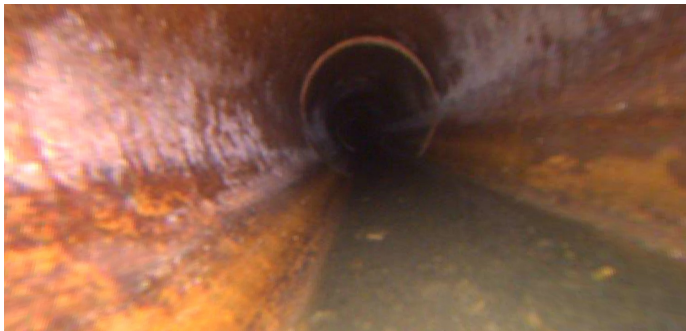
Code: **AMH**
Description: **Manhole**

Distance (ft): **.0**
Structural Grade: **0**
O&M Grade: **0**
Clock Start/From:
Clock To:
1st Value:
2nd Value:
Value Percent:
Continuous Index:
Within 8" of Joint: **NO**
Remarks: **M-806-014**

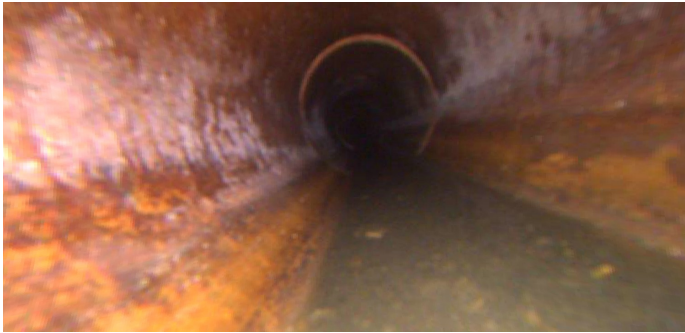
Code:	MWL
Description:	Water Level

Distance (ft):	.0
Structural Grade:	0
O&M Grade:	0
Clock Start/From:	
Clock To:	
1st Value:	
2nd Value:	
Value Percent:	5.000
Continuous Index:	
Within 8" of Joint:	NO
Remarks:

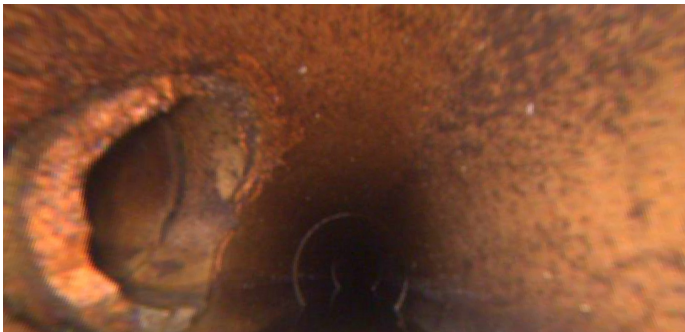
Code:	TBI
Description:	Tap Break-in Intruding

Distance (ft):	18.9
Structural Grade:	0
O&M Grade:	2
Clock Start/From:	9
Clock To:	
1st Value:	4.000
2nd Value:	1.000
Value Percent:	
Continuous Index:	
Within 8" of Joint:	
Remarks:

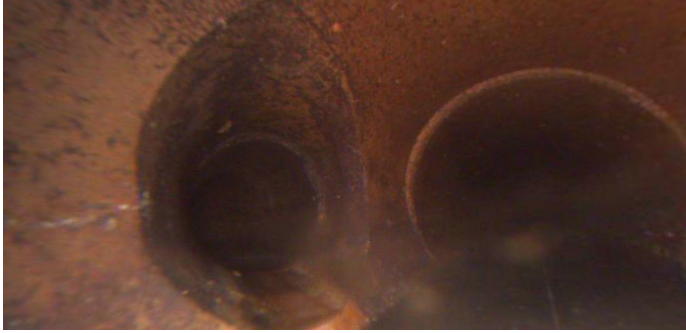
Code: **TFA**
Description: **Tap Factory Active**

Distance (ft): **19.3**
Structural Grade: **0**
O&M Grade: **0**
Clock Start/From: **3**
Clock To:
1st Value: **4.000**
2nd Value:
Value Percent:
Continuous Index:
Within 8" of Joint:
Remarks:

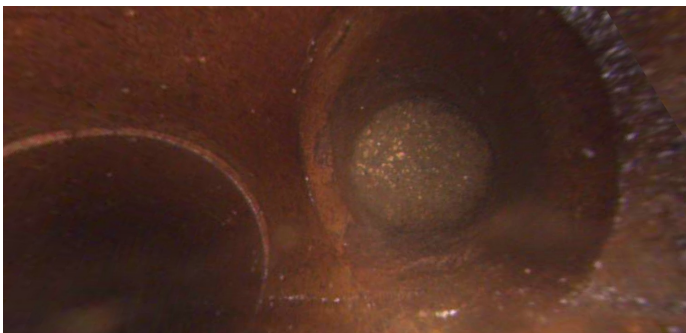
Code: **TFC**
Description: **Tap Factory Capped**

Distance (ft): **25.4**
Structural Grade: **0**
O&M Grade: **0**
Clock Start/From: **9**
Clock To:
1st Value: **4.000**
2nd Value:
Value Percent:
Continuous Index:
Within 8" of Joint:
Remarks:

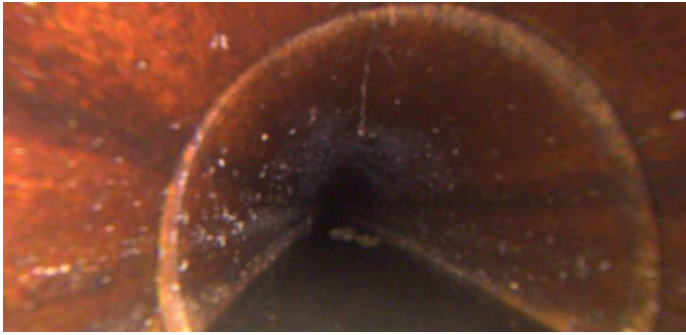
Code: **RFJ**
Description: **Roots Fine Joint**

Distance (ft): **72.6**
Structural Grade: **0**
O&M Grade: **1**
Clock Start/From: **12**
Clock To:
1st Value:
2nd Value:
Value Percent:
Continuous Index:
Within 8" of Joint: **YES**
Remarks:

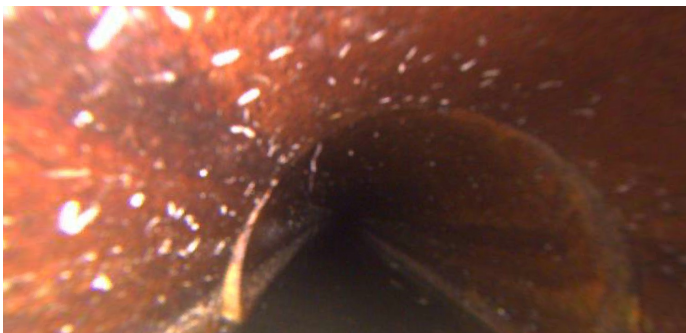
Code: **RFJ**
Description: **Roots Fine Joint**

Distance (ft): **75.5**
Structural Grade: **0**
O&M Grade: **1**
Clock Start/From: **11**
Clock To:
1st Value:
2nd Value:
Value Percent:
Continuous Index:
Within 8" of Joint: **YES**
Remarks:

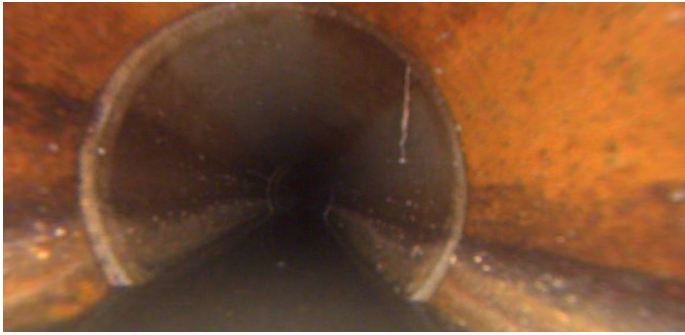
Code: **RFJ**
Description: **Roots Fine Joint**

Distance (ft): **96.9**
Structural Grade: **0**
O&M Grade: **1**
Clock Start/From: **2**
Clock To:
1st Value:
2nd Value:
Value Percent:
Continuous Index:
Within 8" of Joint: **YES**
Remarks:

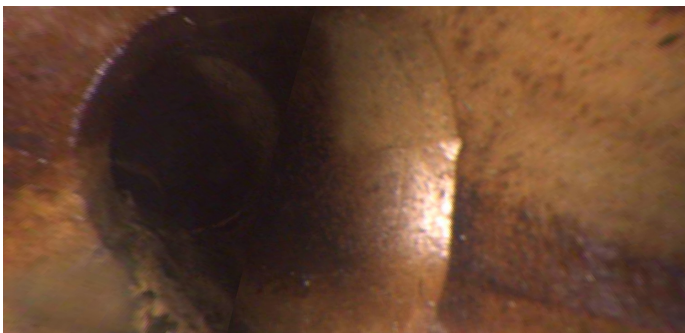
Code: **TF**
Description: **Tap Factory**

Distance (ft): **101.3**
Structural Grade: **0**
O&M Grade: **0**
Clock Start/From: **9**
Clock To:
1st Value: **4.000**
2nd Value:
Value Percent:
Continuous Index:
Within 8" of Joint:
Remarks:

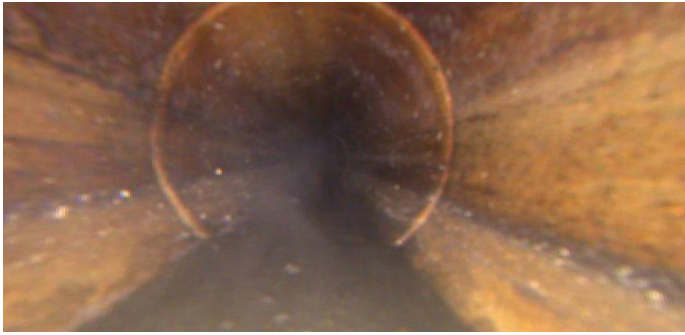
Code: **MGO**
Description: **General Observation**

Distance (ft): **102.9**
Structural Grade: **0**
O&M Grade: **0**
Clock Start/From:
Clock To:
1st Value:
2nd Value:
Value Percent:
Continuous Index:
Within 8" of Joint: **NO**
Remarks: **SLIGHT FOG**

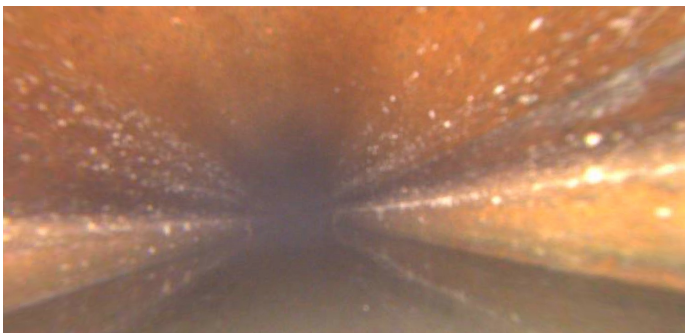
Code: **MWL**
Description: **Water Level**

Distance (ft): **122.2**
Structural Grade: **0**
O&M Grade: **0**
Clock Start/From:
Clock To:
1st Value:
2nd Value:
Value Percent: **30.000**
Continuous Index:
Within 8" of Joint: **NO**
Remarks:

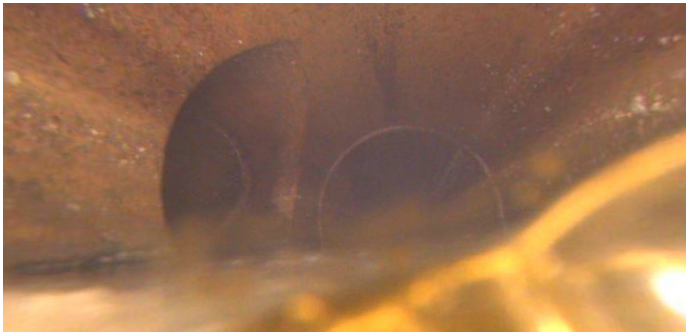
Code: **TF**
Description: **Tap Factory**

Distance (ft): **141.9**
Structural Grade: **0**
O&M Grade: **0**
Clock Start/From: **3**
Clock To:
1st Value: **4.000**
2nd Value:
Value Percent:
Continuous Index:
Within 8" of Joint:
Remarks:

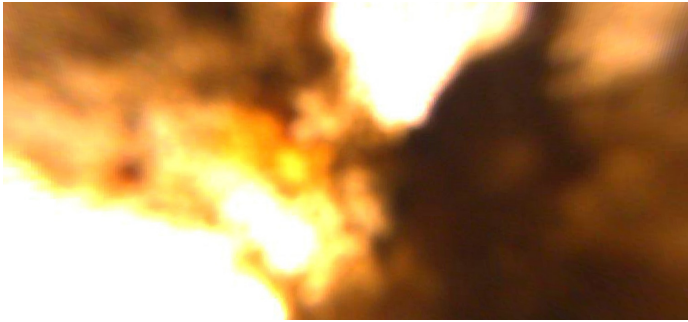
Code:	AMH
Description:	Manhole
Distance (ft):	194.7
Structural Grade:	0
O&M Grade:	0
Clock Start/From:	
Clock To:	
1st Value:	
2nd Value:	
Value Percent:	
Continuous Index:	
Within 8" of Joint:	NO
Remarks:	M-806-015
