Profile/Photo Observation Report

Street:	Memory Lane	Flow Control:	
City:	Hobart, IN	Year Renewed:	
Location:	Light Highway	Tape/Media #:	928
Purpose:	Routine Assessment	Dia/Height:	10"
Use:	Sanitary	Material:	VCP
Drain Area:		Lining:

US MH: **M-806-16** DS MH: **M-806-15** Total Length Surveyed (ft): **50.4**

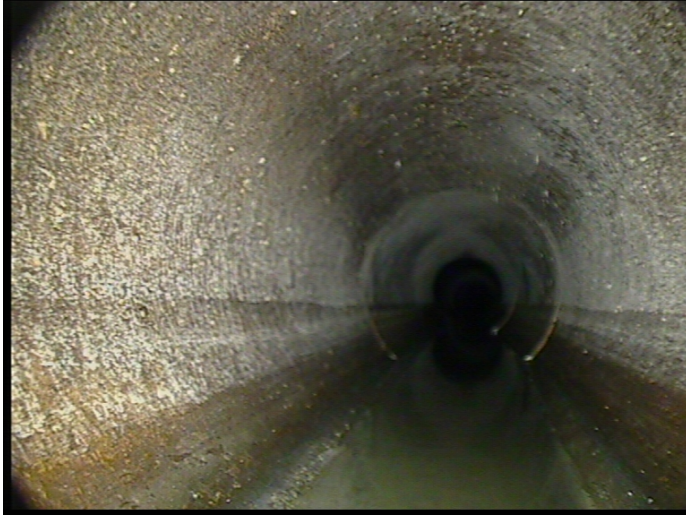
Code: **MWL**
Description: **Water Level**

Distance (ft): **.0**
Structural Grade: **0**
O&M Grade: **0**
Clock Start/From:
Clock To:
1st Value:
2nd Value:
Value Percent: **5.000**
Continuous Index:
Within 8" of Joint: **NO**
Remarks:

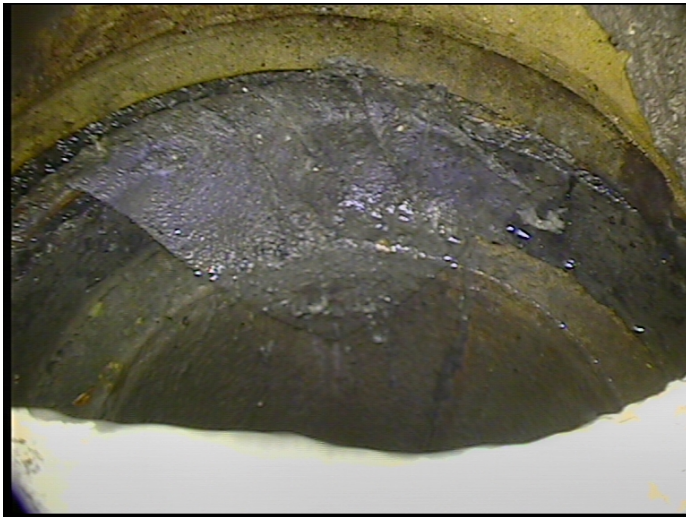
Code: **TFA**
Description: **Tap Factory Active**

Distance (ft): **50.4**
Structural Grade: **0**
O&M Grade: **0**
Clock Start/From: **6**
Clock To:
1st Value: **6.000**
2nd Value:
Value Percent:
Continuous Index:
Within 8" of Joint: **NO**
Remarks: **drop connection**

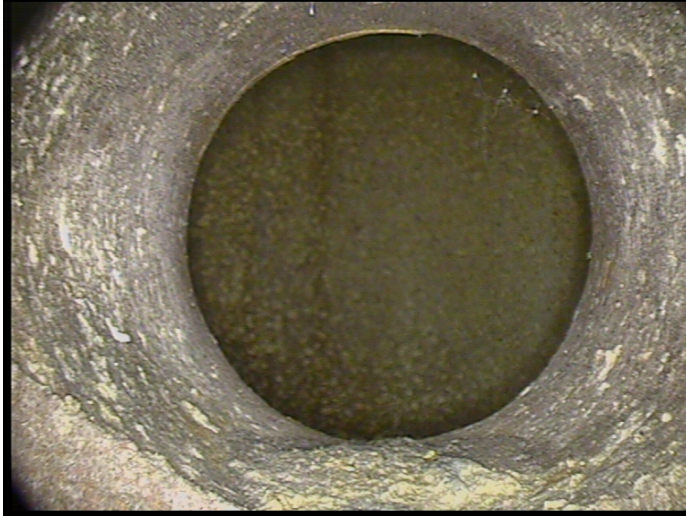
Code:	AMH
Description:	Manhole
Distance (ft):	50.4
Structural Grade:	0
O&M Grade:	0
Clock Start/From:	
Clock To:	
1st Value:	
2nd Value:	
Value Percent:	
Continuous Index:	
Within 8" of Joint:	NO
Remarks:	M-806-15
