Profile/Photo Observation Report

Street:	Capitol	Flow Control:	Not Controlled
City:	Hobart, IN	Year Renewed:	
Location:	Light Highway	Tape/Media #:	
Purpose:	Maintenance Related	Dia/Height:	12"
Use:	Sanitary	Material:	VCP
Drain Area:	NA	Lining:	Cured in Place
Category:	NA		
Comment:	Roots at 78'.

Location Details:		Direction of Survey:	Downstream
US MH:	M-806-024	DS MH:	M-706-007
		Total Length Surveyed (ft):	79.6

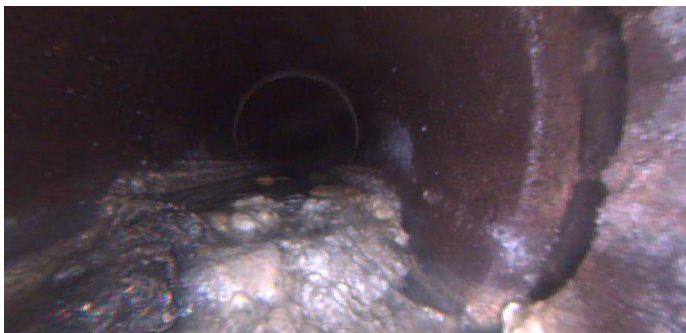
Code: **AMH**
Description: **Manhole**

Distance (ft): **.0**
Structural Grade: **0**
O&M Grade: **0**
Clock Start/From:
Clock To:
1st Value:
2nd Value:
Value Percent:
Continuous Index:
Within 8" of Joint: **NO**
Remarks: **M-806-024**

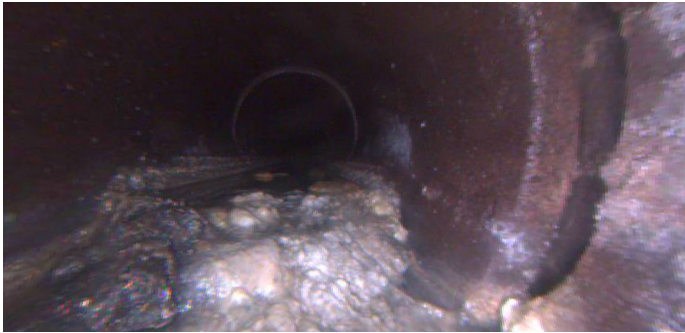
Code:	MWL
Description:	Water Level

Distance (ft):	.0
Structural Grade:	0
O&M Grade:	0
Clock Start/From:	
Clock To:	
1st Value:	
2nd Value:	
Value Percent:	5.000
Continuous Index:	
Within 8" of Joint:	NO
Remarks:

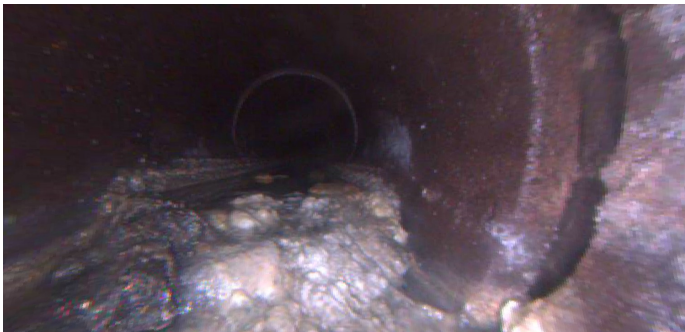
Code:	DSZ
Description:	Deposits Settled Other

Distance (ft):	.0
Structural Grade:	0
O&M Grade:	2
Clock Start/From:	6
Clock To:	
1st Value:	
2nd Value:	
Value Percent:	10.000
Continuous Index:	
Within 8" of Joint:	NO
Remarks:	tissue

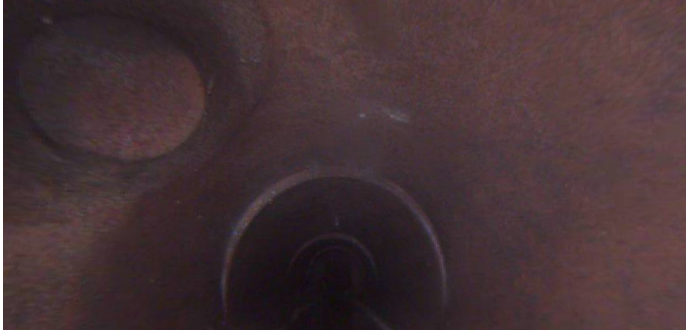
Code: **TFC**
Description: **Tap Factory Capped**

Distance (ft): **23.4**
Structural Grade: **0**
O&M Grade: **0**
Clock Start/From: **11**
Clock To:
1st Value: **4.000**
2nd Value:
Value Percent:
Continuous Index:
Within 8" of Joint: **YES**
Remarks:

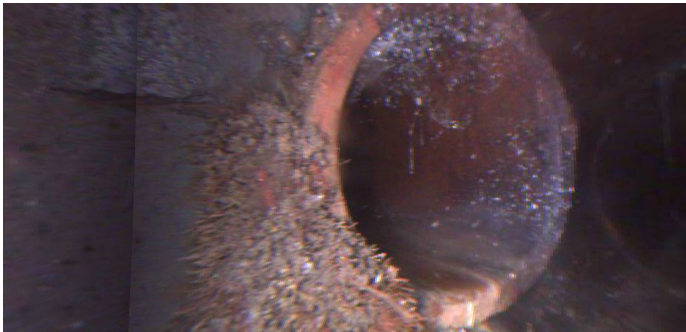
Code: **TBI**
Description: **Tap Break-in Intruding**

Distance (ft): **30.7**
Structural Grade: **0**
O&M Grade: **2**
Clock Start/From: **9**
Clock To:
1st Value: **4.000**
2nd Value: **1.000**
Value Percent:
Continuous Index:
Within 8" of Joint: **YES**
Remarks:

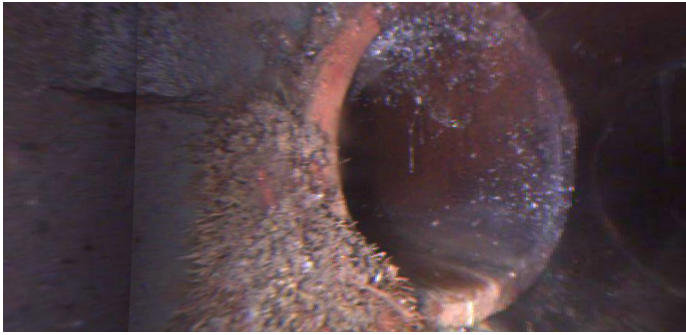
Code: **RFC**
Description: **Roots Fine Connection**

Distance (ft): **30.7**
Structural Grade: **0**
O&M Grade: **1**
Clock Start/From: **7**
Clock To: **9**
1st Value:
2nd Value:
Value Percent:
Continuous Index:
Within 8" of Joint: **NO**
Remarks:

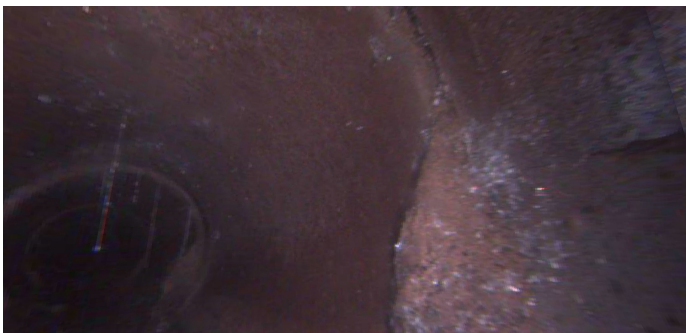
Code: **DAE**
Description: **Deposits Attached Encrustation**

Distance (ft): **30.7**
Structural Grade: **0**
O&M Grade: **2**
Clock Start/From: **3**
Clock To: **5**
1st Value:
2nd Value:
Value Percent: **5.000**
Continuous Index:
Within 8" of Joint: **YES**
Remarks:

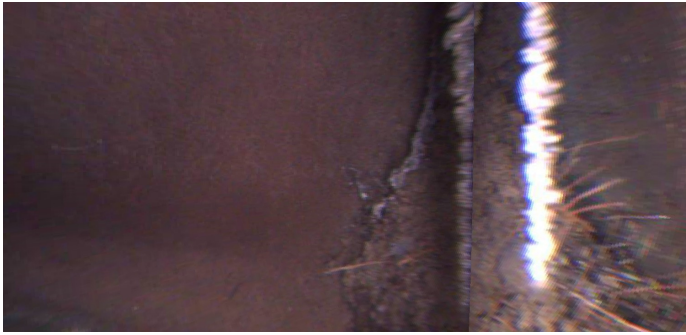
Code: **RFJ**
Description: **Roots Fine Joint**

Distance (ft): **33.1**
Structural Grade: **0**
O&M Grade: **1**
Clock Start/From: **4**
Clock To: **5**
1st Value:
2nd Value:
Value Percent:
Continuous Index: **S01**
Within 8" of Joint: **YES**
Remarks: **wandering**

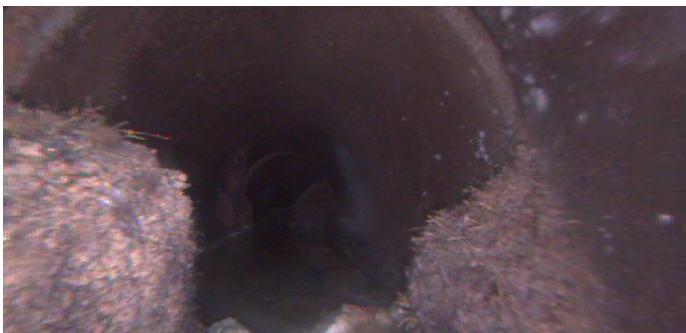
Code: **RMJ**
Description: **Roots Medium Joint**

Distance (ft): **42.8**
Structural Grade: **0**
O&M Grade: **3**
Clock Start/From: **7**
Clock To: **5**
1st Value:
2nd Value:
Value Percent: **20.000**
Continuous Index:
Within 8" of Joint: **YES**
Remarks: **wandering**

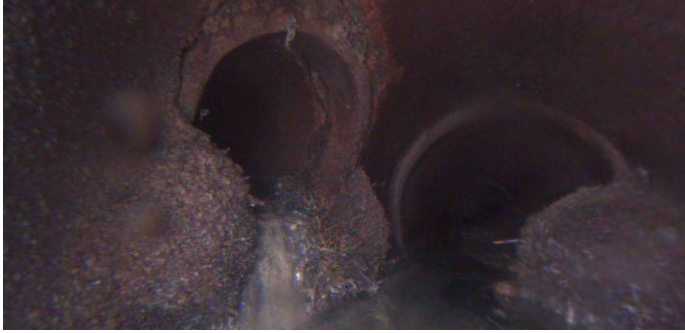
Code: **TBD**
Description: **Tap Break-in Defective**

Distance (ft): **44.8**
Structural Grade: **0**
O&M Grade: **3**
Clock Start/From: **9**
Clock To:
1st Value: **4.000**
2nd Value:
Value Percent:
Continuous Index:
Within 8" of Joint:
Remarks: **roots**

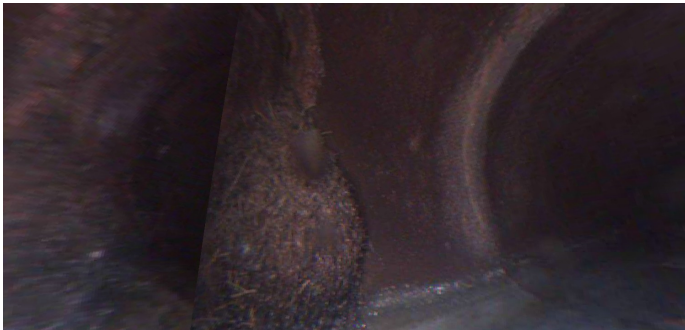
Code: **RMC**
Description: **Roots Medium Connection**

Distance (ft): **45.3**
Structural Grade: **0**
O&M Grade: **3**
Clock Start/From: **3**
Clock To: **5**
1st Value:
2nd Value:
Value Percent: **5.000**
Continuous Index:
Within 8" of Joint: **NO**
Remarks:

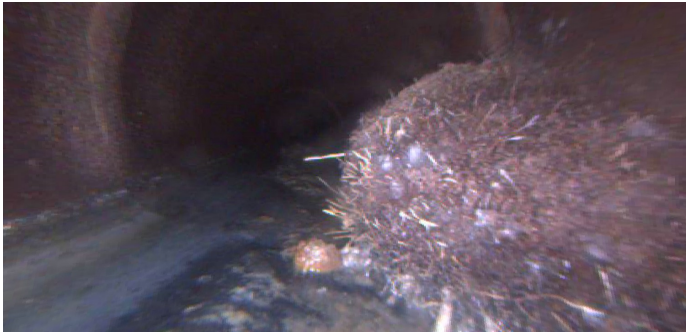
Code: **RMJ**
Description: **Roots Medium Joint**

Distance (ft): **45.5**
Structural Grade: **0**
O&M Grade: **3**
Clock Start/From: **3**
Clock To: **5**
1st Value:
2nd Value:
Value Percent: **10.000**
Continuous Index: **S02**
Within 8" of Joint: **YES**
Remarks: **wandering**

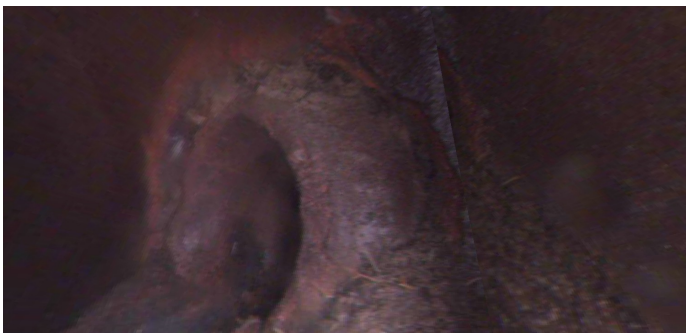
Code: **TBI**
Description: **Tap Break-in Intruding**

Distance (ft): **45.7**
Structural Grade: **0**
O&M Grade: **2**
Clock Start/From: **9**
Clock To:
1st Value: **4.000**
2nd Value: **1.000**
Value Percent:
Continuous Index:
Within 8" of Joint:
Remarks:

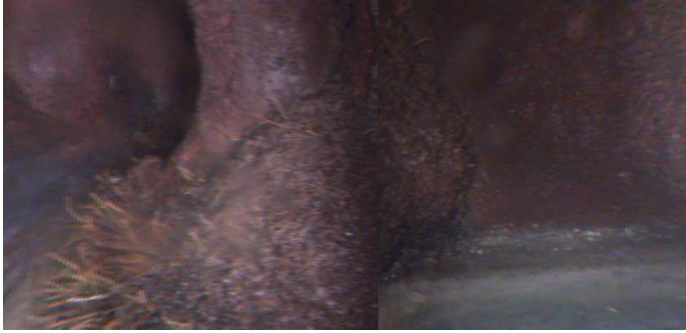
Code: **RMC**
Description: **Roots Medium Connection**

Distance (ft): **45.7**
Structural Grade: **0**
O&M Grade: **3**
Clock Start/From: **5**
Clock To:
1st Value:
2nd Value:
Value Percent: **5.000**
Continuous Index:
Within 8" of Joint: **NO**
Remarks:

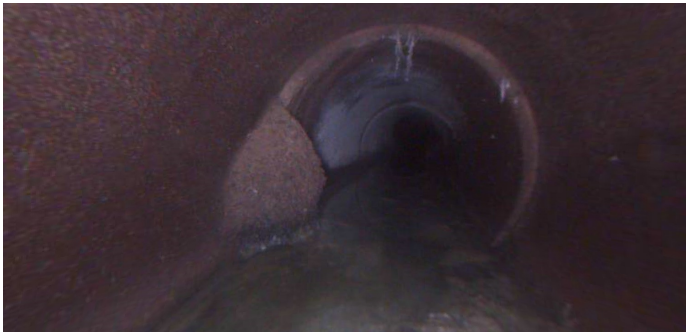
Code: **LR**
Description: **Alignment Right**

Distance (ft): **50.4**
Structural Grade: **0**
O&M Grade: **1**
Clock Start/From:
Clock To:
1st Value:
2nd Value:
Value Percent: **5.000**
Continuous Index:
Within 8" of Joint: **NO**
Remarks:

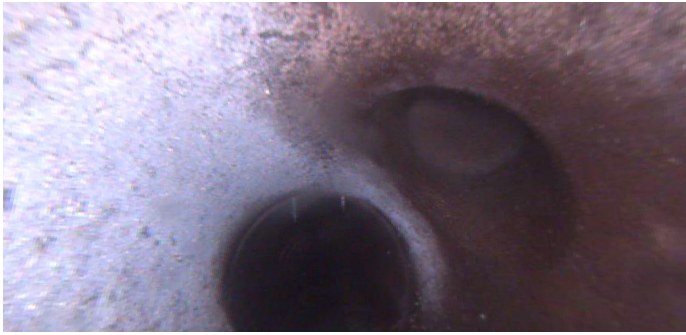
Code: **TFC**
Description: **Tap Factory Capped**

Distance (ft): **56.7**
Structural Grade: **0**
O&M Grade: **0**
Clock Start/From: **1**
Clock To:
1st Value: **4.000**
2nd Value:
Value Percent:
Continuous Index:
Within 8" of Joint: **YES**
Remarks:

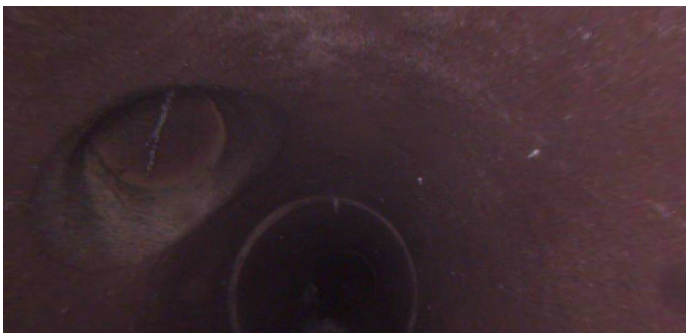
Code: **TFC**
Description: **Tap Factory Capped**

Distance (ft): **59.8**
Structural Grade: **0**
O&M Grade: **0**
Clock Start/From: **11**
Clock To:
1st Value: **4.000**
2nd Value:
Value Percent:
Continuous Index:
Within 8" of Joint: **YES**
Remarks:

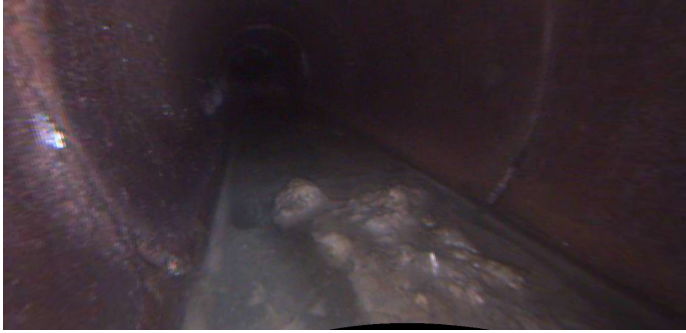
Code: **DSZ**
Description: **Deposits Settled Other**

Distance (ft): **67.2**
Structural Grade: **0**
O&M Grade: **2**
Clock Start/From: **6**
Clock To:
1st Value:
2nd Value:
Value Percent: **5.000**
Continuous Index: **S03**
Within 8" of Joint: **NO**
Remarks: **debris**

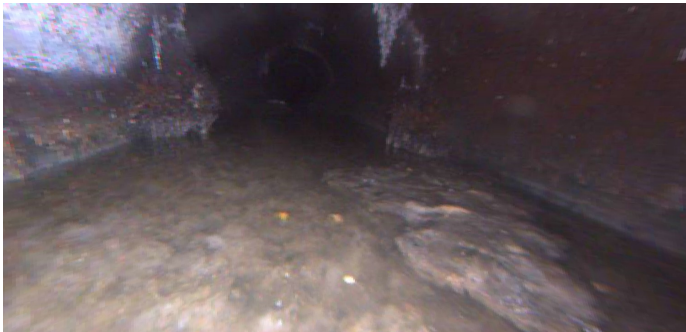
Code: **MSA**
Description: **Abandoned Survey**

Distance (ft): **79.6**
Structural Grade: **0**
O&M Grade: **0**
Clock Start/From:
Clock To:
1st Value:
2nd Value:
Value Percent:
Continuous Index:
Within 8" of Joint: **NO**
Remarks: **camera stopped/debris?**

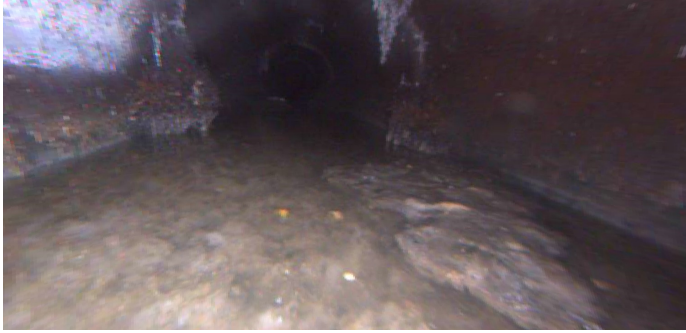
Code: **DSZ**
Description: **Deposits Settled Other**

Distance (ft): **79.6**
Structural Grade: **0**
O&M Grade: **2**
Clock Start/From: **6**
Clock To:
1st Value:
2nd Value:
Value Percent: **5.000**
Continuous Index: **F03**
Within 8" of Joint: **NO**
Remarks: **debris**

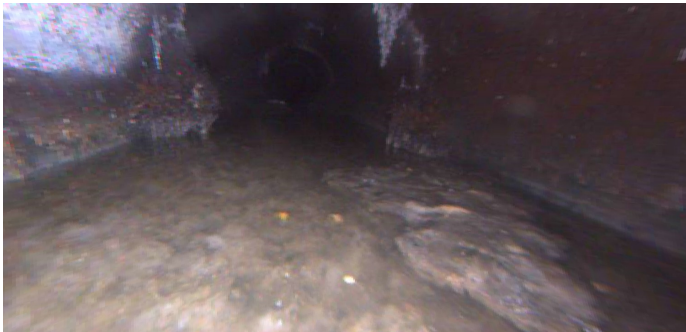
Code: **RMJ**
Description: **Roots Medium Joint**

Distance (ft): **79.6**
Structural Grade: **0**
O&M Grade: **3**
Clock Start/From: **3**
Clock To: **5**
1st Value:
2nd Value:
Value Percent: **10.000**
Continuous Index: **F02**
Within 8" of Joint: **YES**
Remarks: **wandering**

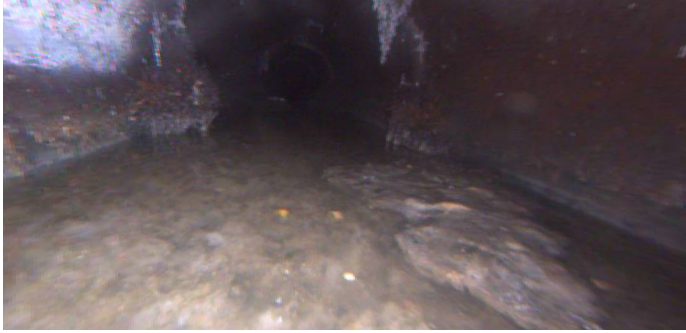
Code:	RFJ
Description:	Roots Fine Joint
Distance (ft):	79.6
Structural Grade:	0
O&M Grade:	1
Clock Start/From:	4
Clock To:	5
1st Value:	
2nd Value:	
Value Percent:	
Continuous Index:	F01
Within 8" of Joint:	YES
Remarks:	wandering
