Profile/Photo Observation Report

Date:	02/26/2022	Weather:		Coding:	PACP 7.0
Pipe Length (ft):	301.9	Owner:	City of Hobart	Pre Clean:	Heavy Cleaning
P.O.#:	YES502259	Surveyor:	S. Bucklin	PSR:	P-706-007-024
Customer:	City of Hobart, IN (Red	Clean Date:	02/22/2022	Shape:	C

Street:	South Linda Street	Flow Control:	Not Controlled
City:	Hobart, IN	Year Renewed:	
Location:	Local rural streets with light traffic, t	Tape/Media #:	
Purpose:	Routine Assessment	Dia/Height:	12"
Use:	Sanitary Sewage Pipe	Material:	VCP
Drain Area:		Lining:	None
Category:	NA		
Comment:			
Location Details:		Direction of Survey:	Upstream
US MH:	M-806-024	DS MH:	M-706-007
		Total Length Surveyed (ft):	31.8

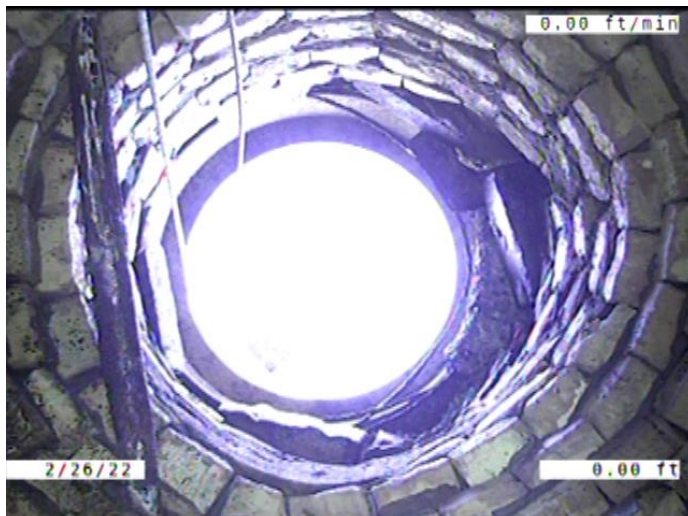
Code: **AMH**
 Description: **Manhole**

Distance (ft): **.0**
 Structural Grade: **0**
 O&M Grade: **0**
 Clock Start/From:
 Clock To:
 1st Value:
 2nd Value:
 Value Percent:
 Continuous Index:
 Within 8" of Joint: **NO**
 Remarks: **M-706-007**

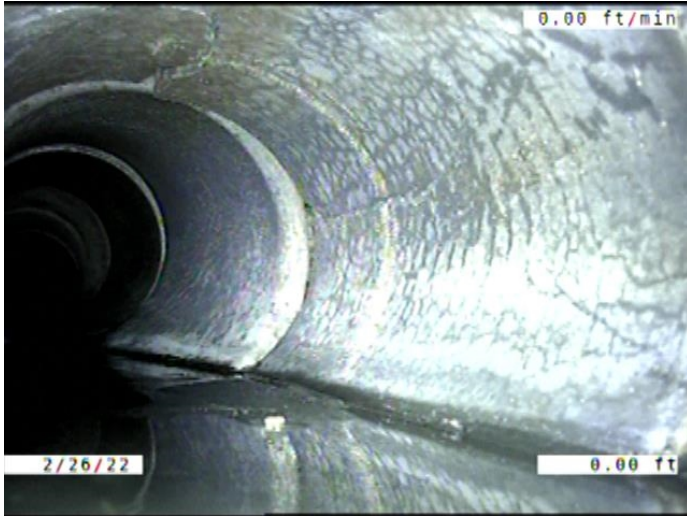
Code: **MWL**
Description: **Miscellaneous Water Level**

Distance (ft): **.0**
Structural Grade: **0**
O&M Grade: **0**
Clock Start/From:
Clock To:
1st Value:
2nd Value:
Value Percent: **5.000**
Continuous Index:
Within 8" of Joint: **NO**
Remarks:

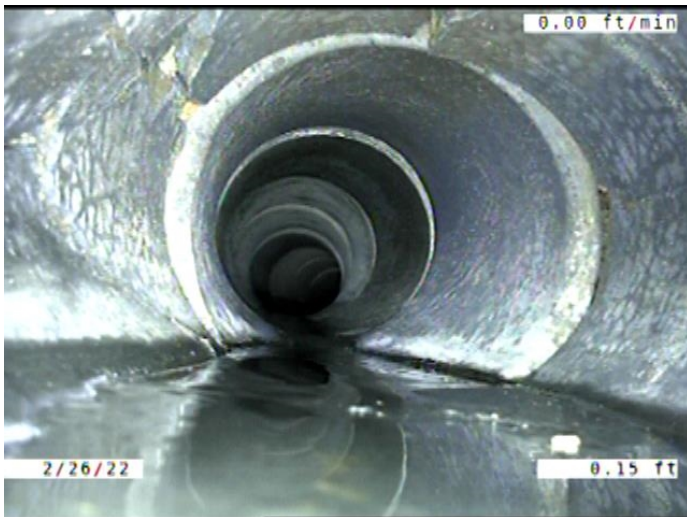
Code: **DSF**
Description: **Deposits Settled Fine**

Distance (ft): **.2**
Structural Grade: **0**
O&M Grade: **2**
Clock Start/From: **5**
Clock To: **7**
1st Value:
2nd Value:
Value Percent: **5.000**
Continuous Index: **S01**
Within 8" of Joint: **YES**
Remarks:

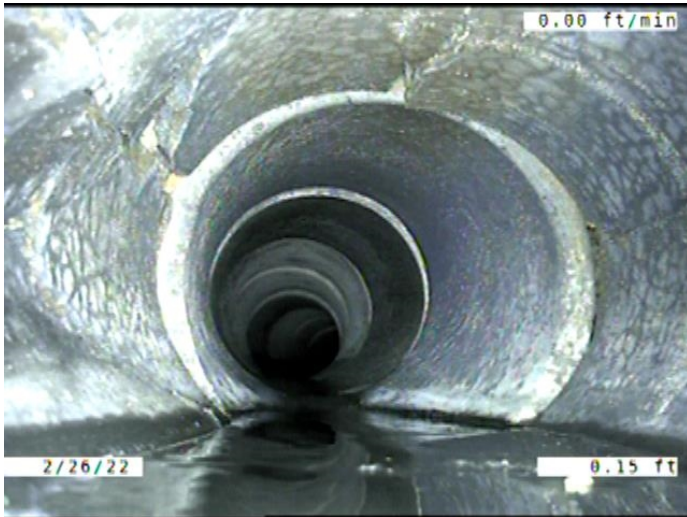
Code: **B**
 Description: **Broken**

Distance (ft): **.2**
 Structural Grade: **4**
 O&M Grade: **0**
 Clock Start/From: **8**
 Clock To: **4**
 1st Value:
 2nd Value:
 Value Percent:
 Continuous Index:
 Within 8" of Joint: **YES**
 Remarks:

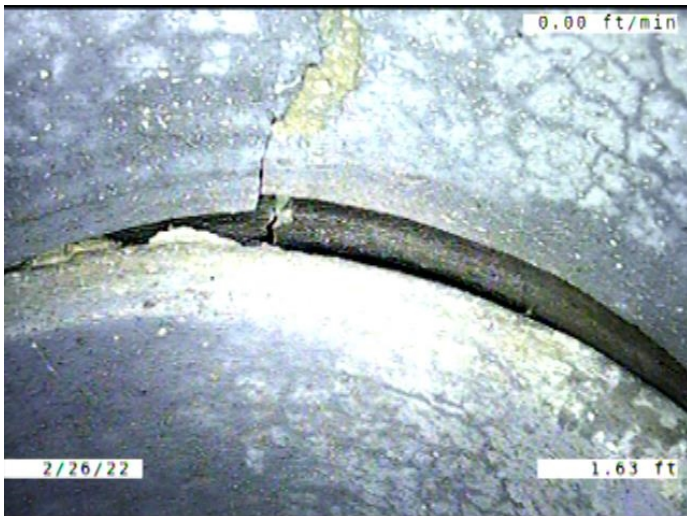
Code: **JOMD**
 Description: **Joint Offset Medium Defective**

Distance (ft): **1.6**
 Structural Grade: **3**
 O&M Grade: **0**
 Clock Start/From:
 Clock To:
 1st Value:
 2nd Value:
 Value Percent:
 Continuous Index:
 Within 8" of Joint: **NO**
 Remarks: **VOID VISIBLE**

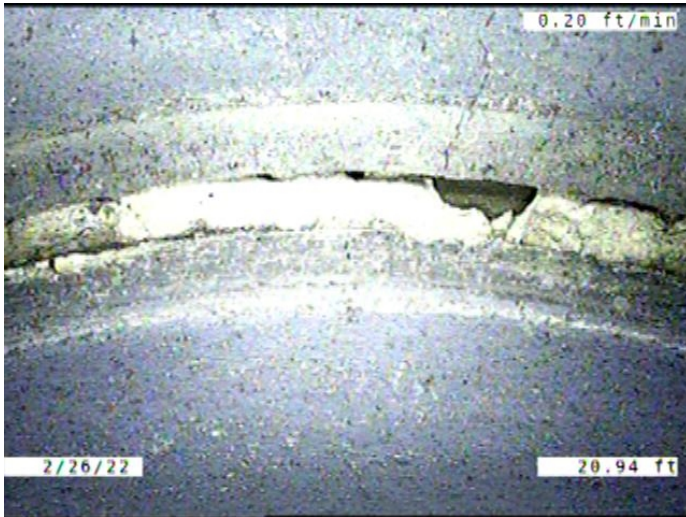
Code: **JOM**
Description: **Joint Offset Medium**

Distance (ft): **20.9**
Structural Grade: **3**
O&M Grade: **0**
Clock Start/From:
Clock To:
1st Value:
2nd Value:
Value Percent:
Continuous Index:
Within 8" of Joint: **NO**
Remarks:

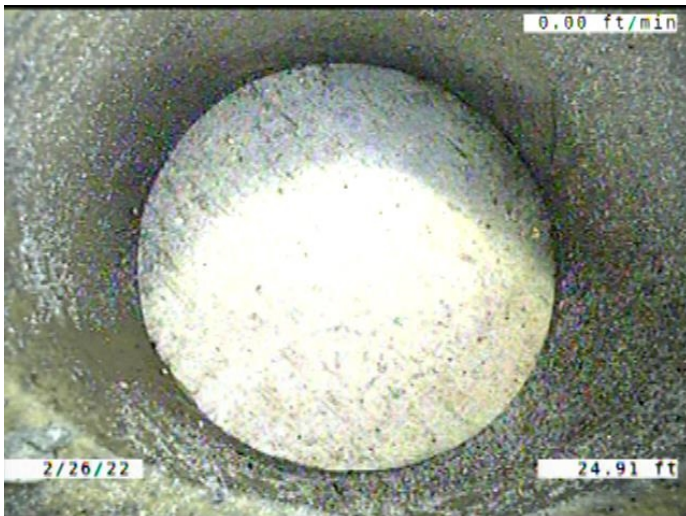
Code: **TFC**
Description: **Tap Factory Capped**

Distance (ft): **24.9**
Structural Grade: **0**
O&M Grade: **0**
Clock Start/From: **11**
Clock To:
1st Value: **6.000**
2nd Value:
Value Percent:
Continuous Index:
Within 8" of Joint: **YES**
Remarks:

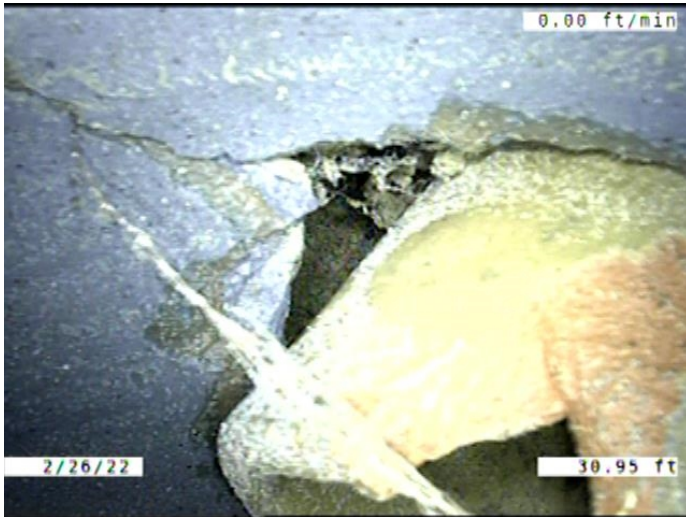
Code: **BVV**
 Description: **Broken Void Visible**

Distance (ft): **31.0**
 Structural Grade: **5**
 O&M Grade: **0**
 Clock Start/From: **8**
 Clock To: **4**
 1st Value:
 2nd Value:
 Value Percent:
 Continuous Index:
 Within 8" of Joint: **NO**
 Remarks:

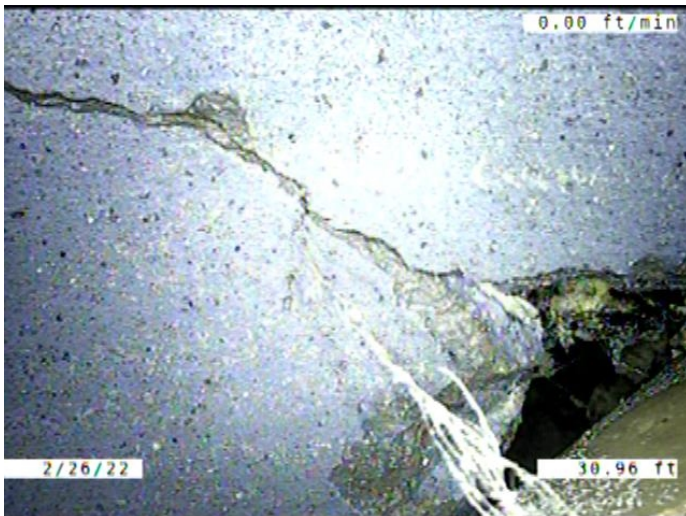
Code: **RFB**
 Description: **Roots Fine Barrel**

Distance (ft): **31.0**
 Structural Grade: **0**
 O&M Grade: **2**
 Clock Start/From: **1**
 Clock To:
 1st Value:
 2nd Value:
 Value Percent:
 Continuous Index:
 Within 8" of Joint: **NO**
 Remarks:

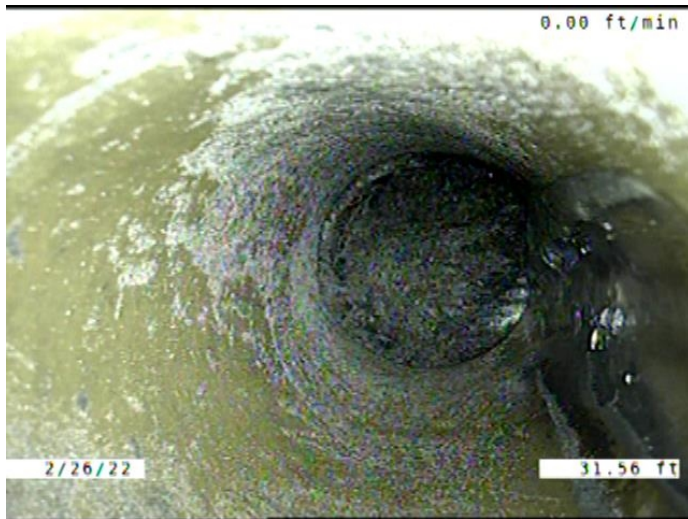
Code: **TBI**
Description: **Tap Break-in Intruding**

Distance (ft): **31.6**
Structural Grade: **0**
O&M Grade: **2**
Clock Start/From: **3**
Clock To:
1st Value: **6.000**
2nd Value: **3.000**
Value Percent:
Continuous Index:
Within 8" of Joint: **NO**
Remarks: **95% PLUGGED WITH ROOTS.
CONSTANTLY RUNNING WATER.**

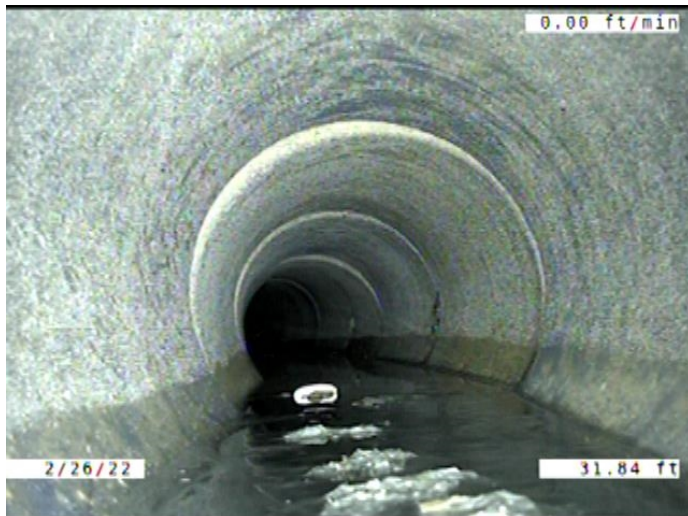
Code: **DSF**
Description: **Deposits Settled Fine**

Distance (ft): **31.8**
Structural Grade: **0**
O&M Grade: **2**
Clock Start/From: **5**
Clock To: **7**
1st Value:
2nd Value:
Value Percent: **5.000**
Continuous Index: **F01**
Within 8" of Joint: **YES**
Remarks:

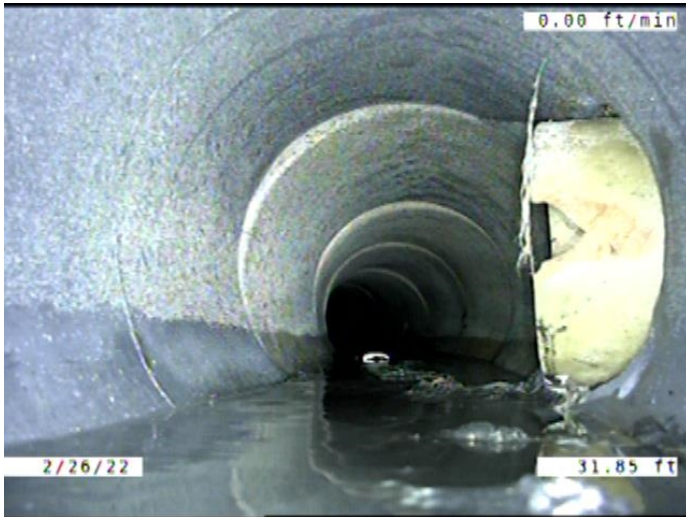
Code: **MSA**
Description: **Miscellaneous Survey Abandoned**

Distance (ft): **31.8**
Structural Grade: **0**
O&M Grade: **0**
Clock Start/From:
Clock To:
1st Value:
2nd Value:
Value Percent:
Continuous Index:
Within 8" of Joint: **NO**
Remarks: **CAMERA CANT MAKE IT PAST PROTRUDING TAP.**
