Profile/Photo Observation Report

Date:	02/28/2022	Weather:		Coding:	PACP 7.0
Pipe Length (ft):	302.0	Owner:	City of Hobart	Pre Clean:	Heavy Cleaning
P.O.#:	YES502259	Surveyor:	S. Bucklin	PSR:	P-706-007-024
Customer:	City of Hobart, IN (Red	Clean Date:	02/22/2022	Shape:	C

Street:	South Linda Street	Flow Control:	Not Controlled
City:	Hobart, IN	Year Renewed:	
Location:	Local rural streets with light traffic, t	Tape/Media #:	
Purpose:	Routine Assessment	Dia/Height:	12"
Use:	Sanitary Sewage Pipe	Material:	VCP
Drain Area:		Lining:	None
Category:	NA		
Comment:			
Location Details:		Direction of Survey:	Downstream
US MH:	M-806-024	DS MH:	M-706-007
		Total Length Surveyed (ft):	269.7

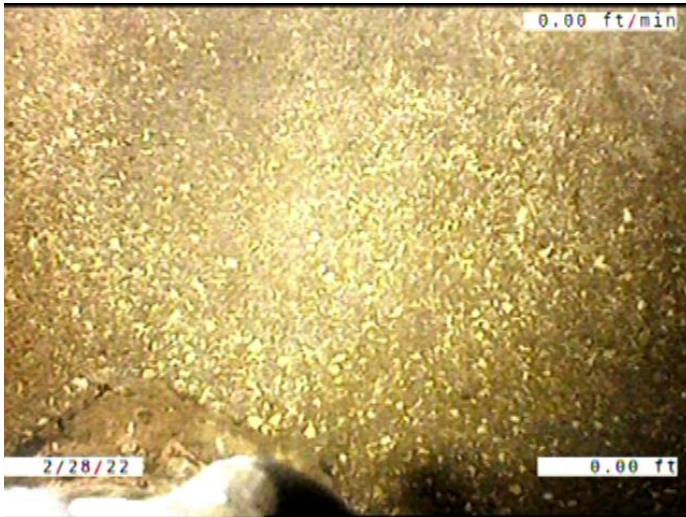
Code: **AMH**
 Description: **Manhole**

Distance (ft): **.0**
 Structural Grade: **0**
 O&M Grade: **0**
 Clock Start/From:
 Clock To:
 1st Value:
 2nd Value:
 Value Percent:
 Continuous Index:
 Within 8" of Joint: **NO**
 Remarks: **M-806-024**

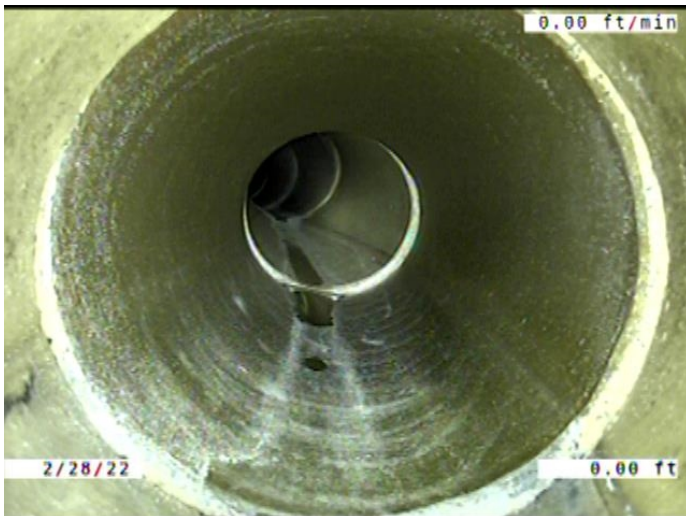
Code: **MWL**
 Description: **Miscellaneous Water Level**

Distance (ft): **.0**
 Structural Grade: **0**
 O&M Grade: **0**
 Clock Start/From:
 Clock To:
 1st Value:
 2nd Value:
 Value Percent: **5.000**
 Continuous Index:
 Within 8" of Joint: **NO**
 Remarks:

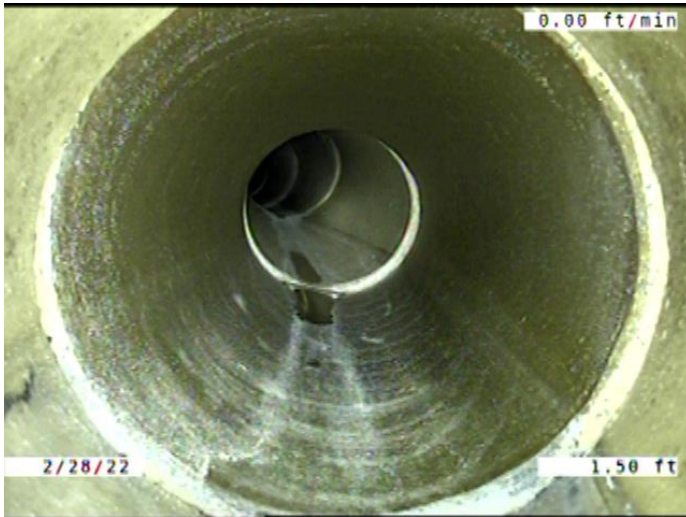
Code: **MGO**
Description: **Miscellaneous General Observation**

Distance (ft): **1.5**
Structural Grade: **0**
O&M Grade: **0**
Clock Start/From:
Clock To:
1st Value:
2nd Value:
Value Percent:
Continuous Index:
Within 8" of Joint: **NO**
Remarks: **DROP INTO THE MANHOLE. HAD TO START IN THE PIPE.**

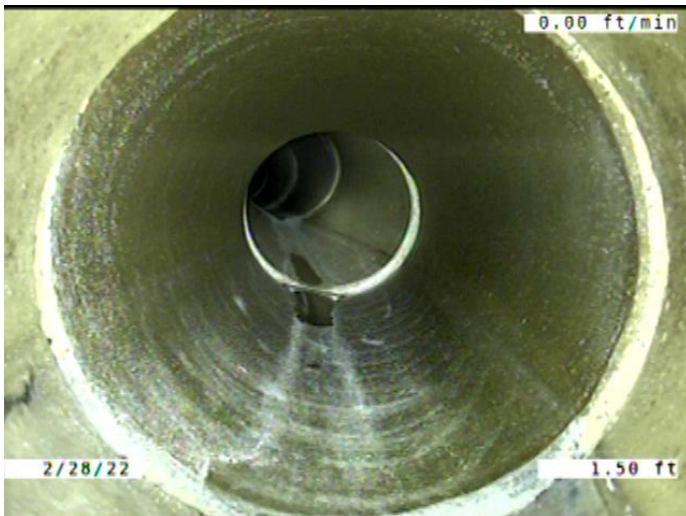
Code: **MWLS**
Description: **Miscellaneous Water Level Sag**

Distance (ft): **1.5**
Structural Grade: **2**
O&M Grade: **0**
Clock Start/From:
Clock To:
1st Value:
2nd Value:
Value Percent: **5.000**
Continuous Index: **S01**
Within 8" of Joint: **NO**
Remarks:

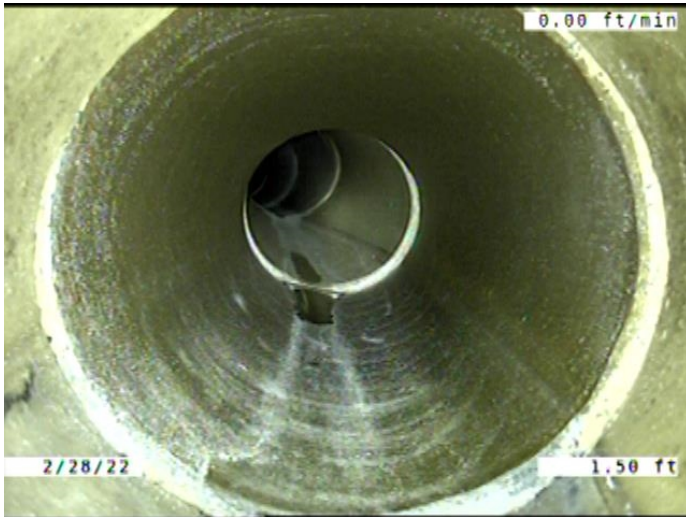
Code:	MGO
Description:	Miscellaneous General Observation
Distance (ft):	1.5
Structural Grade:	0
O&M Grade:	0
Clock Start/From:	
Clock To:	
1st Value:	
2nd Value:	
Value Percent:	
Continuous Index:	
Within 8" of Joint:	NO
Remarks:	-7.5% INCLINE

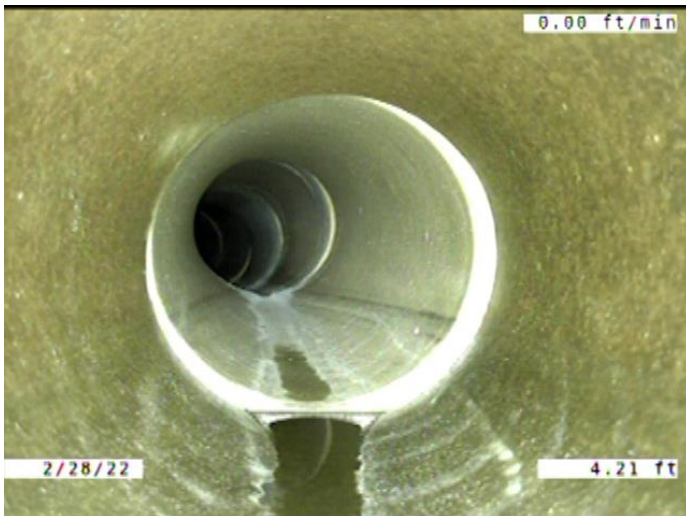
Code:	LLU
Description:	Line Left Up
Distance (ft):	4.2
Structural Grade:	0
O&M Grade:	1
Clock Start/From:	
Clock To:	
1st Value:	
2nd Value:	
Value Percent:	10.000
Continuous Index:	
Within 8" of Joint:	NO
Remarks:

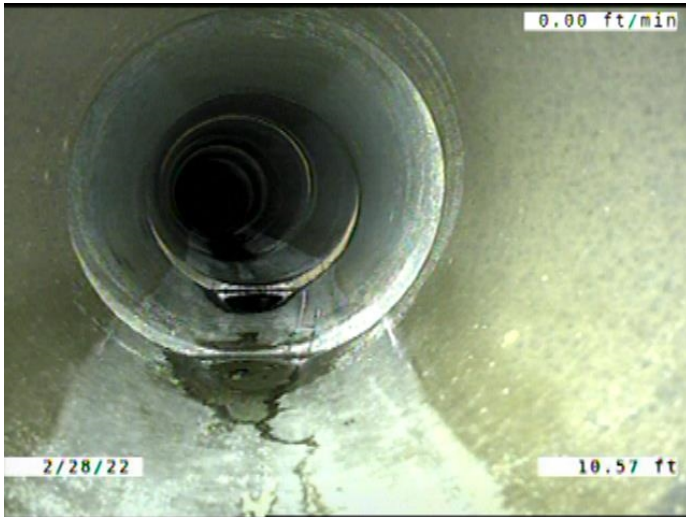
Code: **MWLS**
 Description: **Miscellaneous Water Level Sag**

Distance (ft): **10.6**
 Structural Grade: **2**
 O&M Grade: **0**
 Clock Start/From:
 Clock To:
 1st Value:
 2nd Value:
 Value Percent: **5.000**
 Continuous Index: **F01**
 Within 8" of Joint: **NO**
 Remarks:

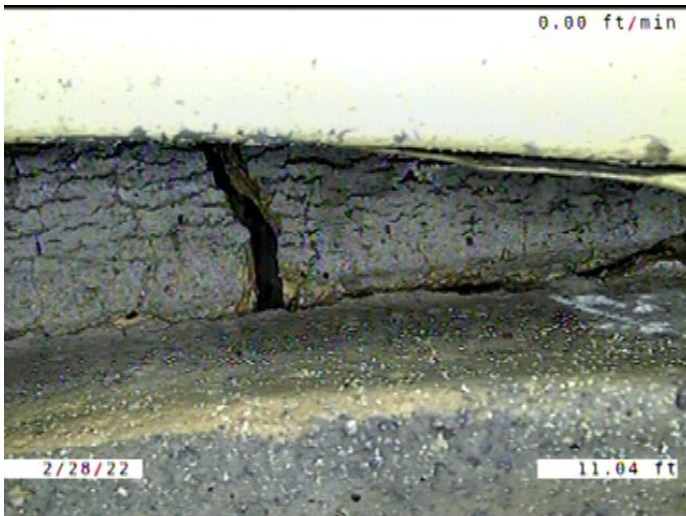
Code: **BSV**
 Description: **Broken Soil Visible**

Distance (ft): **11.0**
 Structural Grade: **5**
 O&M Grade: **0**
 Clock Start/From: **12**
 Clock To: **12**
 1st Value:
 2nd Value:
 Value Percent:
 Continuous Index:
 Within 8" of Joint: **YES**
 Remarks:

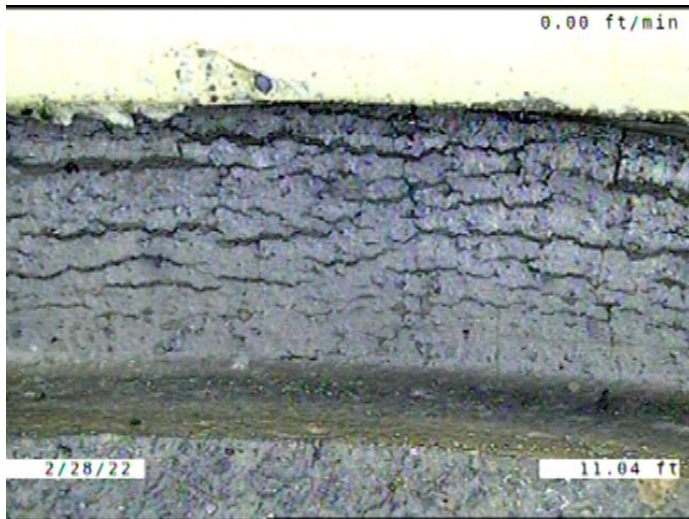
Code: **JAL**
Description: **Joint Angular Large**

Distance (ft): **11.0**
Structural Grade: **4**
O&M Grade: **0**
Clock Start/From:
Clock To:
1st Value:
2nd Value:
Value Percent:
Continuous Index:
Within 8" of Joint: **NO**
Remarks:

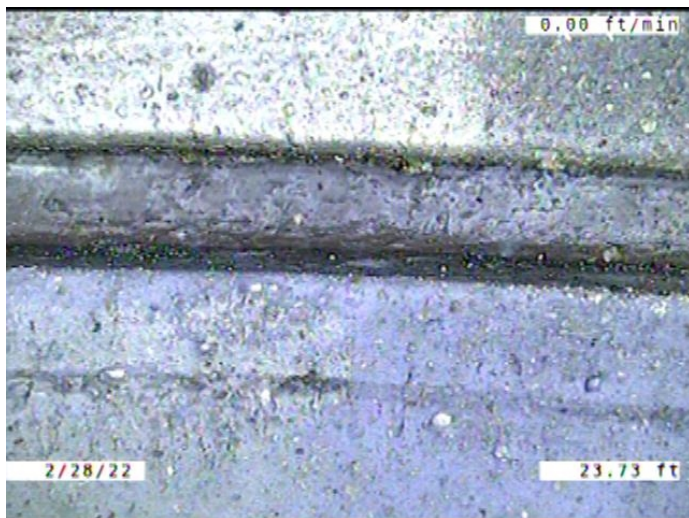
Code: **JAM**
Description: **Joint Angular Medium**

Distance (ft): **23.7**
Structural Grade: **3**
O&M Grade: **0**
Clock Start/From:
Clock To:
1st Value:
2nd Value:
Value Percent:
Continuous Index: **S02**
Within 8" of Joint: **NO**
Remarks:

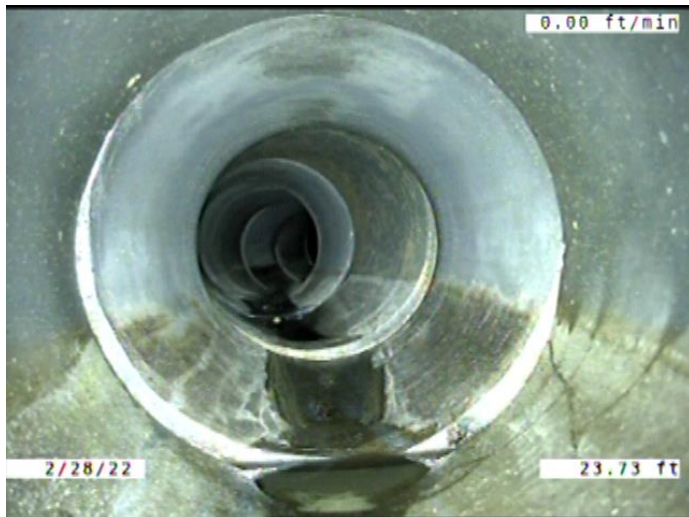
Code: **LL**
 Description: **Line Left**

Distance (ft): **23.7**
 Structural Grade: **0**
 O&M Grade: **1**
 Clock Start/From:
 Clock To:
 1st Value:
 2nd Value:
 Value Percent: **5.000**
 Continuous Index: **S03**
 Within 8" of Joint: **NO**
 Remarks:

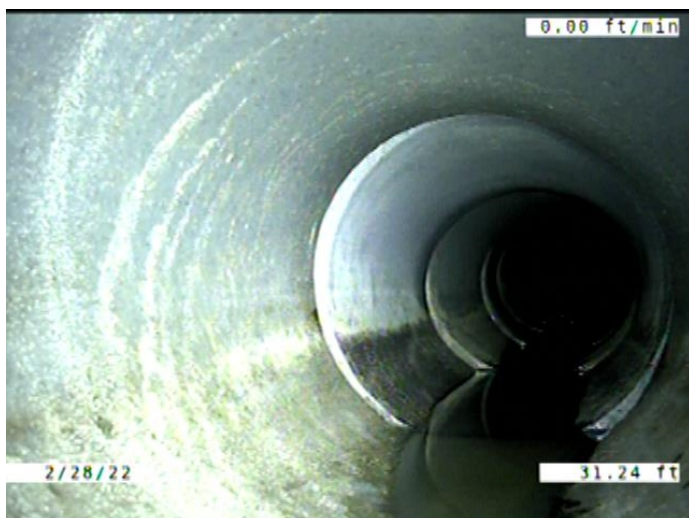
Code: **LL**
 Description: **Line Left**

Distance (ft): **31.2**
 Structural Grade: **0**
 O&M Grade: **1**
 Clock Start/From:
 Clock To:
 1st Value:
 2nd Value:
 Value Percent: **5.000**
 Continuous Index: **F03**
 Within 8" of Joint: **NO**
 Remarks:

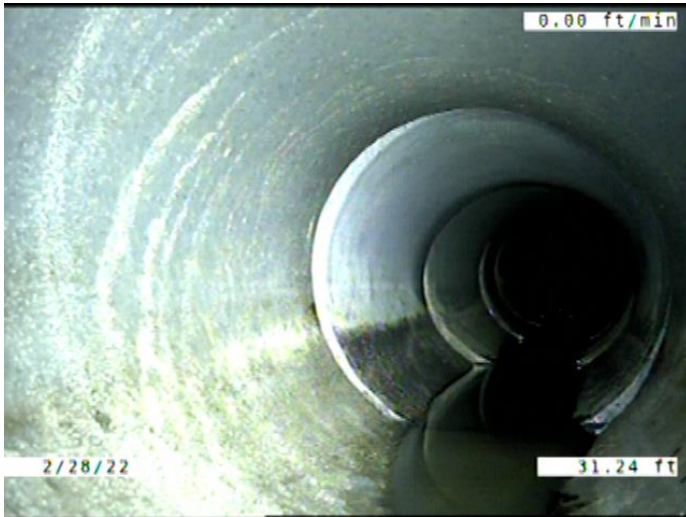
Code: **LR**
Description: **Line Right**

Distance (ft): **31.2**
Structural Grade: **0**
O&M Grade: **1**
Clock Start/From:
Clock To:
1st Value:
2nd Value:
Value Percent: **10.000**
Continuous Index:
Within 8" of Joint: **NO**
Remarks:

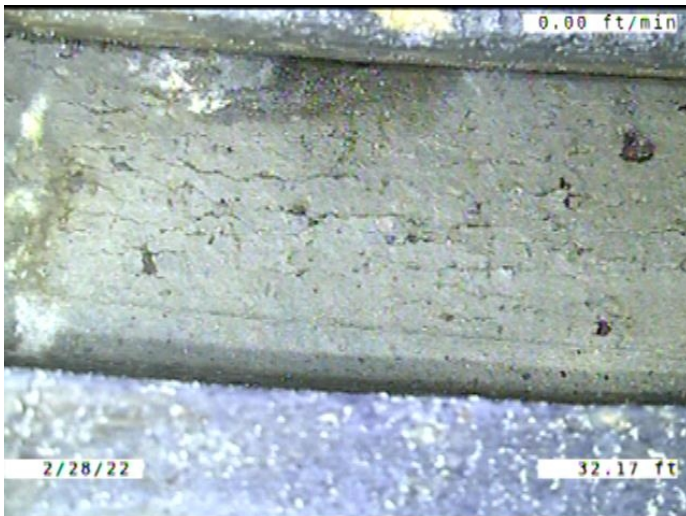
Code: **JAL**
Description: **Joint Angular Large**

Distance (ft): **32.2**
Structural Grade: **4**
O&M Grade: **0**
Clock Start/From:
Clock To:
1st Value:
2nd Value:
Value Percent:
Continuous Index:
Within 8" of Joint: **NO**
Remarks:

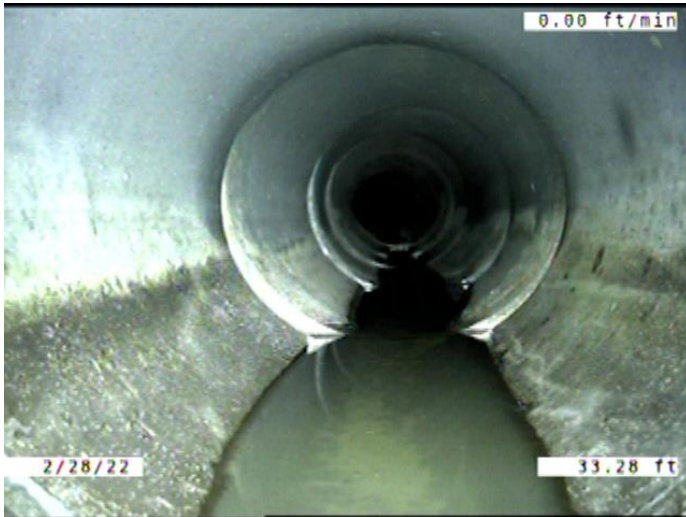
Code: **MWLS**
 Description: **Miscellaneous Water Level Sag**

Distance (ft): **33.3**
 Structural Grade: **2**
 O&M Grade: **0**
 Clock Start/From:
 Clock To:
 1st Value:
 2nd Value:
 Value Percent: **10.000**
 Continuous Index:
 Within 8" of Joint: **NO**
 Remarks:

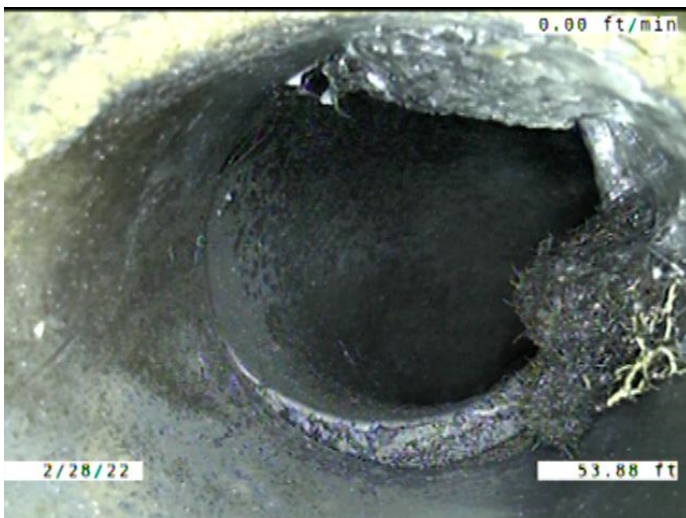
Code: **TF**
 Description: **Tap Factory**

Distance (ft): **53.9**
 Structural Grade: **0**
 O&M Grade: **0**
 Clock Start/From: **1**
 Clock To:
 1st Value: **6.000**
 2nd Value:
 Value Percent:
 Continuous Index:
 Within 8" of Joint: **YES**
 Remarks: **SERVICE TO MAIN CONNECTION
 OFFSET AND ROOTS GROWING IN IT.**

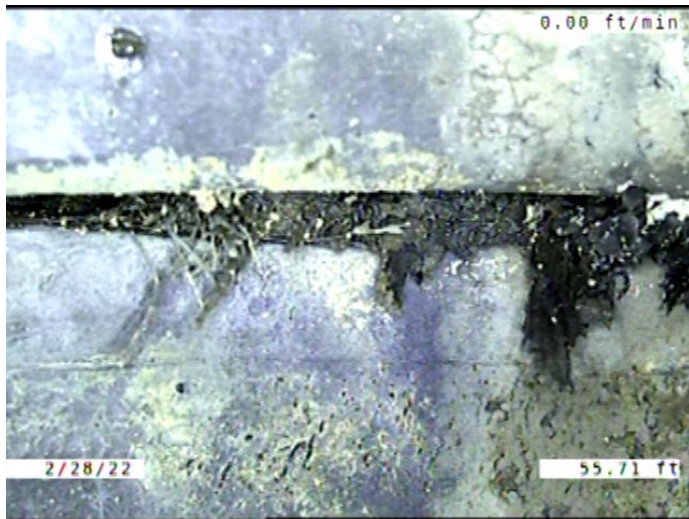
Code: **RFJ**
Description: **Roots Fine Joint**

Distance (ft): **55.7**
Structural Grade: **0**
O&M Grade: **1**
Clock Start/From: **8**
Clock To: **10**
1st Value:
2nd Value:
Value Percent:
Continuous Index:
Within 8" of Joint: **YES**
Remarks:

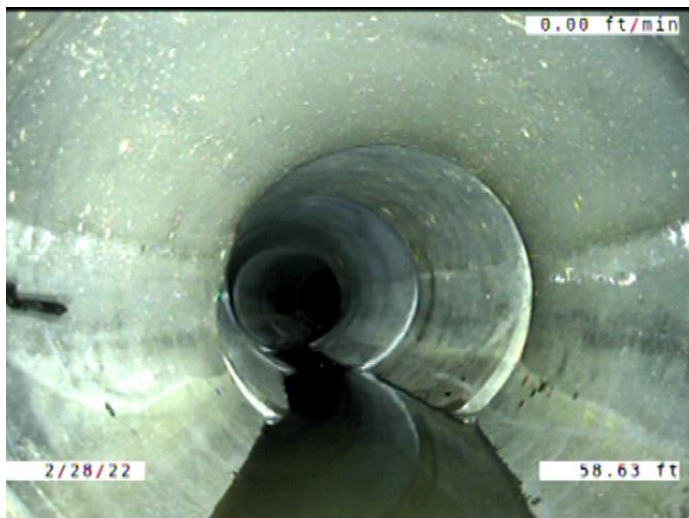
Code: **MWLS**
Description: **Miscellaneous Water Level Sag**

Distance (ft): **58.6**
Structural Grade: **2**
O&M Grade: **0**
Clock Start/From:
Clock To:
1st Value:
2nd Value:
Value Percent: **10.000**
Continuous Index:
Within 8" of Joint: **NO**
Remarks:

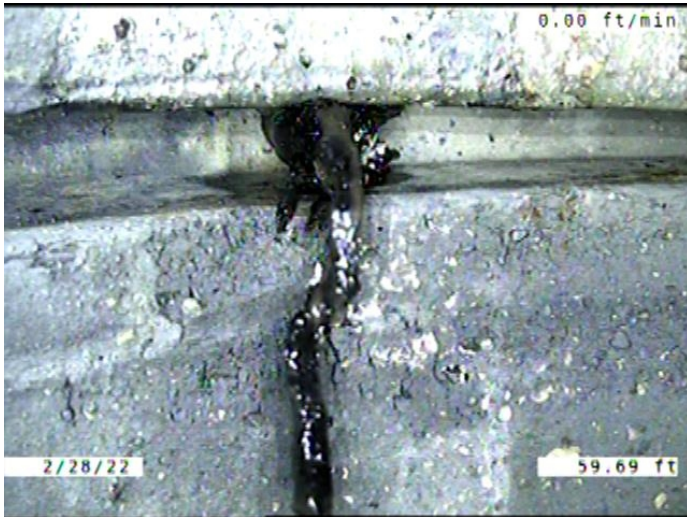
Code: **RFJ**
Description: **Roots Fine Joint**

Distance (ft): **59.7**
Structural Grade: **0**
O&M Grade: **1**
Clock Start/From: **10**
Clock To:
1st Value:
2nd Value:
Value Percent:
Continuous Index:
Within 8" of Joint: **YES**
Remarks:

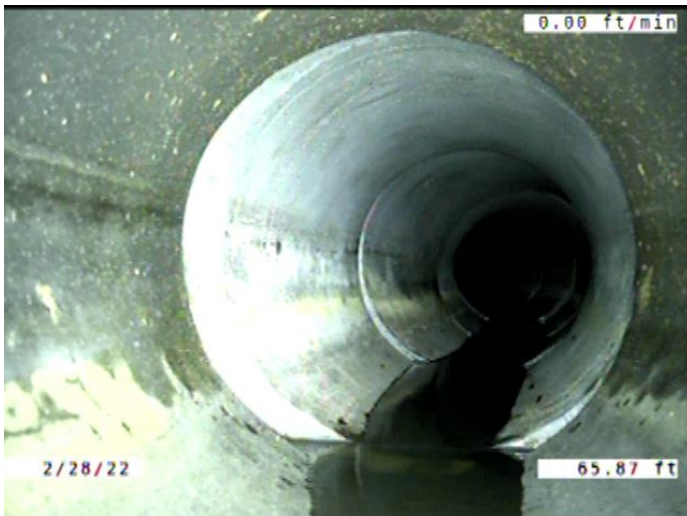
Code: **LR**
Description: **Line Right**

Distance (ft): **65.9**
Structural Grade: **0**
O&M Grade: **1**
Clock Start/From:
Clock To:
1st Value:
2nd Value:
Value Percent: **5.000**
Continuous Index:
Within 8" of Joint: **NO**
Remarks:

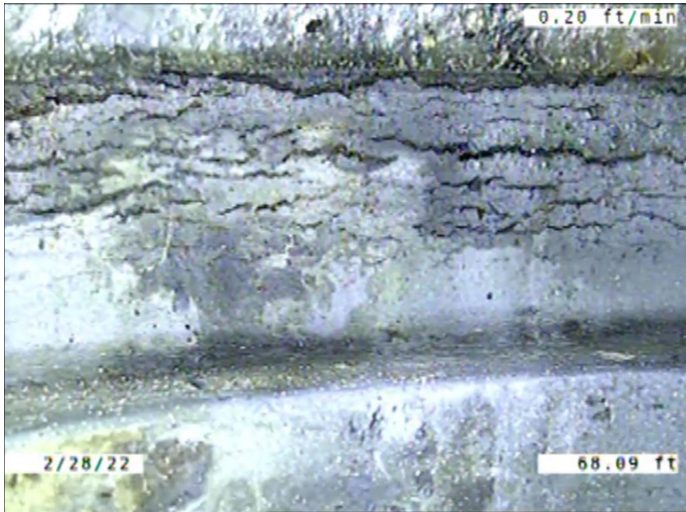
Code: **FM**
 Description: **Fracture Multiple**

Distance (ft): **68.1**
 Structural Grade: **4**
 O&M Grade: **0**
 Clock Start/From: **8**
 Clock To: **10**
 1st Value:
 2nd Value:
 Value Percent:
 Continuous Index:
 Within 8" of Joint: **YES**
 Remarks:

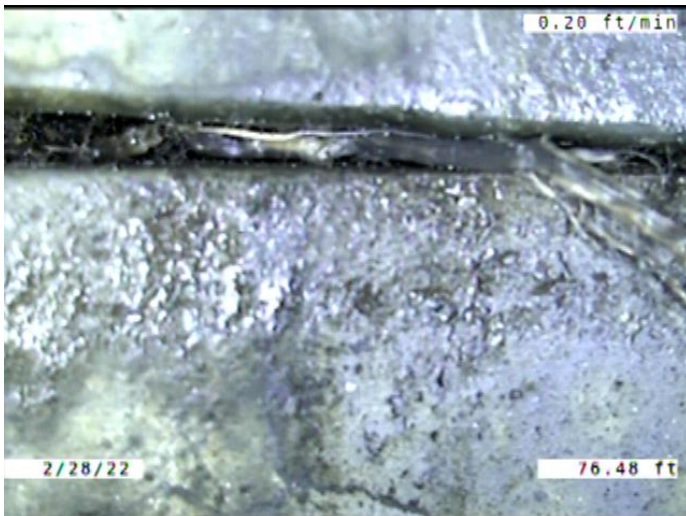
Code: **RFJ**
 Description: **Roots Fine Joint**

Distance (ft): **76.5**
 Structural Grade: **0**
 O&M Grade: **1**
 Clock Start/From: **9**
 Clock To: **10**
 1st Value:
 2nd Value:
 Value Percent:
 Continuous Index:
 Within 8" of Joint: **YES**
 Remarks:

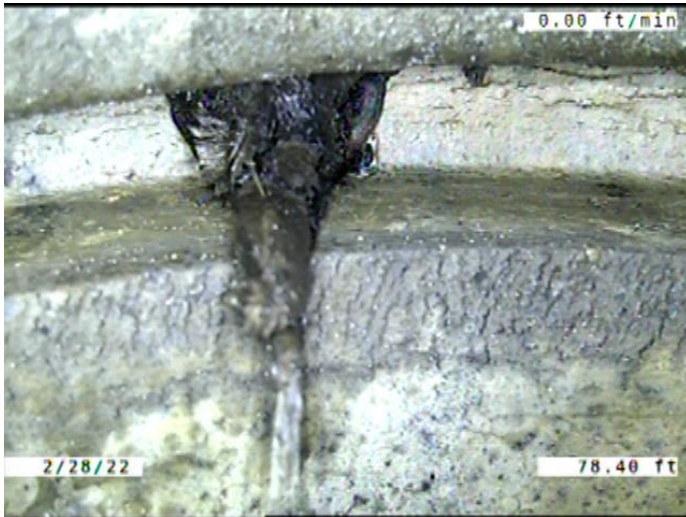
Code: **RFJ**
Description: **Roots Fine Joint**

Distance (ft): **78.4**
Structural Grade: **0**
O&M Grade: **1**
Clock Start/From: **10**
Clock To:
1st Value:
2nd Value:
Value Percent:
Continuous Index:
Within 8" of Joint: **YES**
Remarks:

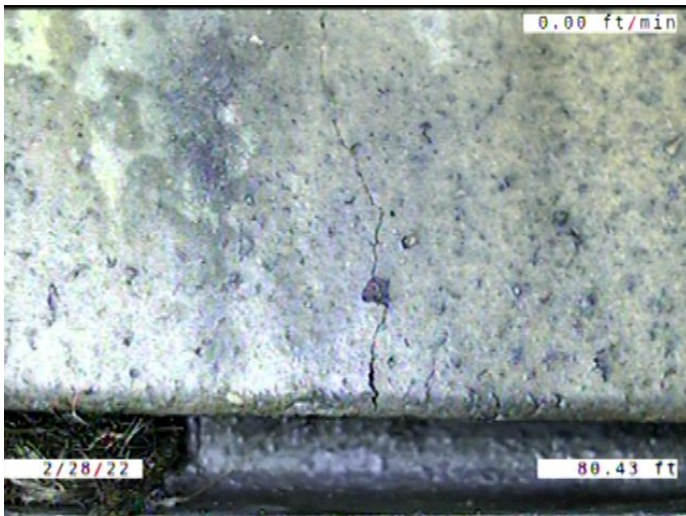
Code: **CL**
Description: **Crack Longitudinal**

Distance (ft): **80.4**
Structural Grade: **2**
O&M Grade: **0**
Clock Start/From: **10**
Clock To:
1st Value:
2nd Value:
Value Percent:
Continuous Index:
Within 8" of Joint: **YES**
Remarks:

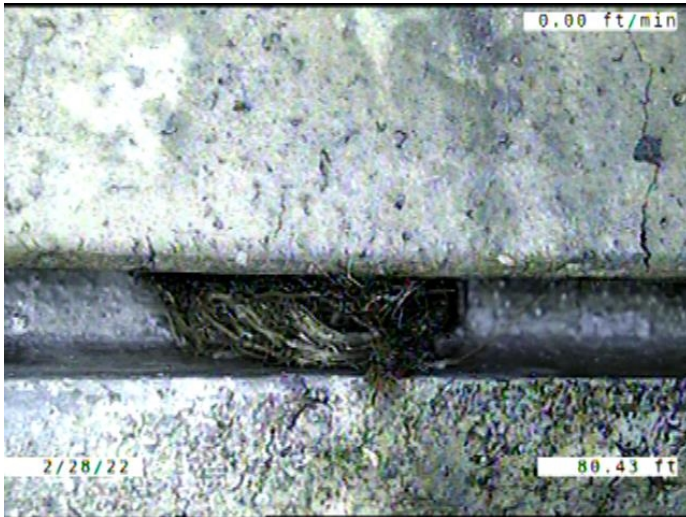
Code: **RFJ**
Description: **Roots Fine Joint**

Distance (ft): **80.4**
Structural Grade: **0**
O&M Grade: **1**
Clock Start/From: **9**
Clock To:
1st Value:
2nd Value:
Value Percent:
Continuous Index:
Within 8" of Joint: **YES**
Remarks:

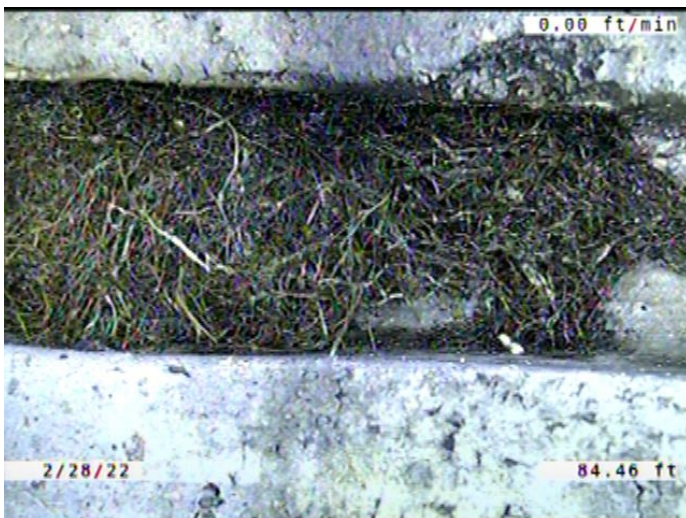
Code: **RFJ**
Description: **Roots Fine Joint**

Distance (ft): **84.5**
Structural Grade: **0**
O&M Grade: **1**
Clock Start/From: **9**
Clock To: **3**
1st Value:
2nd Value:
Value Percent:
Continuous Index: **S04**
Within 8" of Joint: **YES**
Remarks:

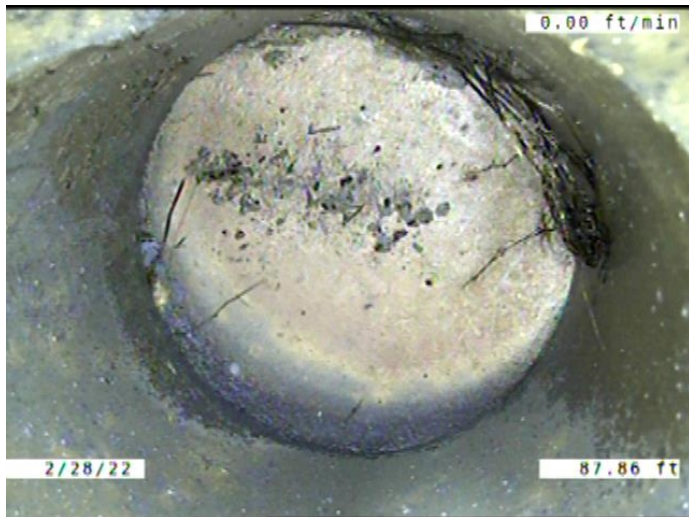
Code:	TFC
Description:	Tap Factory Capped
Distance (ft):	87.9
Structural Grade:	0
O&M Grade:	0
Clock Start/From:	2
Clock To:	
1st Value:	6.000
2nd Value:	
Value Percent:	
Continuous Index:	
Within 8" of Joint:	YES
Remarks:	ROOTS GROWING AROUND THE CAP

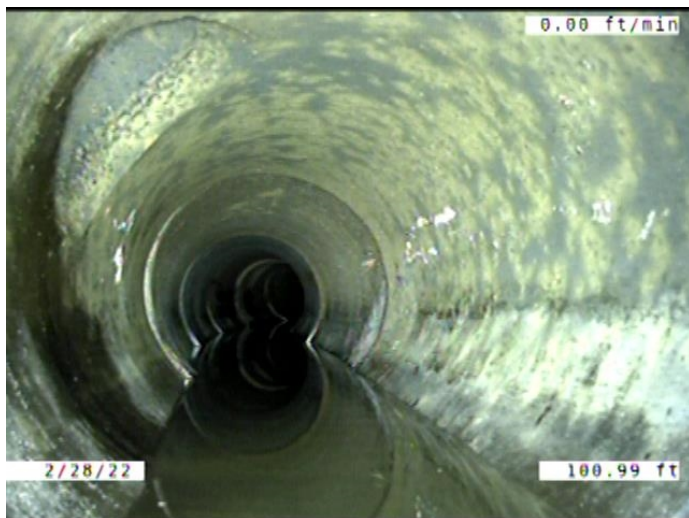
Code:	LL
Description:	Line Left
Distance (ft):	101.0
Structural Grade:	0
O&M Grade:	1
Clock Start/From:	
Clock To:	
1st Value:	
2nd Value:	
Value Percent:	5.000
Continuous Index:	
Within 8" of Joint:	NO
Remarks:

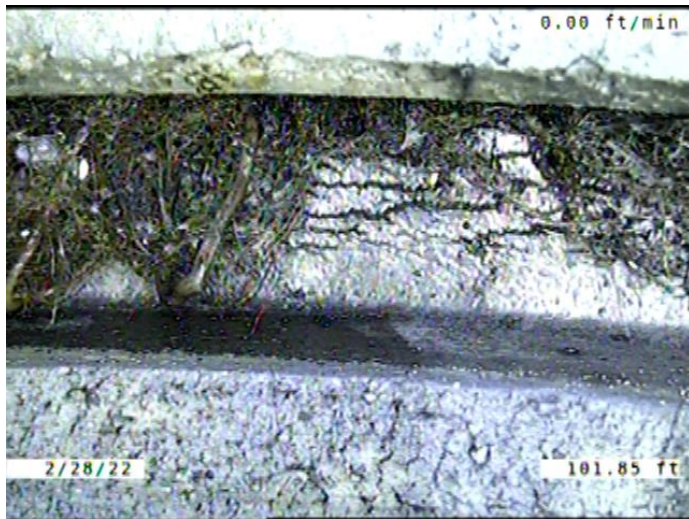
Code: **JAL**
 Description: **Joint Angular Large**

Distance (ft): **101.9**
 Structural Grade: **4**
 O&M Grade: **0**
 Clock Start/From:
 Clock To:
 1st Value:
 2nd Value:
 Value Percent:
 Continuous Index:
 Within 8" of Joint: **NO**
 Remarks:

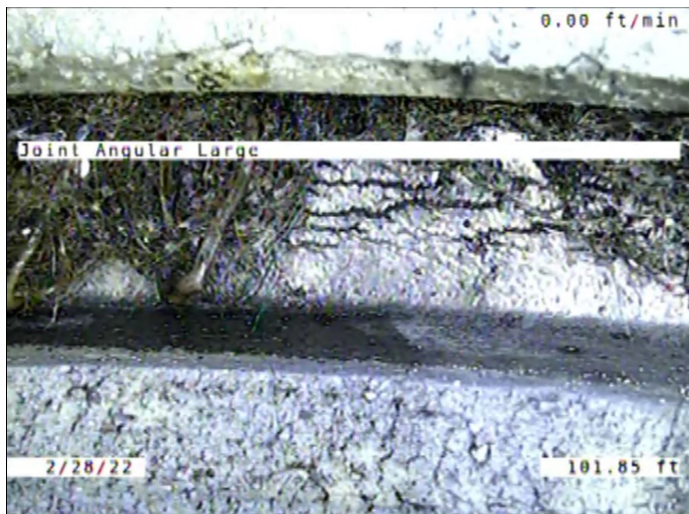
Code: **FM**
 Description: **Fracture Multiple**

Distance (ft): **101.9**
 Structural Grade: **4**
 O&M Grade: **0**
 Clock Start/From: **8**
 Clock To: **10**
 1st Value:
 2nd Value:
 Value Percent:
 Continuous Index:
 Within 8" of Joint: **YES**
 Remarks:

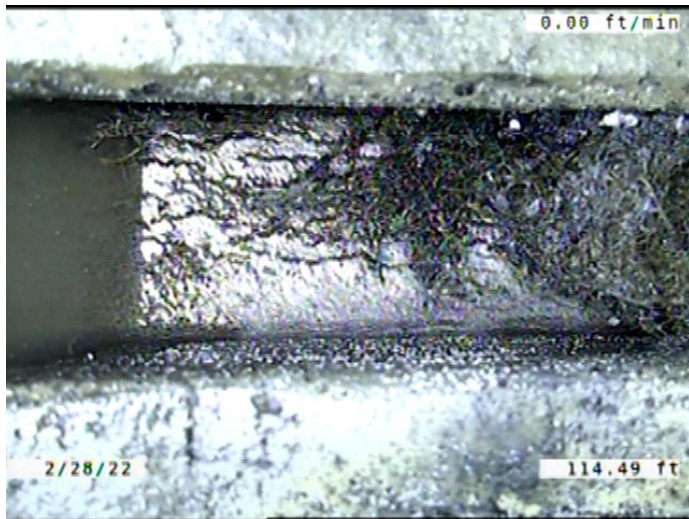
Code: **JAL**
 Description: **Joint Angular Large**

Distance (ft): **114.5**
 Structural Grade: **4**
 O&M Grade: **0**
 Clock Start/From:
 Clock To:
 1st Value:
 2nd Value:
 Value Percent:
 Continuous Index:
 Within 8" of Joint: **NO**
 Remarks:

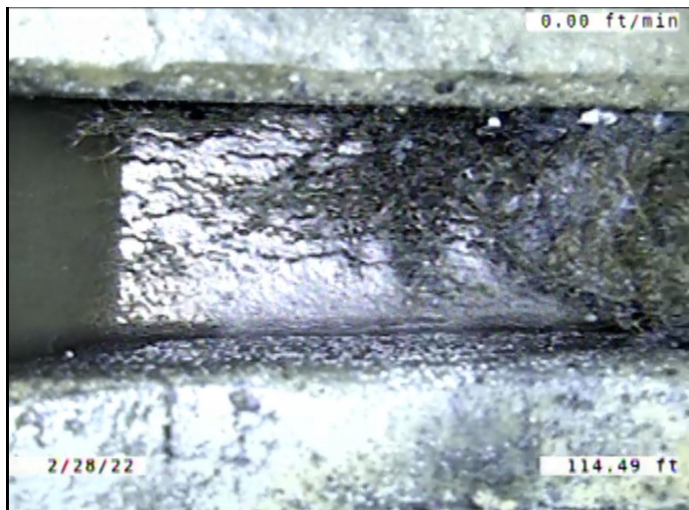
Code: **FM**
 Description: **Fracture Multiple**

Distance (ft): **114.5**
 Structural Grade: **4**
 O&M Grade: **0**
 Clock Start/From: **8**
 Clock To: **10**
 1st Value:
 2nd Value:
 Value Percent:
 Continuous Index:
 Within 8" of Joint: **YES**
 Remarks:

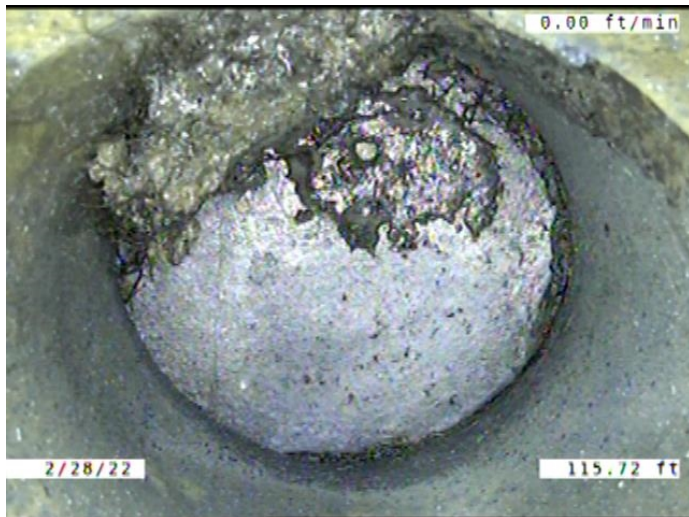
Code: **TFD**
Description: **Tap Factory Defective**

Distance (ft): **115.7**
Structural Grade: **0**
O&M Grade: **3**
Clock Start/From: **11**
Clock To:
1st Value: **6.000**
2nd Value:
Value Percent:
Continuous Index:
Within 8" of Joint: **YES**
Remarks: **ROOTS GROWING AROUND THE CAP**

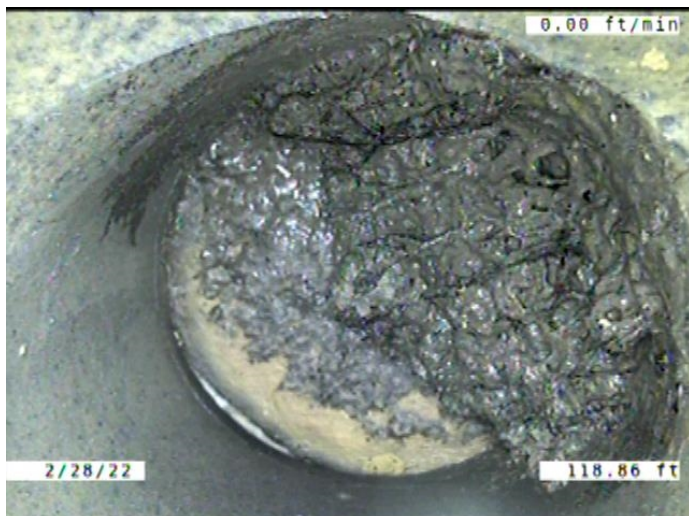
Code: **TFD**
Description: **Tap Factory Defective**

Distance (ft): **118.9**
Structural Grade: **0**
O&M Grade: **3**
Clock Start/From: **1**
Clock To:
1st Value: **6.000**
2nd Value:
Value Percent:
Continuous Index:
Within 8" of Joint: **YES**
Remarks: **ROOTS GROWING AROUND THE CAP**

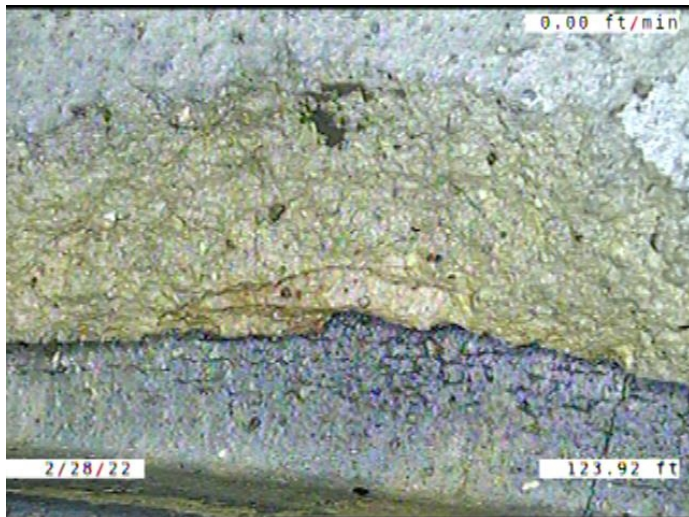
Code: **SMW**
 Description: **Surface Damage Missing Wall**

Distance (ft): **123.9**
 Structural Grade: **5**
 O&M Grade: **0**
 Clock Start/From: **1**
 Clock To: **3**
 1st Value:
 2nd Value:
 Value Percent:
 Continuous Index:
 Within 8" of Joint: **YES**
 Remarks: **THE INSIDE OF THE JOINT.**

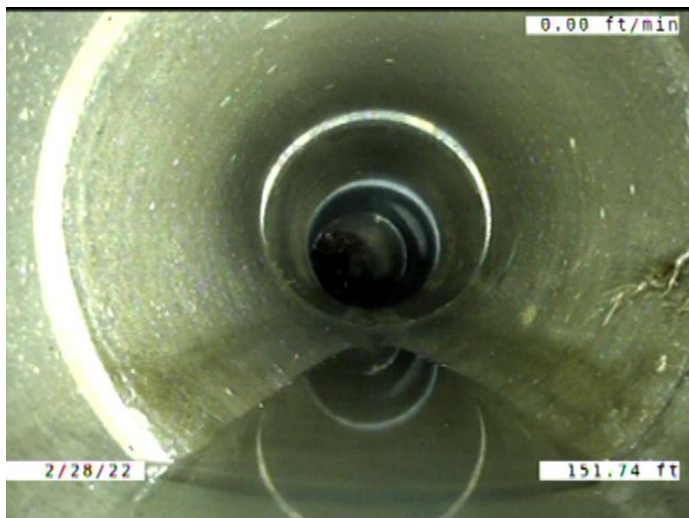
Code: **MWLS**
 Description: **Miscellaneous Water Level Sag**

Distance (ft): **151.7**
 Structural Grade: **2**
 O&M Grade: **0**
 Clock Start/From:
 Clock To:
 1st Value:
 2nd Value:
 Value Percent: **10.000**
 Continuous Index:
 Within 8" of Joint: **NO**
 Remarks:

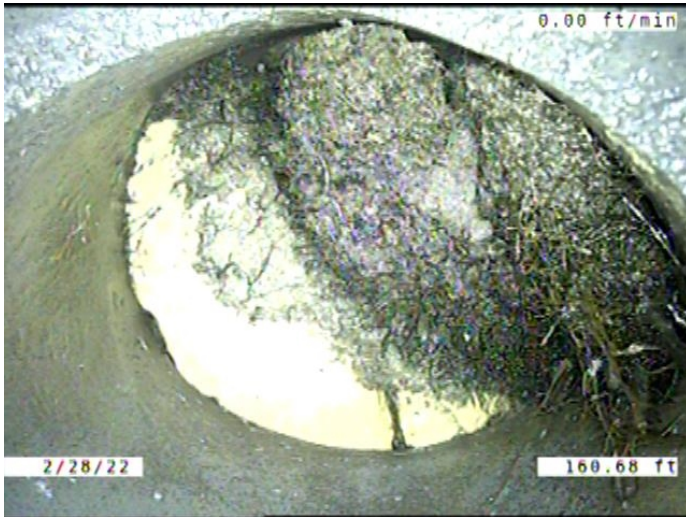
Code:	TFD
Description:	Tap Factory Defective
Distance (ft):	160.7
Structural Grade:	0
O&M Grade:	3
Clock Start/From:	2
Clock To:	
1st Value:	6.000
2nd Value:	
Value Percent:	
Continuous Index:	
Within 8" of Joint:	YES
Remarks:	CAPPED. CAP BROKEN. ROOTS GROWING AROUND AND THROUGH

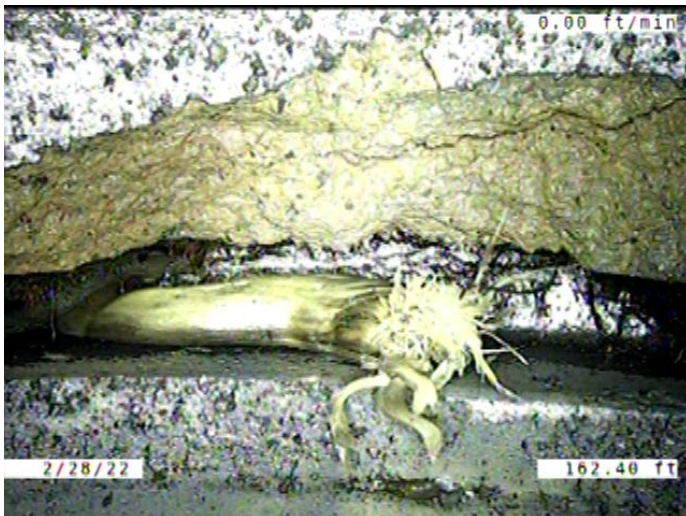
Code:	SZ
Description:	Surface Damage Other
Distance (ft):	162.4
Structural Grade:	0
O&M Grade:	0
Clock Start/From:	12
Clock To:	1
1st Value:	
2nd Value:	
Value Percent:	
Continuous Index:	
Within 8" of Joint:	YES
Remarks:	A PIECE CHIPPED AWAY FROM THE JOINT.

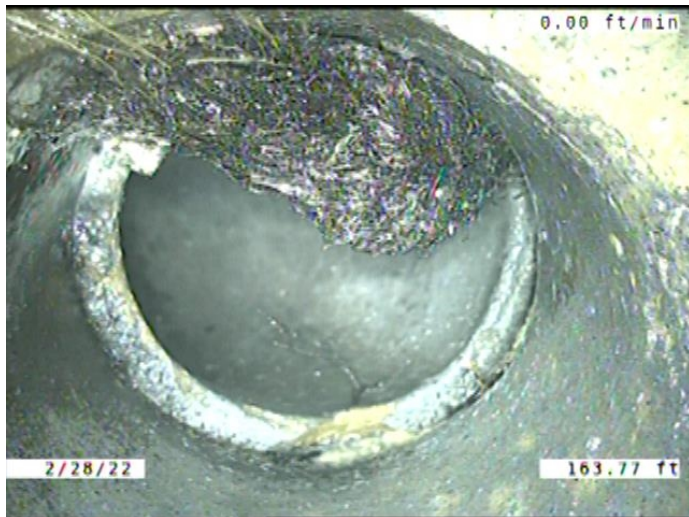
Code: **TF**
 Description: **Tap Factory**

Distance (ft): **163.8**
 Structural Grade: **0**
 O&M Grade: **0**
 Clock Start/From: **11**
 Clock To:
 1st Value: **6.000**

2nd Value:
 Value Percent:
 Continuous Index:
 Within 8" of Joint: **YES**
 Remarks: **SERVICE TO MAIN CONNECTION
 OFFSET AND ROOTS GROWING IN IT.**

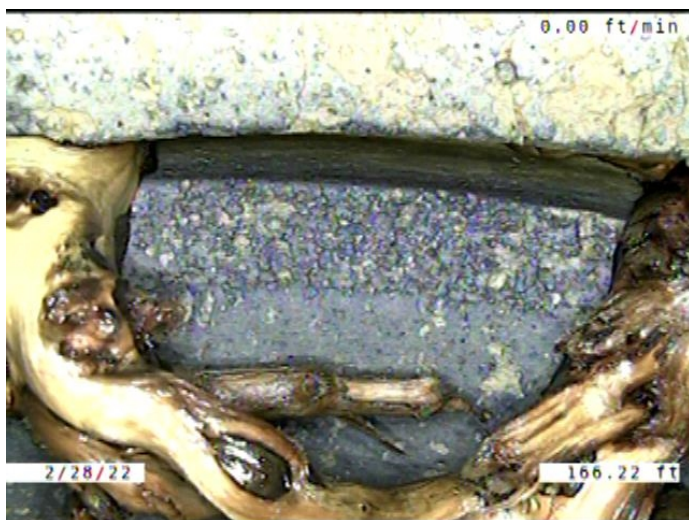
Code: **RTJ**
 Description: **Roots Tap Joint**

Distance (ft): **166.2**
 Structural Grade: **0**
 O&M Grade: **2**
 Clock Start/From: **11**
 Clock To: **2**

1st Value:
 2nd Value:
 Value Percent: **5.000**
 Continuous Index:
 Within 8" of Joint: **YES**
 Remarks:

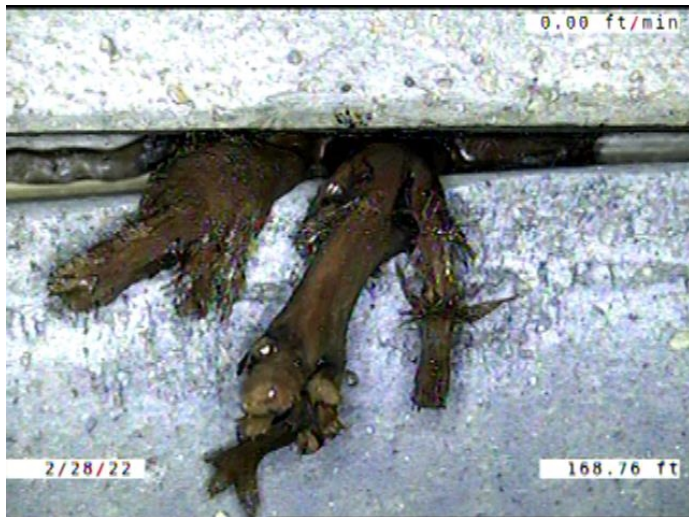
Code: **RTJ**
 Description: **Roots Tap Joint**

Distance (ft): **168.8**
 Structural Grade: **0**
 O&M Grade: **2**
 Clock Start/From: **12**
 Clock To:
 1st Value:
 2nd Value:
 Value Percent: **5.000**
 Continuous Index:
 Within 8" of Joint: **YES**
 Remarks:

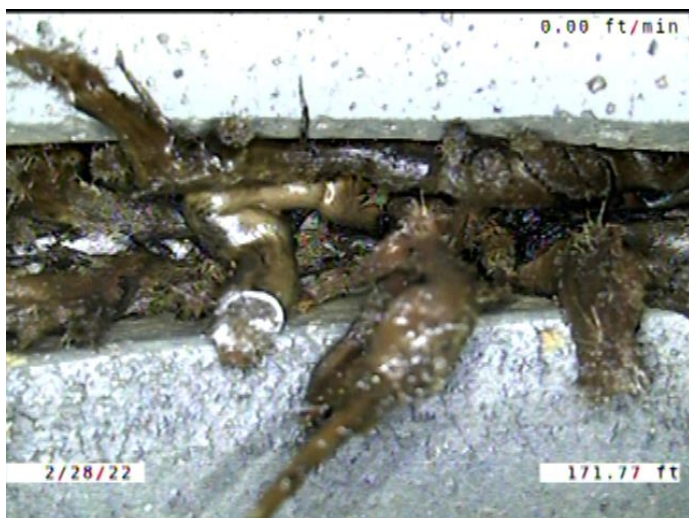
Code: **RTJ**
 Description: **Roots Tap Joint**

Distance (ft): **171.8**
 Structural Grade: **0**
 O&M Grade: **2**
 Clock Start/From: **10**
 Clock To: **12**
 1st Value:
 2nd Value:
 Value Percent: **5.000**
 Continuous Index:
 Within 8" of Joint: **YES**
 Remarks:

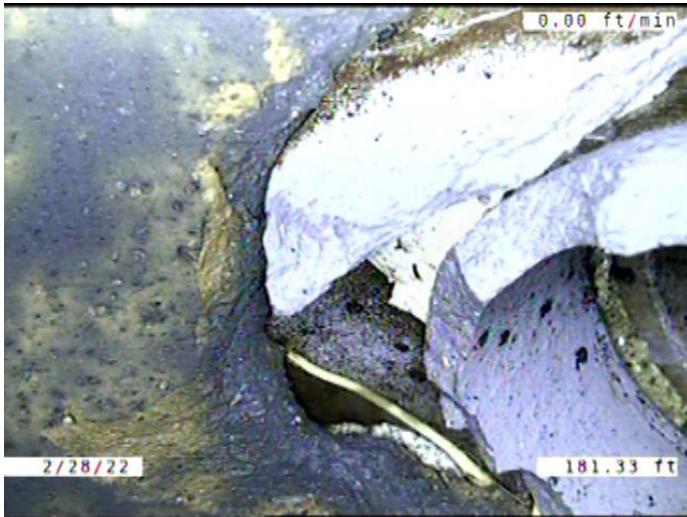
Code: **B**
Description: **Broken**

Distance (ft): **181.3**
Structural Grade: **4**
O&M Grade: **0**
Clock Start/From: **1**
Clock To: **5**
1st Value:
2nd Value:
Value Percent:
Continuous Index:
Within 8" of Joint: **YES**
Remarks:

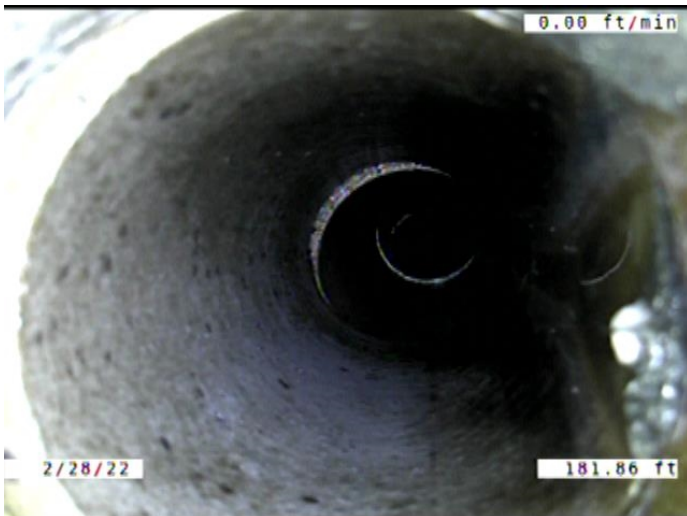
Code: **TBI**
Description: **Tap Break-in Intruding**

Distance (ft): **181.9**
Structural Grade: **0**
O&M Grade: **2**
Clock Start/From: **3**
Clock To:
1st Value: **6.000**
2nd Value: **1.000**
Value Percent:
Continuous Index:
Within 8" of Joint: **NO**
Remarks:

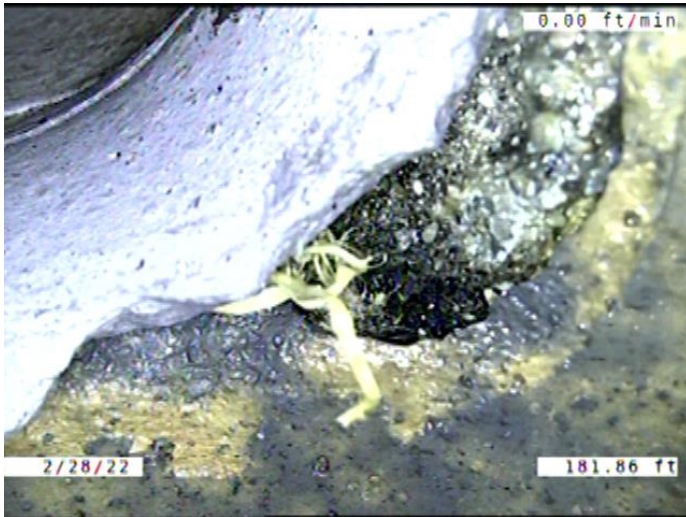
Code: **RFB**
 Description: **Roots Fine Barrel**

Distance (ft): **181.9**
 Structural Grade: **0**
 O&M Grade: **2**
 Clock Start/From: **1**
 Clock To: **4**
 1st Value:
 2nd Value:
 Value Percent:
 Continuous Index:
 Within 8" of Joint: **NO**
 Remarks:

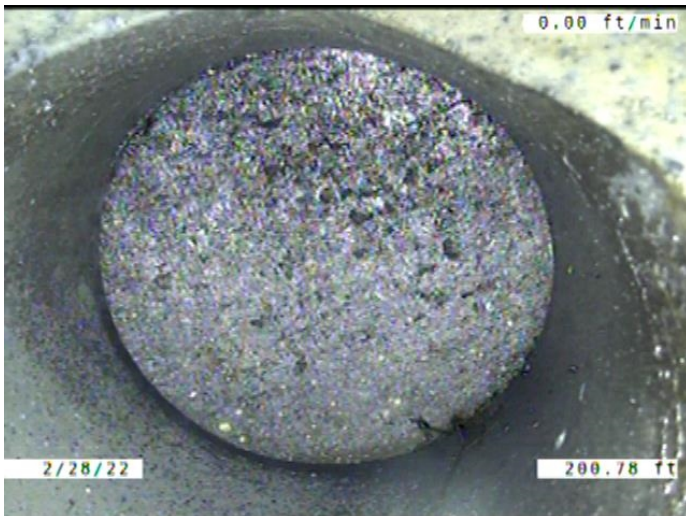
Code: **TFC**
 Description: **Tap Factory Capped**

Distance (ft): **200.8**
 Structural Grade: **0**
 O&M Grade: **0**
 Clock Start/From: **1**
 Clock To:
 1st Value: **6.000**
 2nd Value:
 Value Percent:
 Continuous Index:
 Within 8" of Joint: **YES**
 Remarks: **ROOTS GROWING AROUND THE CAP**

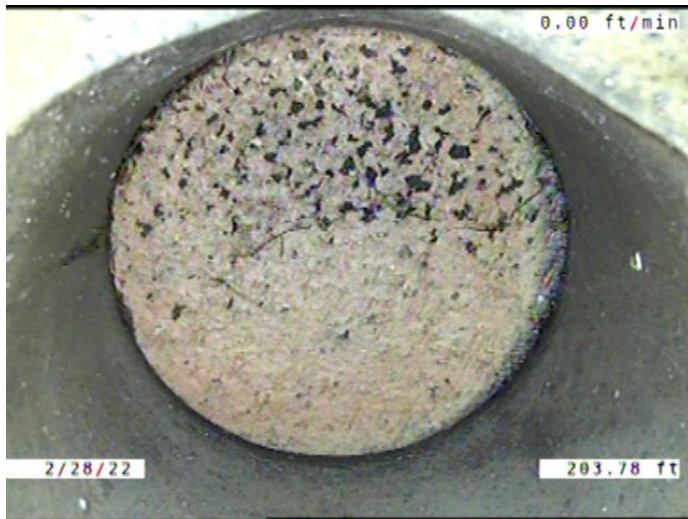
Code: **TFC**
Description: **Tap Factory Capped**

Distance (ft): **203.8**
Structural Grade: **0**
O&M Grade: **0**
Clock Start/From: **11**
Clock To:
1st Value: **6.000**
2nd Value:
Value Percent:
Continuous Index:
Within 8" of Joint: **YES**
Remarks: **ROOTS GROWING AROUND THE CAP**

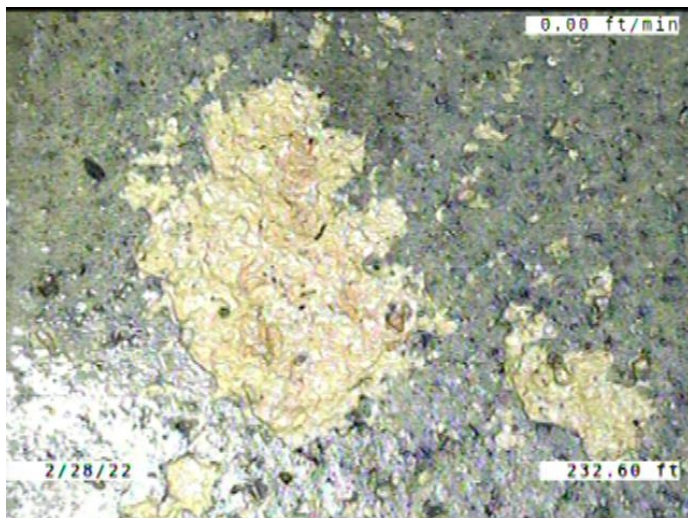
Code: **SSS**
Description: **Surface Damage Surface Spalling**

Distance (ft): **232.6**
Structural Grade: **2**
O&M Grade: **0**
Clock Start/From: **4**
Clock To: **5**
1st Value:
2nd Value:
Value Percent:
Continuous Index:
Within 8" of Joint: **NO**
Remarks:

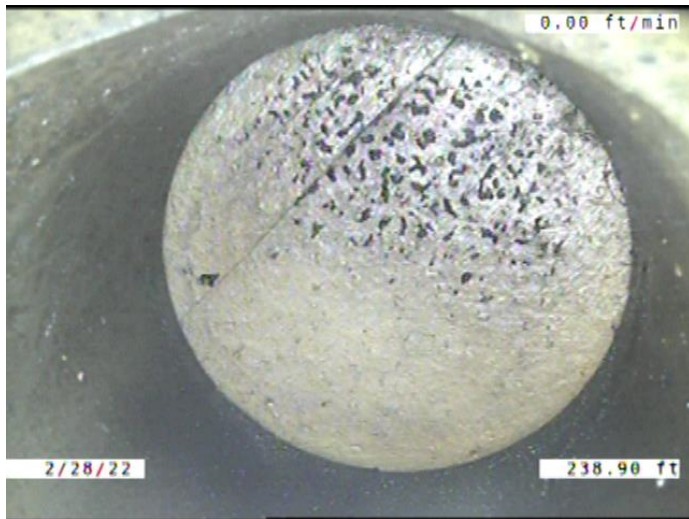
Code: **TFC**
Description: **Tap Factory Capped**

Distance (ft): **238.9**
Structural Grade: **0**
O&M Grade: **0**
Clock Start/From: **2**
Clock To:
1st Value: **6.000**
2nd Value:
Value Percent:
Continuous Index:
Within 8" of Joint: **YES**
Remarks:

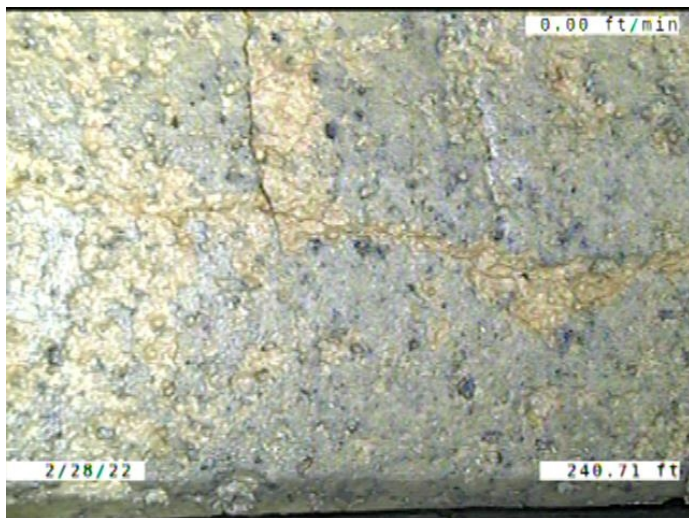
Code: **CM**
Description: **Crack Multiple**

Distance (ft): **240.7**
Structural Grade: **3**
O&M Grade: **0**
Clock Start/From: **9**
Clock To: **10**
1st Value:
2nd Value:
Value Percent:
Continuous Index:
Within 8" of Joint: **YES**
Remarks:

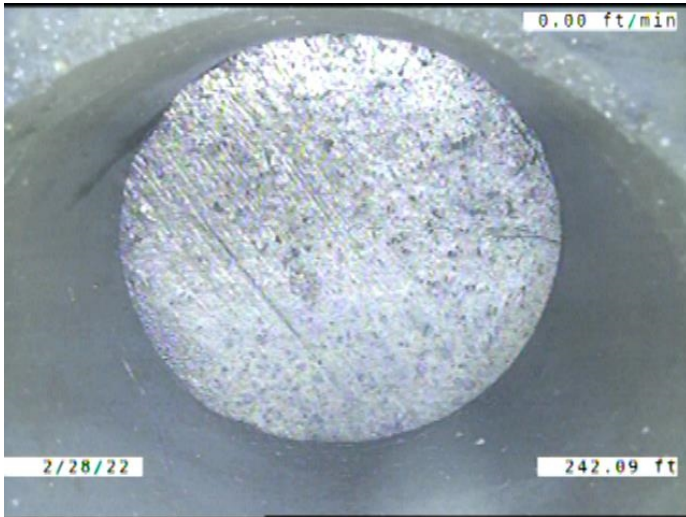
Code: **TFC**
 Description: **Tap Factory Capped**

Distance (ft): **242.1**
 Structural Grade: **0**
 O&M Grade: **0**
 Clock Start/From: **11**
 Clock To:
 1st Value: **6.000**
 2nd Value:
 Value Percent:
 Continuous Index:
 Within 8" of Joint: **YES**
 Remarks:

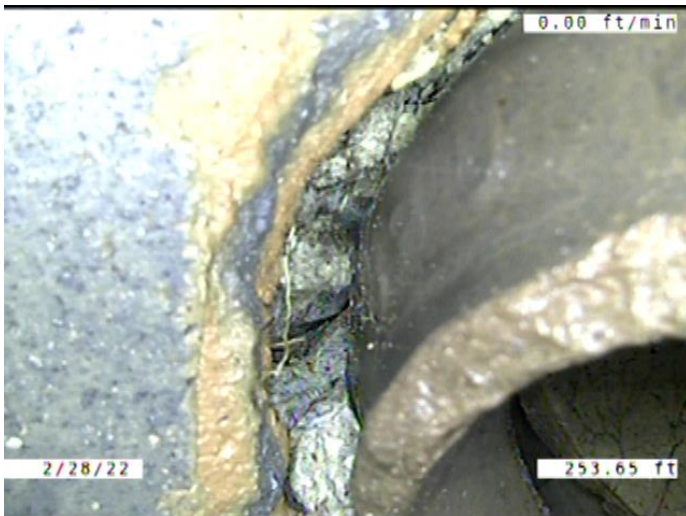
Code: **SSS**
 Description: **Surface Damage Surface Spalling**

Distance (ft): **253.7**
 Structural Grade: **2**
 O&M Grade: **0**
 Clock Start/From: **2**
 Clock To: **4**
 1st Value:
 2nd Value:
 Value Percent:
 Continuous Index:
 Within 8" of Joint: **YES**
 Remarks:

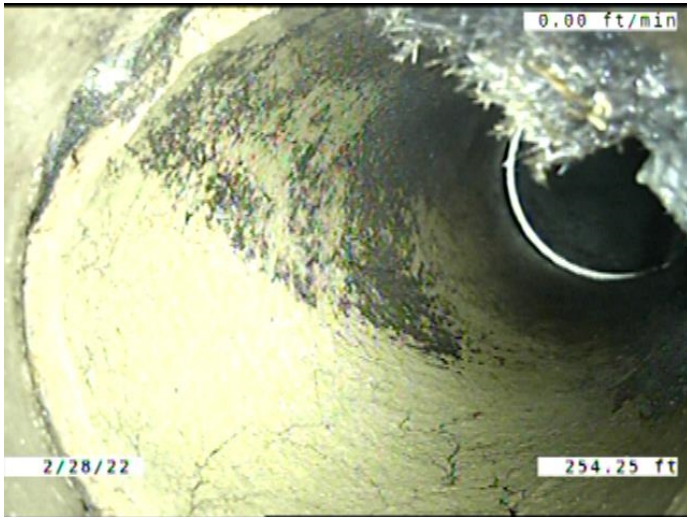
Code: **TB**
 Description: **Tap Break-in/Hammer**

Distance (ft): **254.2**
 Structural Grade: **0**
 O&M Grade: **0**
 Clock Start/From: **3**
 Clock To:
 1st Value: **6.000**
 2nd Value:
 Value Percent:
 Continuous Index:
 Within 8" of Joint: **YES**
 Remarks:
