Profile/Photo Observation Report

Date:	02/28/2022	Weather:		Coding:	PACP 7.0
Pipe Length (ft):	302.0	Owner:	City of Hobart	Pre Clean:	Heavy Cleaning
P.O.#:	YES502259	Surveyor:	S. Bucklin	PSR:	P-706-007-024
Customer:	City of Hobart, IN (Red	Clean Date:	02/22/2022	Shape:	C

Street:	South Linda Street	Flow Control:	Not Controlled
City:	Hobart, IN	Year Renewed:	
Location:	Local rural streets with light traffic, t	Tape/Media #:	
Purpose:	Routine Assessment	Dia/Height:	12"
Use:	Sanitary Sewage Pipe	Material:	VCP
Drain Area:		Lining:	None
Category:	NA		
Comment:			
Location Details:		Direction of Survey:	Downstream
US MH:	M-806-024	DS MH:	M-706-007
		Total Length Surveyed (ft):	269.7

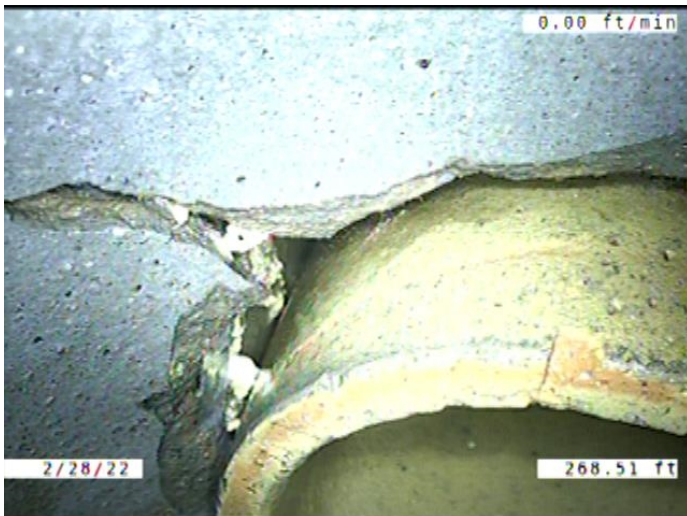
Code: **B**
 Description: **Broken**

Distance (ft): **268.5**
 Structural Grade: **4**
 O&M Grade: **0**
 Clock Start/From: **12**
 Clock To: **12**
 1st Value:
 2nd Value:
 Value Percent:
 Continuous Index:
 Within 8" of Joint: **YES**
 Remarks:

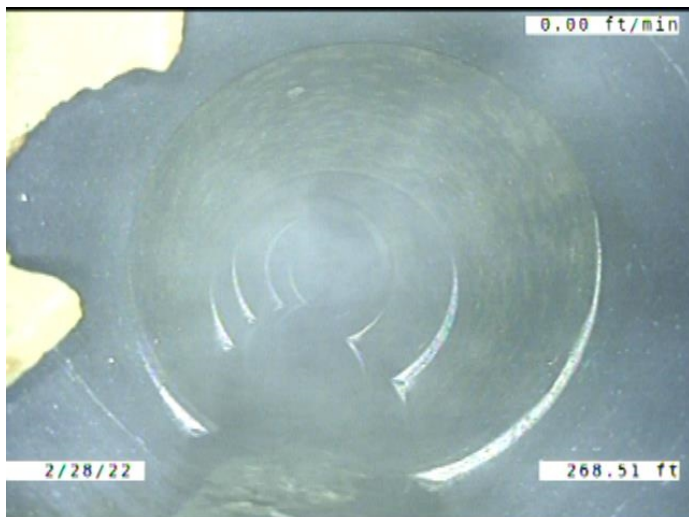
Code: **JAM**
 Description: **Joint Angular Medium**

Distance (ft): **268.5**
 Structural Grade: **3**
 O&M Grade: **0**
 Clock Start/From:
 Clock To:
 1st Value:
 2nd Value:
 Value Percent:
 Continuous Index: **F02**
 Within 8" of Joint: **NO**
 Remarks:

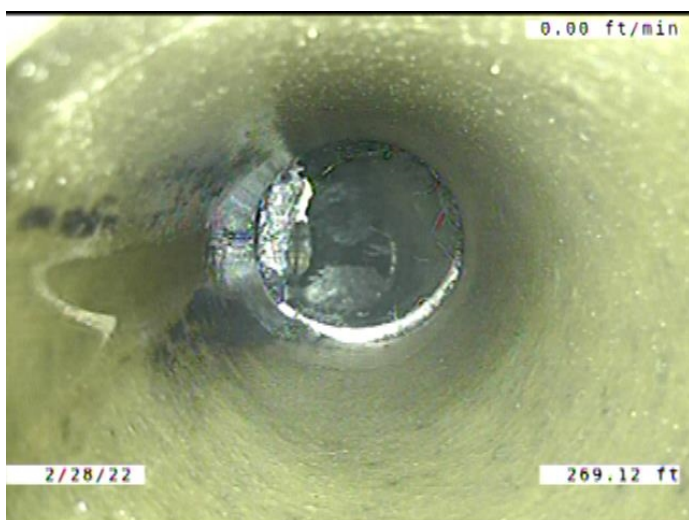
Code: **TBI**
 Description: **Tap Break-in Intruding**

Distance (ft): **269.1**
 Structural Grade: **0**
 O&M Grade: **2**
 Clock Start/From: **9**
 Clock To:
 1st Value: **6.000**
 2nd Value: **3.000**
 Value Percent:
 Continuous Index:
 Within 8" of Joint: **NO**
 Remarks:

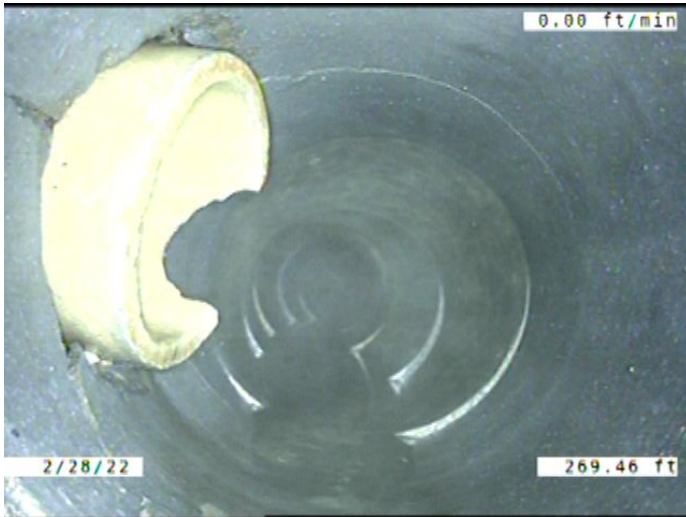
Code: **RFJ**
 Description: **Roots Fine Joint**

Distance (ft): **269.5**
 Structural Grade: **0**
 O&M Grade: **1**
 Clock Start/From: **9**
 Clock To: **3**
 1st Value:
 2nd Value:
 Value Percent:
 Continuous Index: **F04**
 Within 8" of Joint: **YES**
 Remarks:

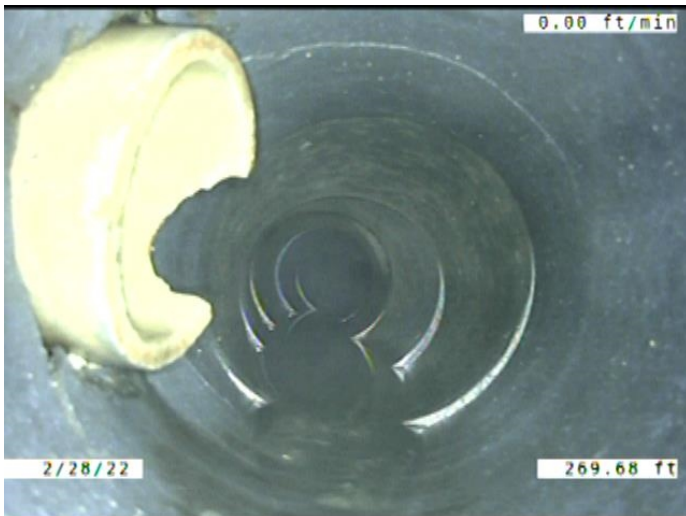
Code: **MSA**
 Description: **Miscellaneous Survey Abandoned**

Distance (ft): **269.7**
 Structural Grade: **0**
 O&M Grade: **0**
 Clock Start/From:
 Clock To:
 1st Value:
 2nd Value:
 Value Percent:
 Continuous Index:
 Within 8" of Joint: **NO**
 Remarks: **CAMERA CANT MAKE IT PAST PROTRUDING TAP.MADE IT TO THE**
