Profile/Photo Observation Report

Date:	02/27/2022	Weather:		Coding:	PACP 7.0
Pipe Length (ft):	169.0	Owner:	City of Hobart	Pre Clean:	Heavy Cleaning
P.O.#:	YES502259	Surveyor:	S. Bucklin	PSR:	M-806-025.1_M-806-025
Customer:	City of Hobart, IN (Red	Clean Date:	02/22/2022	Shape:	C

Street:	South Main Street	Flow Control:	Not Controlled
City:	Hobart, IN	Year Renewed:	
Location:	Easement/Right of Way	Tape/Media #:	
Purpose:	Routine Assessment	Dia/Height:	6"
Use:	Sanitary Sewage Pipe	Material:	VCP
Drain Area:		Lining:	None
Category:	NA		
Comment:

Location Details:		Direction of Survey:	Upstream
US MH:	M-806-025.1	DS MH:	M-806-025
		Total Length Surveyed (ft):	175.8

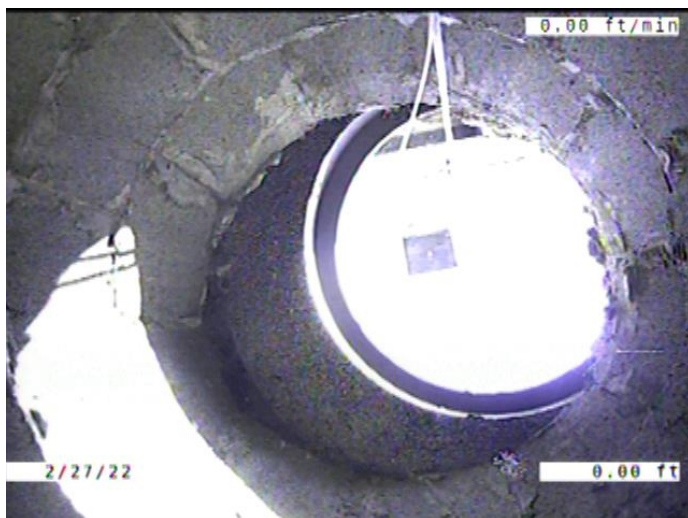
Code: **AMH**
Description: **Manhole**

Distance (ft): **.0**
Structural Grade: **0**
O&M Grade: **0**
Clock Start/From:
Clock To:
1st Value:
2nd Value:
Value Percent:
Continuous Index:
Within 8" of Joint: **NO**
Remarks: **M-806-025.1**

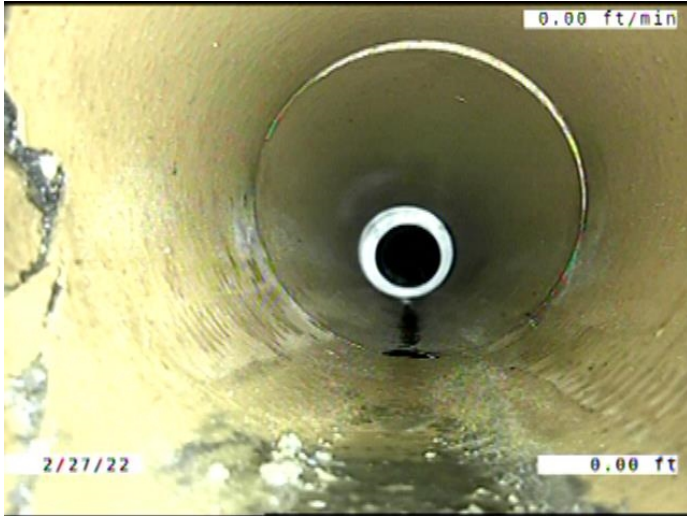
Code: **MWL**
Description: **Miscellaneous Water Level**

Distance (ft): **.0**
Structural Grade: **0**
O&M Grade: **0**
Clock Start/From:
Clock To:
1st Value:
2nd Value:
Value Percent: **5.000**
Continuous Index:
Within 8" of Joint: **NO**
Remarks:

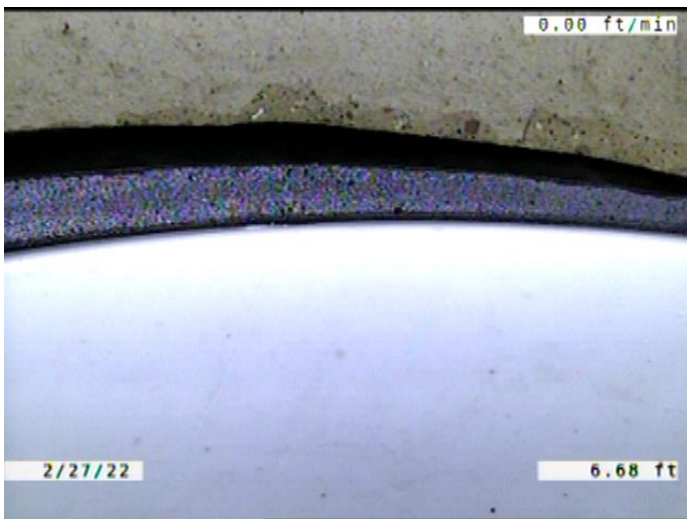
Code: **MMC**
Description: **Miscellaneous Material Change**

Distance (ft): **6.7**
Structural Grade: **0**
O&M Grade: **0**
Clock Start/From:
Clock To:
1st Value:
2nd Value:
Value Percent:
Continuous Index:
Within 8" of Joint: **NO**
Remarks: **VCP TO PVC**

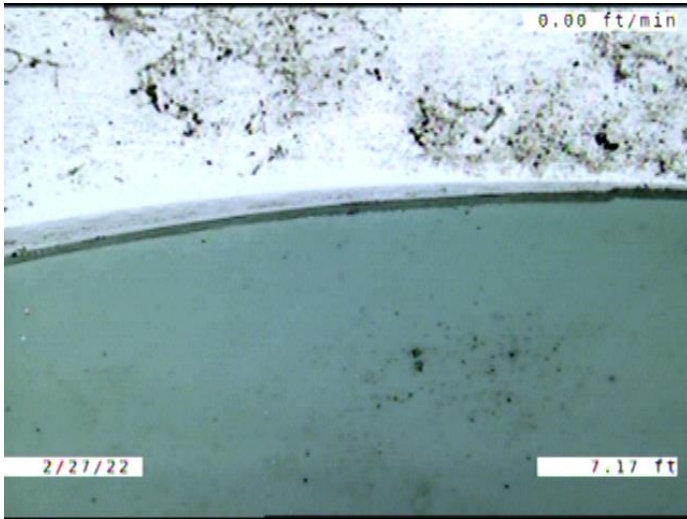
Code: **MSC**
Description: **Miscellaneous Shape/Size Change**

Distance (ft): **7.2**
Structural Grade: **0**
O&M Grade: **0**
Clock Start/From:
Clock To:
1st Value: **6.000**
2nd Value:
Value Percent:
Continuous Index:
Within 8" of Joint: **NO**
Remarks:

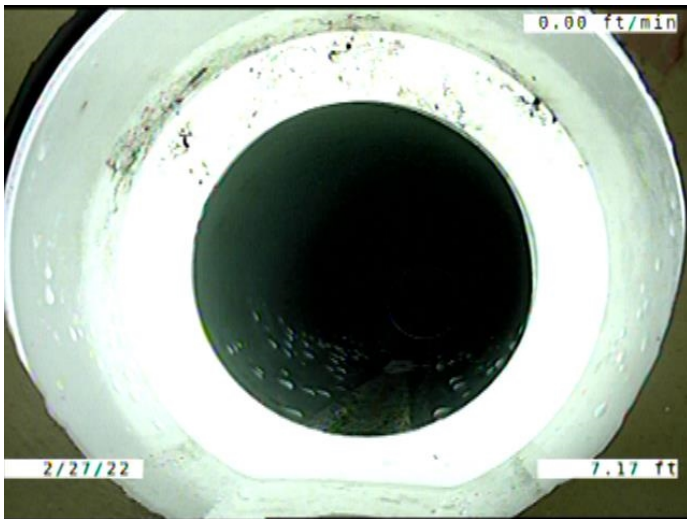
Code: **MGO**
Description: **Miscellaneous General Observation**

Distance (ft): **7.2**
Structural Grade: **0**
O&M Grade: **0**
Clock Start/From:
Clock To:
1st Value:
2nd Value:
Value Percent:
Continuous Index:
Within 8" of Joint: **NO**
Remarks: **8" TO 6"**

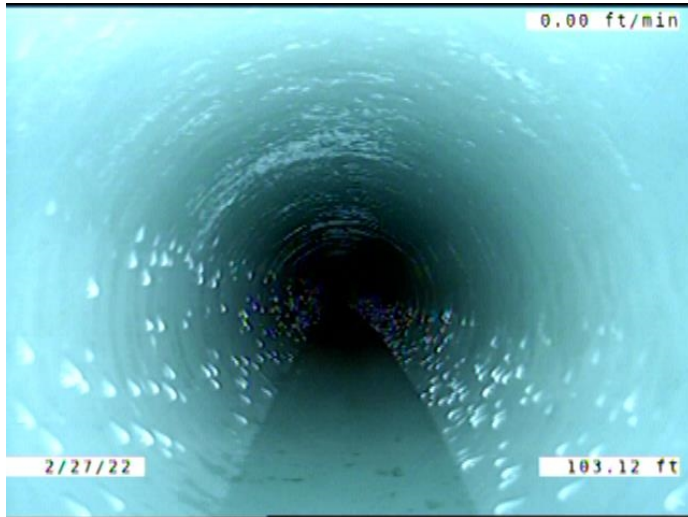
Code: **MWLS**
 Description: **Miscellaneous Water Level Sag**

Distance (ft): **103.1**
 Structural Grade: **2**
 O&M Grade: **0**
 Clock Start/From:
 Clock To:
 1st Value:
 2nd Value:
 Value Percent: **5.000**
 Continuous Index: **S01**
 Within 8" of Joint: **NO**
 Remarks:

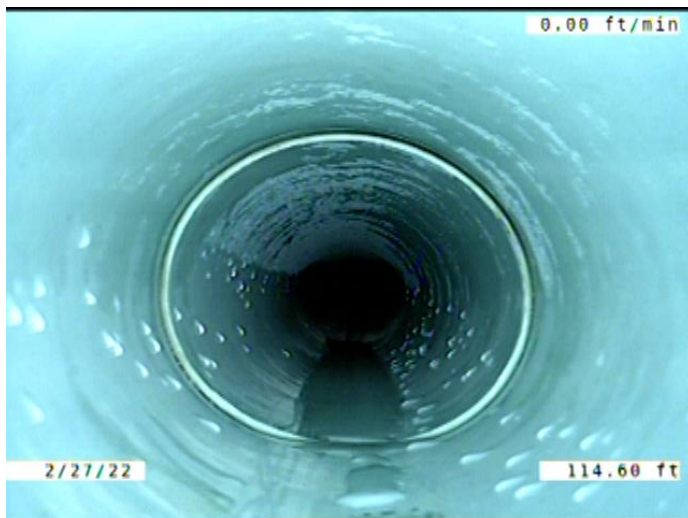
Code: **MWLS**
 Description: **Miscellaneous Water Level Sag**

Distance (ft): **114.6**
 Structural Grade: **2**
 O&M Grade: **0**
 Clock Start/From:
 Clock To:
 1st Value:
 2nd Value:
 Value Percent: **5.000**
 Continuous Index: **F01**
 Within 8" of Joint: **NO**
 Remarks:

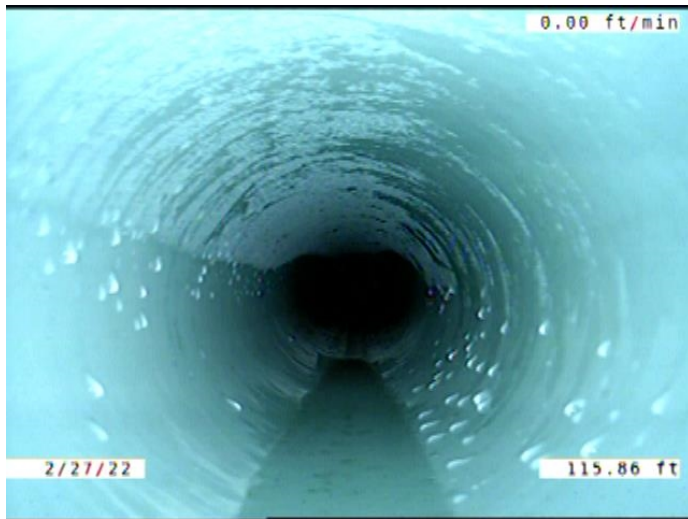
Code: **MWLS**
Description: **Miscellaneous Water Level Sag**

Distance (ft): **115.9**
Structural Grade: **2**
O&M Grade: **0**
Clock Start/From:
Clock To:
1st Value:
2nd Value:
Value Percent: **5.000**
Continuous Index:
Within 8" of Joint: **NO**
Remarks:

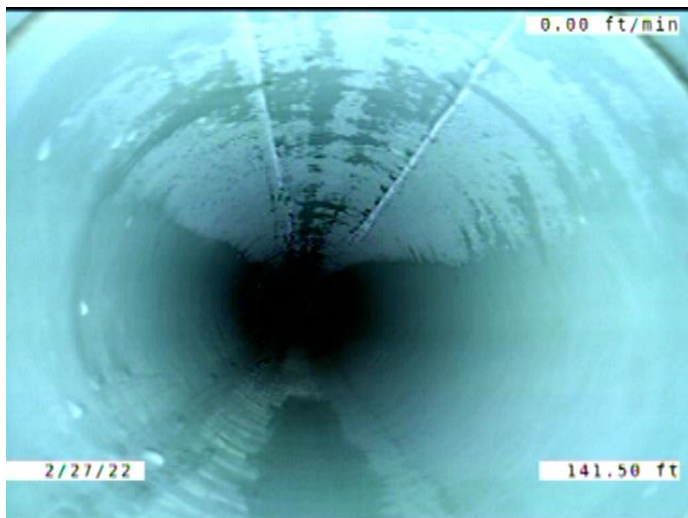
Code: **LL**
Description: **Line Left**

Distance (ft): **141.5**
Structural Grade: **0**
O&M Grade: **1**
Clock Start/From:
Clock To:
1st Value:
2nd Value:
Value Percent: **10.000**
Continuous Index:
Within 8" of Joint: **NO**
Remarks:

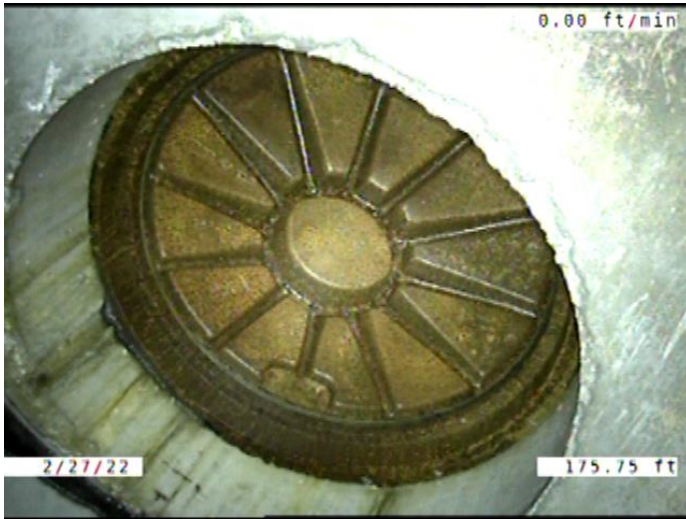
Code:	AMH
Description:	Manhole
Distance (ft):	175.8
Structural Grade:	0
O&M Grade:	0
Clock Start/From:	
Clock To:	
1st Value:	
2nd Value:	
Value Percent:	
Continuous Index:	
Within 8" of Joint:	NO
Remarks:	M-806-025.1
