## Profile/Photo Observation Report

Street:	<b>Capitol</b>	Flow Control:	<b>Not Controlled</b>
City:	<b>Hobart, IN</b>	Year Renewed:	
Location:	<b>Light Highway</b>	Tape/Media #:	
Purpose:	<b>Maintenance Related</b>	Dia/Height:	<b>8"</b>
Use:	<b>Sanitary</b>	Material:	<b>PVC</b>
Drain Area:	<b>NA</b>	Lining:	<b>Cured in Place</b>
Category:	<b>NA</b>		
Comment:	<b>flow incorrect</b>

Location Details:		Direction of Survey:	<b>Downstream</b>
US MH:	<b>M-806-027</b>	DS MH:	<b>M-806-028</b>
		Total Length Surveyed (ft):	<b>203.8</b>

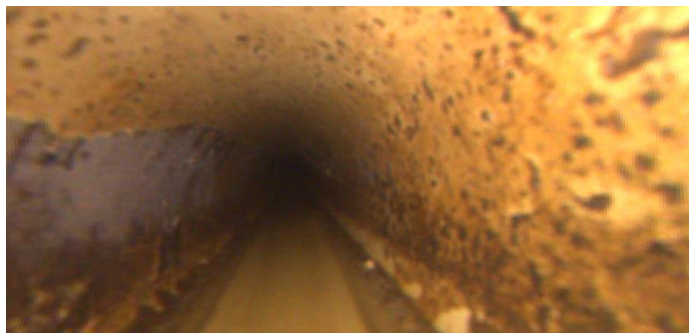
Code: **AMH**  
Description: **Manhole**

Distance (ft): **.0**  
Structural Grade: **0**  
O&M Grade: **0**  
Clock Start/From:  
Clock To:  
1st Value:  
2nd Value:  
Value Percent:  
Continuous Index:  
Within 8" of Joint: **NO**  
Remarks: **M-806-027**

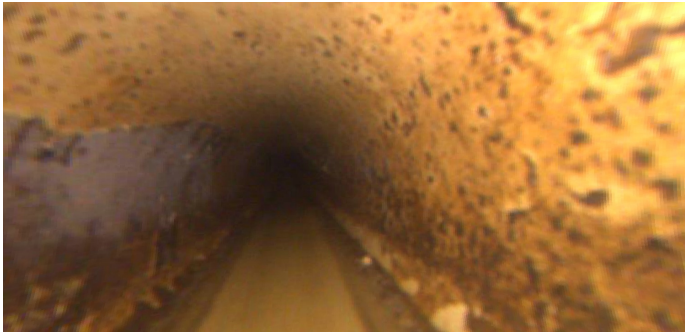
Code:	<b>MWL</b>
Description:	<b>Water Level</b>

Distance (ft):	<b>.0</b>
Structural Grade:	<b>0</b>
O&M Grade:	<b>0</b>
Clock Start/From:	
Clock To:	
1st Value:	
2nd Value:	
Value Percent:	<b>5.000</b>
Continuous Index:	
Within 8" of Joint:	<b>NO</b>
Remarks:

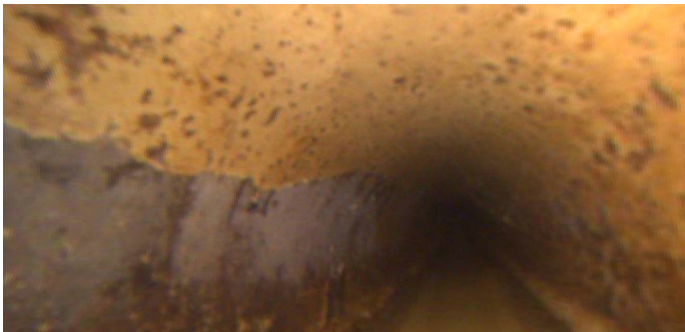
Code:	<b>CL</b>
Description:	<b>Crack Longitudinal</b>

Distance (ft):	<b>.0</b>
Structural Grade:	<b>2</b>
O&M Grade:	<b>0</b>
Clock Start/From:	<b>10</b>
Clock To:	
1st Value:	
2nd Value:	
Value Percent:	
Continuous Index:	
Within 8" of Joint:	
Remarks:

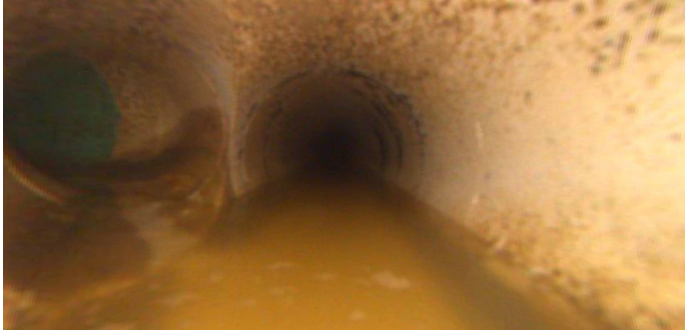
Code: **TF**  
Description: **Tap Factory**

Distance (ft): **41.3**  
Structural Grade: **0**  
O&M Grade: **0**  
Clock Start/From: **9**  
Clock To:  
1st Value: **4.000**  
2nd Value:  
Value Percent:  
Continuous Index:  
Within 8" of Joint: **YES**  
Remarks:

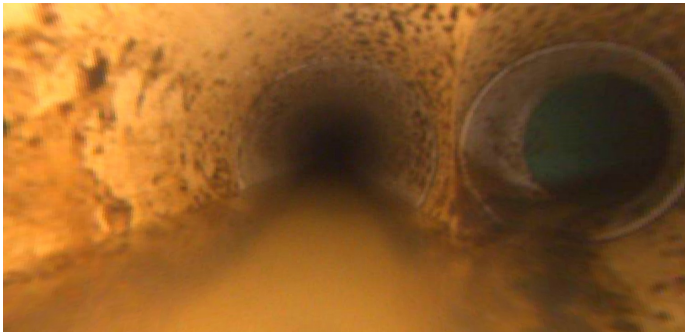
Code: **TF**  
Description: **Tap Factory**

Distance (ft): **80.8**  
Structural Grade: **0**  
O&M Grade: **0**  
Clock Start/From: **3**  
Clock To:  
1st Value: **4.000**  
2nd Value:  
Value Percent:  
Continuous Index:  
Within 8" of Joint: **YES**  
Remarks:

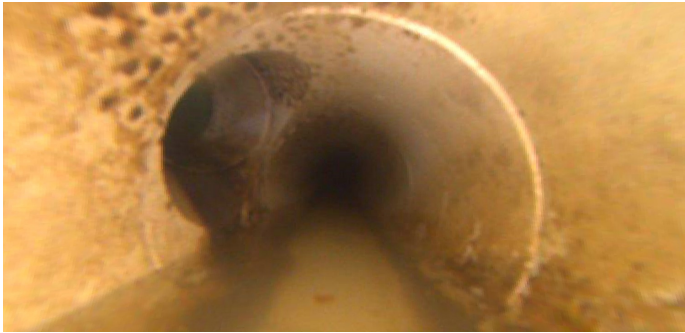
Code: **TF**  
Description: **Tap Factory**

Distance (ft): **95.7**  
Structural Grade: **0**  
O&M Grade: **0**  
Clock Start/From: **10**  
Clock To:  
1st Value: **4.000**  
2nd Value:  
Value Percent:  
Continuous Index:  
Within 8" of Joint: **YES**  
Remarks:

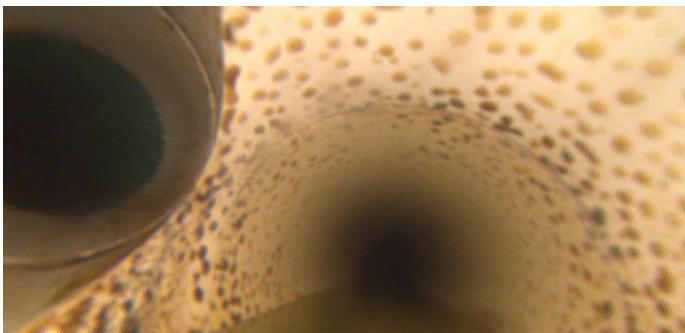
Code: **TF**  
Description: **Tap Factory**

Distance (ft): **187.1**  
Structural Grade: **0**  
O&M Grade: **0**  
Clock Start/From: **10**  
Clock To:  
1st Value: **4.000**  
2nd Value:  
Value Percent:  
Continuous Index:  
Within 8" of Joint: **YES**  
Remarks:

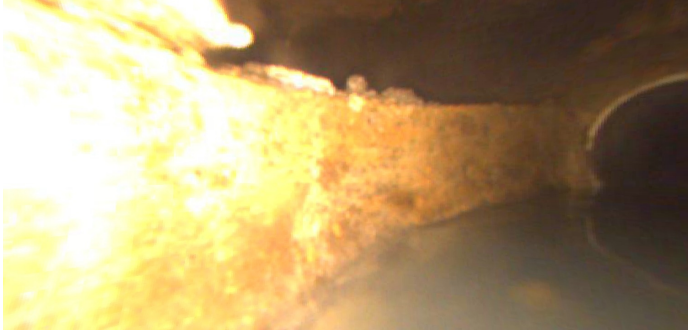
Code:	AMH
Description:	Manhole
Distance (ft):	203.8
Structural Grade:	0
O&M Grade:	0
Clock Start/From:	
Clock To:	
1st Value:	
2nd Value:	
Value Percent:	
Continuous Index:	
Within 8" of Joint:	NO
Remarks:	M-806-028
