## Profile/Photo Observation Report

Date:	<b>04/12/2018</b>	Weather:		Coding:	<b>PACP 6.0</b>
Pipe Length (ft):	<b>292.9</b>	Owner:	<b>NA</b>	Pre Clean:	<b>Not Known</b>
P.O.#:		Surveyor:	<b>Jen Costello</b>	PSR:	<b>P-806-029-031</b>
Customer:		Clean Date:	<b>01/01/1900</b>	Shape:	<b>C</b>

Street:	<b>E 8TH ST &amp; 9TH CT</b>	Flow Control:	<b>Not Controlled</b>
City:	<b>Hobart, IN</b>	Year Renewed:	
Location:	<b>Sidewalk</b>	Tape/Media #:	
Purpose:	<b>Maintenance Related</b>	Dia/Height:	<b>8"</b>
Use:	<b>Sanitary</b>	Material:	<b>PVC</b>
Drain Area:	<b>NA</b>	Lining:	<b>Cured in Place</b>
Category:	<b>NA</b>		
Comment:

Location Details:		Direction of Survey:	<b>Upstream</b>
US MH:	<b>M-806-031</b>	DS MH:	<b>M-806-029</b>
		Total Length Surveyed (ft):	<b>292.9</b>

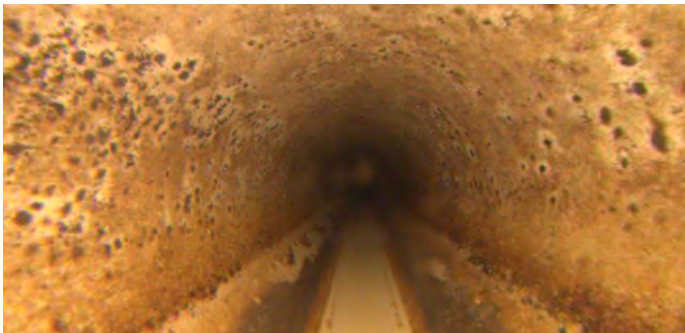
Code: **AMH**  
Description: **Manhole**

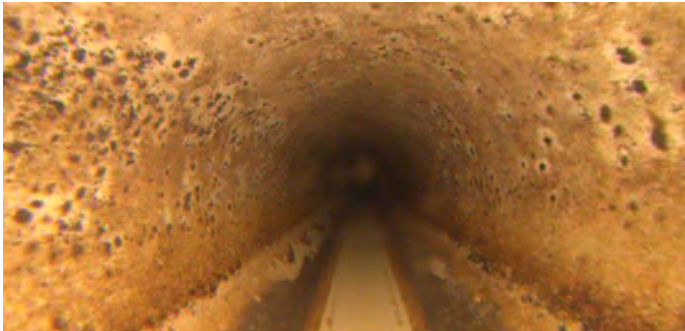
Code:	<b>MWL</b>
Description:	<b>Water Level</b>

Distance (ft):	<b>.0</b>
Structural Grade:	<b>0</b>
O&M Grade:	<b>0</b>
Clock Start/From:	
Clock To:	
1st Value:	
2nd Value:	
Value Percent:	<b>5.000</b>
Continuous Index:	
Within 8" of Joint:	<b>NO</b>
Remarks:

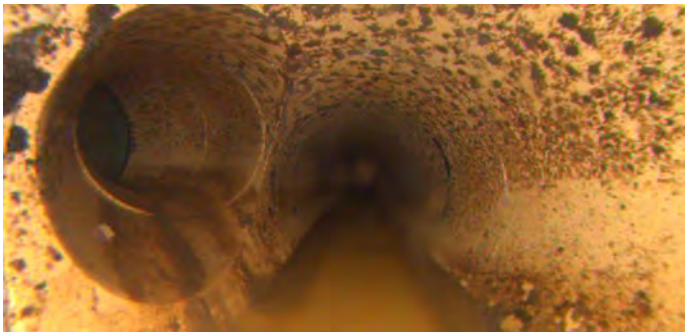
Code:	<b>TFA</b>
Description:	<b>Tap Factory Active</b>

Distance (ft):	<b>30.0</b>
Structural Grade:	<b>0</b>
O&M Grade:	<b>0</b>
Clock Start/From:	<b>9</b>
Clock To:	
1st Value:	<b>4.000</b>
2nd Value:	
Value Percent:	
Continuous Index:	
Within 8" of Joint:	
Remarks:

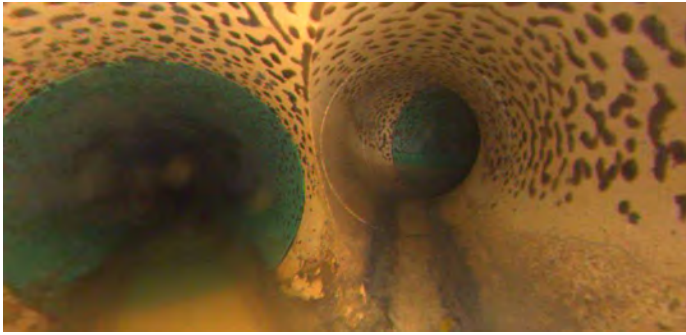
Code: **TF**  
Description: **Tap Factory**

Distance (ft): **76.6**  
Structural Grade: **0**  
O&M Grade: **0**  
Clock Start/From: **3**  
Clock To:  
1st Value: **4.000**  
2nd Value:  
Value Percent:  
Continuous Index:  
Within 8" of Joint:  
Remarks:

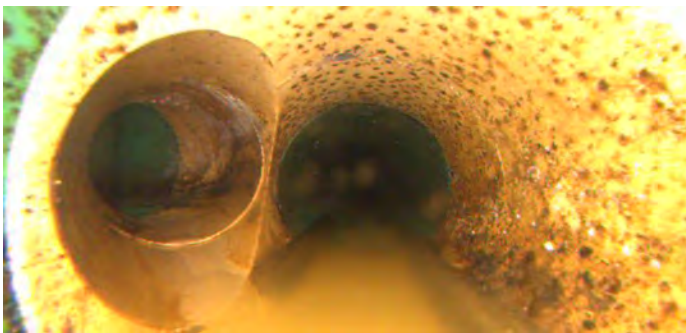
Code: **TFA**  
Description: **Tap Factory Active**

Distance (ft): **110.7**  
Structural Grade: **0**  
O&M Grade: **0**  
Clock Start/From: **9**  
Clock To:  
1st Value: **4.000**  
2nd Value:  
Value Percent:  
Continuous Index:  
Within 8" of Joint:  
Remarks:

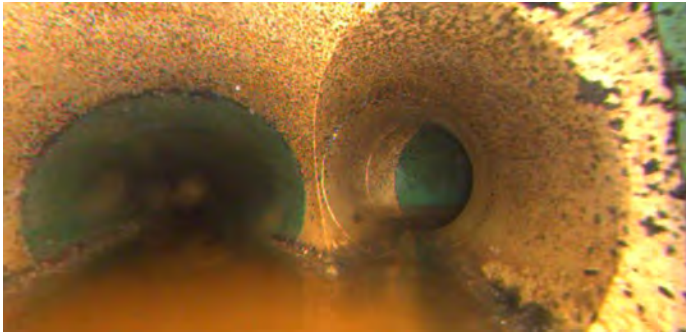
Code: **TFA**  
Description: **Tap Factory Active**

Distance (ft): **196.8**  
Structural Grade: **0**  
O&M Grade: **0**  
Clock Start/From: **3**  
Clock To:  
1st Value: **4.000**  
2nd Value:  
Value Percent:  
Continuous Index:  
Within 8" of Joint:  
Remarks:

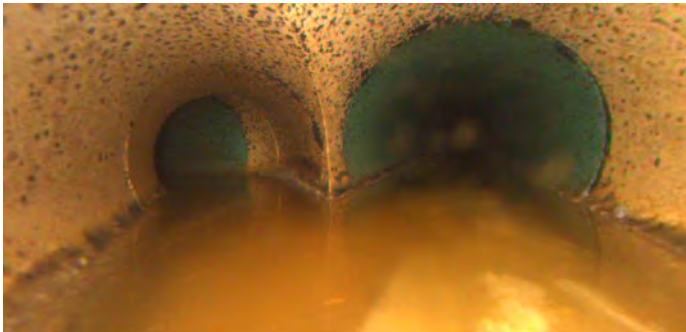
Code: **TFA**  
Description: **Tap Factory Active**

Distance (ft): **203.2**  
Structural Grade: **0**  
O&M Grade: **0**  
Clock Start/From: **9**  
Clock To:  
1st Value: **4.000**  
2nd Value:  
Value Percent:  
Continuous Index:  
Within 8" of Joint:  
Remarks:

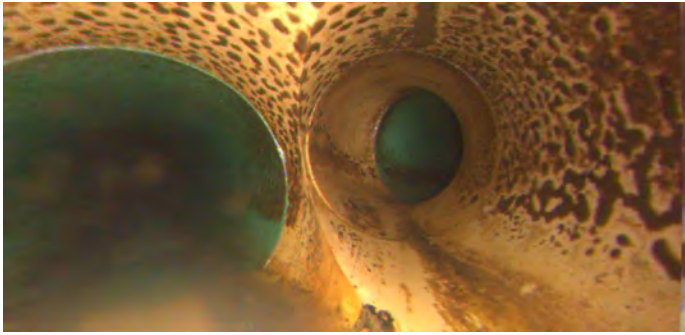
Code: **TF**  
Description: **Tap Factory**

Distance (ft): **278.5**  
Structural Grade: **0**  
O&M Grade: **0**  
Clock Start/From: **3**  
Clock To:  
1st Value: **4.000**  
2nd Value:  
Value Percent:  
Continuous Index:  
Within 8" of Joint:  
Remarks:

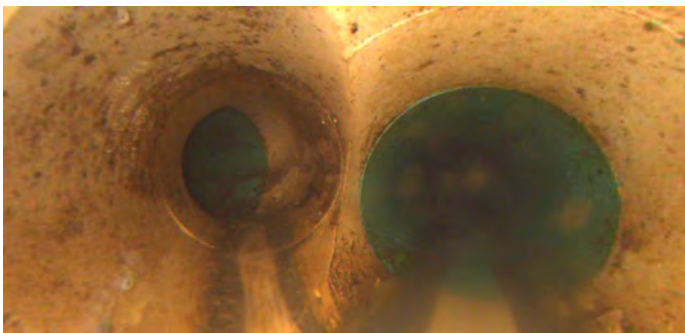
Code: **TF**  
Description: **Tap Factory**

Distance (ft): **282.3**  
Structural Grade: **0**  
O&M Grade: **0**  
Clock Start/From: **9**  
Clock To:  
1st Value: **4.000**  
2nd Value:  
Value Percent:  
Continuous Index:  
Within 8" of Joint:  
Remarks:

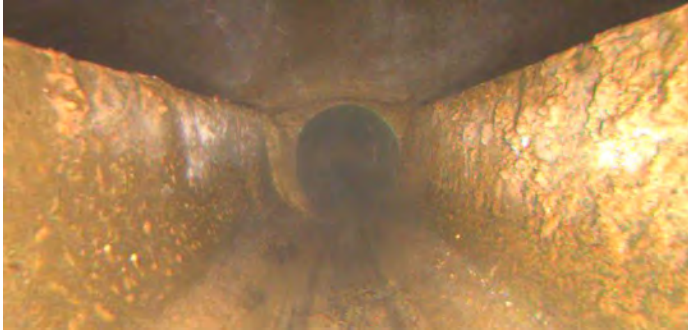
Code:	<b>AMH</b>
Description:	<b>Manhole</b>
Distance (ft):	<b>292.9</b>
Structural Grade:	<b>0</b>
O&M Grade:	<b>0</b>
Clock Start/From:	
Clock To:	
1st Value:	
2nd Value:	
Value Percent:	
Continuous Index:	
Within 8" of Joint:	<b>NO</b>
Remarks:	<b>M-806-031</b>
