Profile/Photo Observation Report

Date:	04/12/2018	Weather:		Coding:	PACP 6.0
Pipe Length (ft):	292.9	Owner:	NA	Pre Clean:	Not Known
P.O.#:		Surveyor:	Jen Costello	PSR:	P-806-029-031
Customer:		Clean Date:	01/01/1900	Shape:	C

Street:	Capitol	Flow Control:	Not Controlled
City:	Hobart, IN	Year Renewed:	
Location:	Sidewalk	Tape/Media #:	
Purpose:	Maintenance Related	Dia/Height:	8"
Use:	Sanitary	Material:	PVC
Drain Area:	NA	Lining:	Cured in Place
Category:	NA		
Comment:

Location Details:		Direction of Survey:	Upstream
US MH:	M-806-031	DS MH:	M-806-029
		Total Length Surveyed (ft):	292.9

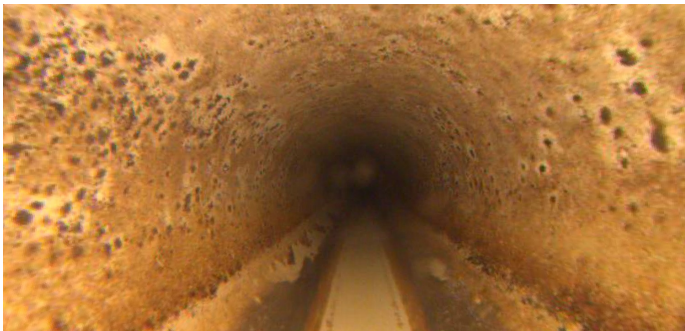
Code: **AMH**
Description: **Manhole**

Distance (ft): **.0**
Structural Grade: **0**
O&M Grade: **0**
Clock Start/From:
Clock To:
1st Value:
2nd Value:
Value Percent:
Continuous Index:
Within 8" of Joint: **NO**
Remarks: **M-806-029**

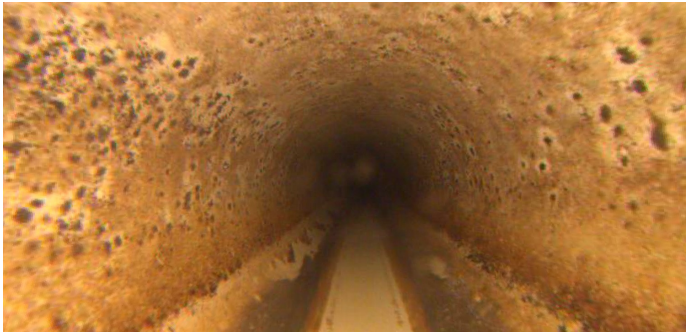
Code:	MWL
Description:	Water Level

Distance (ft):	.0
Structural Grade:	0
O&M Grade:	0
Clock Start/From:	
Clock To:	
1st Value:	
2nd Value:	
Value Percent:	5.000
Continuous Index:	
Within 8" of Joint:	NO
Remarks:

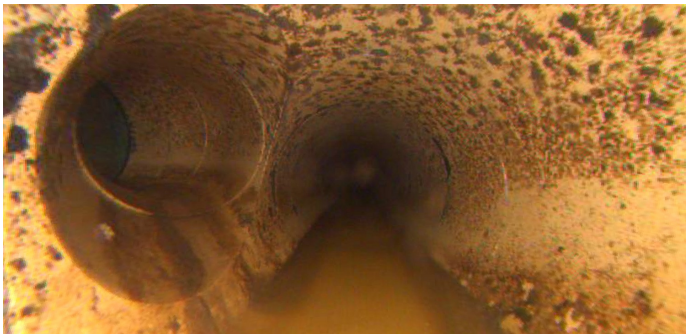
Code:	TFA
Description:	Tap Factory Active

Distance (ft):	30.0
Structural Grade:	0
O&M Grade:	0
Clock Start/From:	9
Clock To:	
1st Value:	4.000
2nd Value:	
Value Percent:	
Continuous Index:	
Within 8" of Joint:	
Remarks:

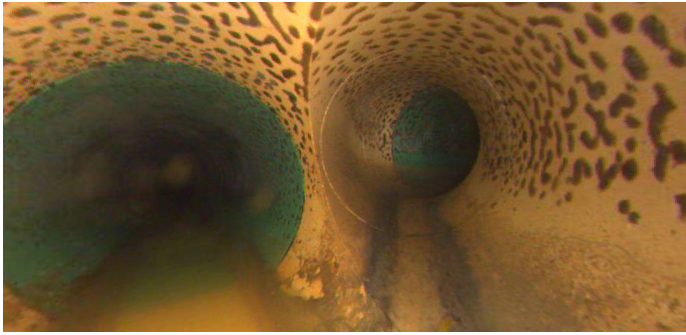
Code: **TF**
Description: **Tap Factory**

Distance (ft): **76.6**
Structural Grade: **0**
O&M Grade: **0**
Clock Start/From: **3**
Clock To:
1st Value: **4.000**
2nd Value:
Value Percent:
Continuous Index:
Within 8" of Joint:
Remarks:

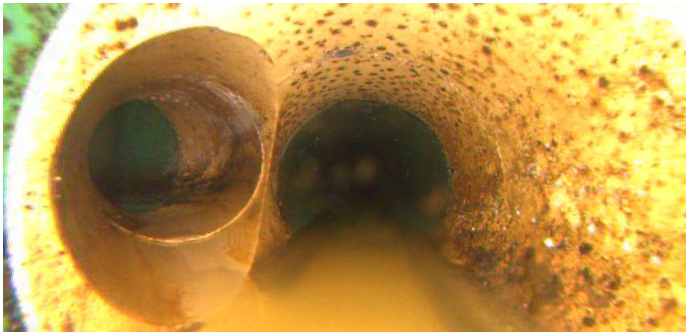
Code: **TFA**
Description: **Tap Factory Active**

Distance (ft): **110.7**
Structural Grade: **0**
O&M Grade: **0**
Clock Start/From: **9**
Clock To:
1st Value: **4.000**
2nd Value:
Value Percent:
Continuous Index:
Within 8" of Joint:
Remarks:

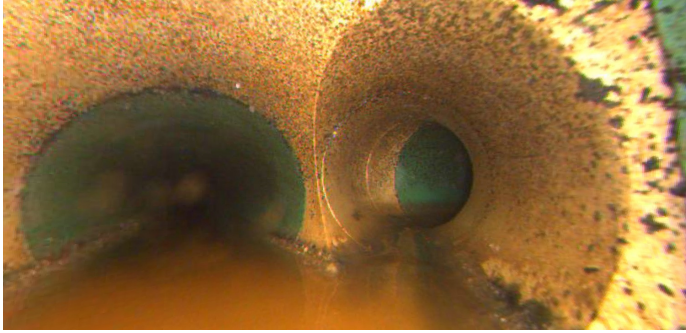
Code: **TFA**
Description: **Tap Factory Active**

Distance (ft): **196.8**
Structural Grade: **0**
O&M Grade: **0**
Clock Start/From: **3**
Clock To:
1st Value: **4.000**
2nd Value:
Value Percent:
Continuous Index:
Within 8" of Joint:
Remarks:

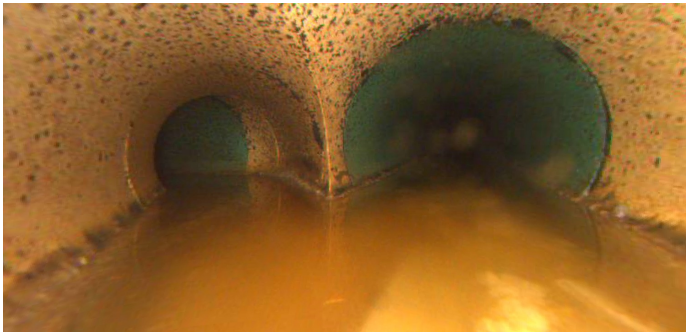
Code: **TFA**
Description: **Tap Factory Active**

Distance (ft): **203.2**
Structural Grade: **0**
O&M Grade: **0**
Clock Start/From: **9**
Clock To:
1st Value: **4.000**
2nd Value:
Value Percent:
Continuous Index:
Within 8" of Joint:
Remarks:

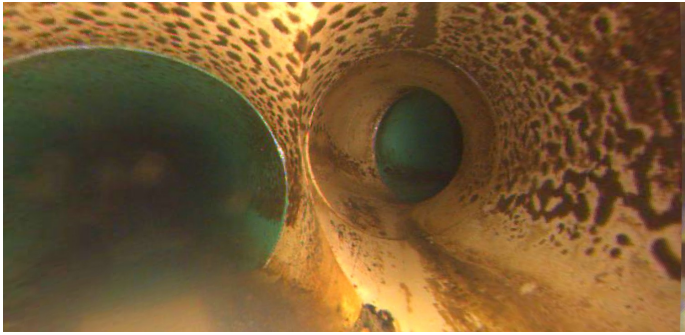
Code: **TF**
Description: **Tap Factory**

Distance (ft): **278.5**
Structural Grade: **0**
O&M Grade: **0**
Clock Start/From: **3**
Clock To:
1st Value: **4.000**
2nd Value:
Value Percent:
Continuous Index:
Within 8" of Joint:
Remarks:

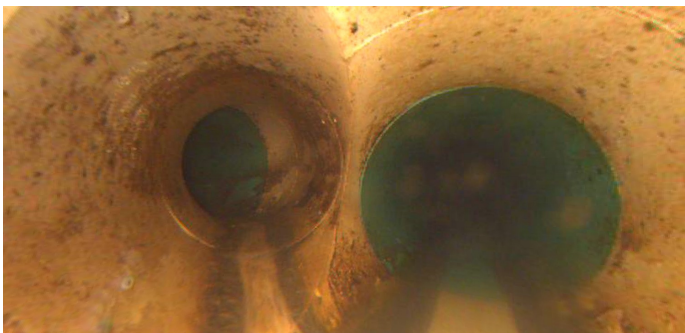
Code: **TF**
Description: **Tap Factory**

Distance (ft): **282.3**
Structural Grade: **0**
O&M Grade: **0**
Clock Start/From: **9**
Clock To:
1st Value: **4.000**
2nd Value:
Value Percent:
Continuous Index:
Within 8" of Joint:
Remarks:

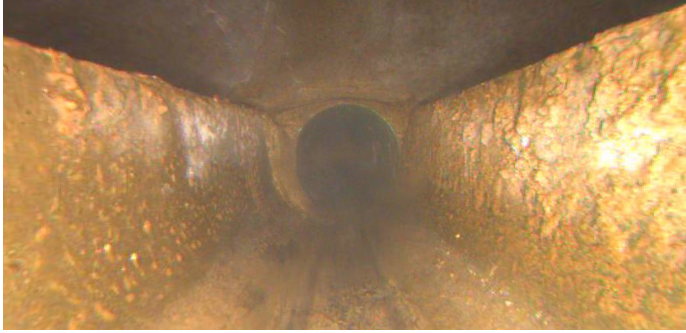
Code:	AMH
Description:	Manhole
Distance (ft):	292.9
Structural Grade:	0
O&M Grade:	0
Clock Start/From:	
Clock To:	
1st Value:	
2nd Value:	
Value Percent:	
Continuous Index:	
Within 8" of Joint:	NO
Remarks:	M-806-031
