Profile/Photo Observation Report

Date:	04/13/2018	Weather:		Coding:	PACP 6.0
Pipe Length (ft):	292.7	Owner:	NA	Pre Clean:	Not Known
P.O.#:		Surveyor:	Jen Costello	PSR:	P-806-031-032
Customer:		Clean Date:	01/01/1900	Shape:	C

Street:	Capitol	Flow Control:	Not Controlled
City:	Hobart, IN	Year Renewed:	
Location:	Ditch	Tape/Media #:	
Purpose:	Maintenance Related	Dia/Height:	8"
Use:	Sanitary	Material:	PVC
Drain Area:	NA	Lining:	Cured in Place
Category:	NA		
Comment:

Location Details:		Direction of Survey:	Upstream
US MH:	M-806-032	DS MH:	M-806-031
		Total Length Surveyed (ft):	294.0

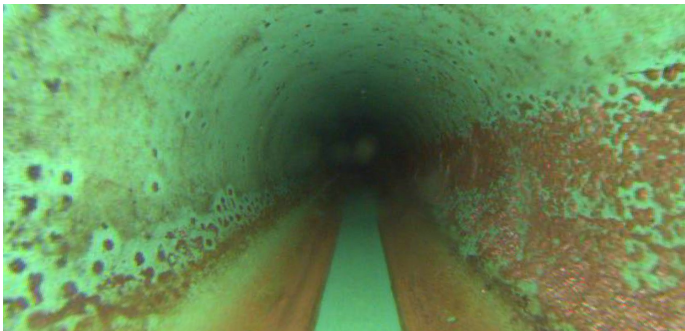
Code: **AMH**
Description: **Manhole**

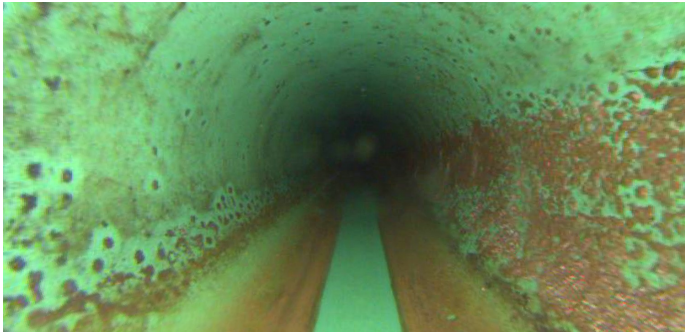
Code:	MWL
Description:	Water Level

Distance (ft):	.0
Structural Grade:	0
O&M Grade:	0
Clock Start/From:	
Clock To:	
1st Value:	
2nd Value:	
Value Percent:	5.000
Continuous Index:	
Within 8" of Joint:	NO
Remarks:

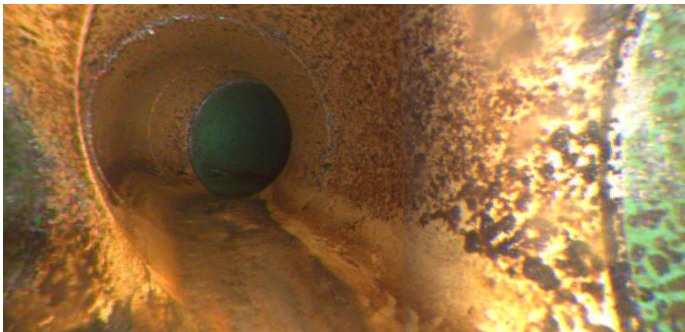
Code:	TF
Description:	Tap Factory

Distance (ft):	64.9
Structural Grade:	0
O&M Grade:	0
Clock Start/From:	3
Clock To:	
1st Value:	4.000
2nd Value:	
Value Percent:	
Continuous Index:	
Within 8" of Joint:	
Remarks:

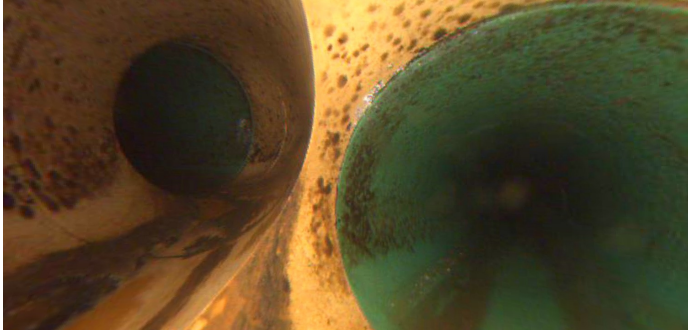
Code: **TF**
Description: **Tap Factory**

Distance (ft): **70.9**
Structural Grade: **0**
O&M Grade: **0**
Clock Start/From: **9**
Clock To:
1st Value: **4.000**
2nd Value:
Value Percent:
Continuous Index:
Within 8" of Joint:
Remarks:

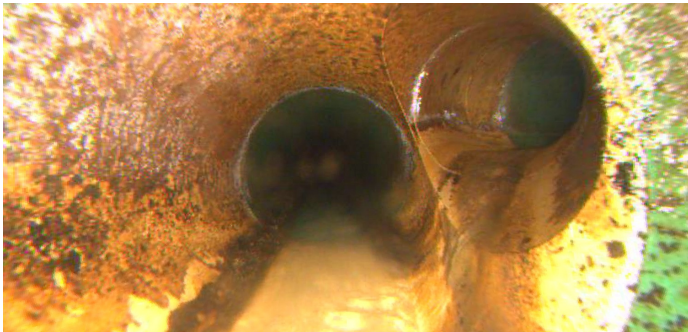
Code: **TFA**
Description: **Tap Factory Active**

Distance (ft): **146.5**
Structural Grade: **0**
O&M Grade: **0**
Clock Start/From: **3**
Clock To:
1st Value: **4.000**
2nd Value:
Value Percent:
Continuous Index:
Within 8" of Joint:
Remarks:

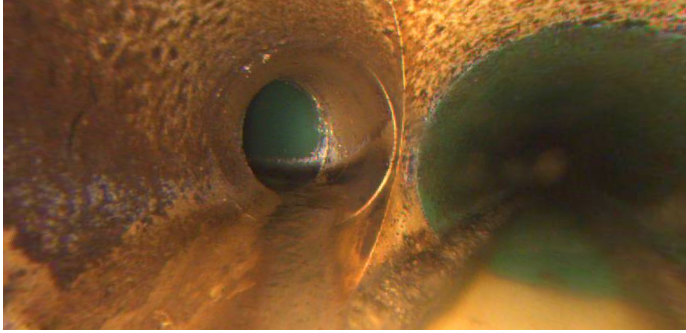
Code: **TFA**
Description: **Tap Factory Active**

Distance (ft): **150.6**
Structural Grade: **0**
O&M Grade: **0**
Clock Start/From: **9**
Clock To:
1st Value: **4.000**
2nd Value:
Value Percent:
Continuous Index:
Within 8" of Joint:
Remarks:

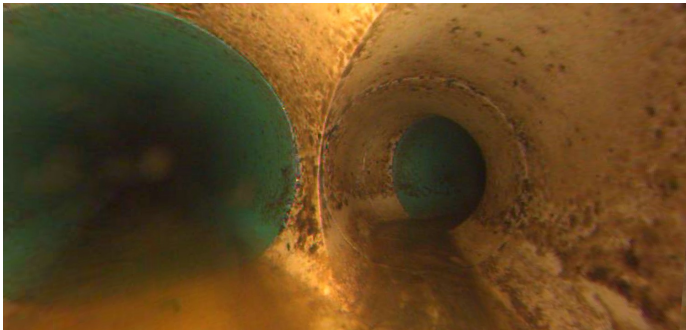
Code: **TFA**
Description: **Tap Factory Active**

Distance (ft): **227.0**
Structural Grade: **0**
O&M Grade: **0**
Clock Start/From: **3**
Clock To:
1st Value: **4.000**
2nd Value:
Value Percent:
Continuous Index:
Within 8" of Joint:
Remarks:

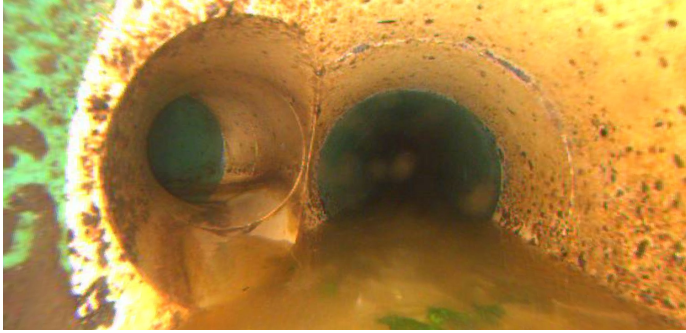
Code: **TFA**
Description: **Tap Factory Active**

Distance (ft): **232.5**
Structural Grade: **0**
O&M Grade: **0**
Clock Start/From: **9**
Clock To:
1st Value: **4.000**
2nd Value:
Value Percent:
Continuous Index:
Within 8" of Joint:
Remarks:

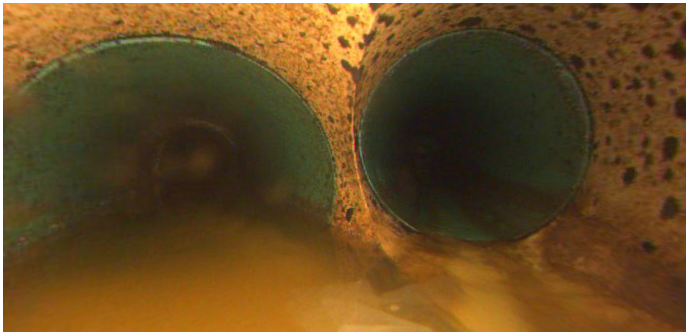
Code: **TF**
Description: **Tap Factory**

Distance (ft): **283.9**
Structural Grade: **0**
O&M Grade: **0**
Clock Start/From: **3**
Clock To:
1st Value: **4.000**
2nd Value:
Value Percent:
Continuous Index:
Within 8" of Joint:
Remarks:

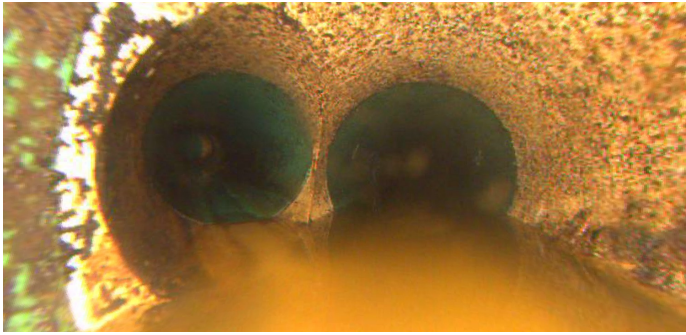
Code: **TFA**
Description: **Tap Factory Active**

Distance (ft): **286.4**
Structural Grade: **0**
O&M Grade: **0**
Clock Start/From: **9**
Clock To:
1st Value: **4.000**
2nd Value:
Value Percent:
Continuous Index:
Within 8" of Joint:
Remarks:

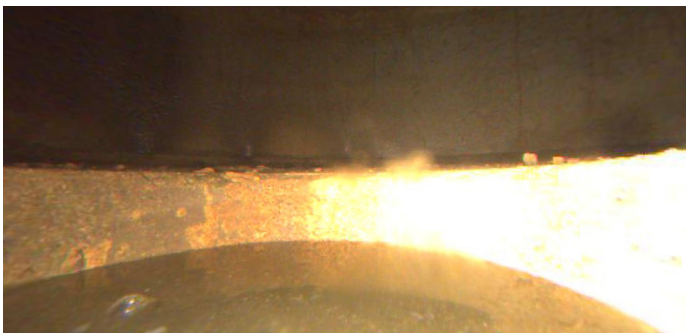
Code: **AMH**
Description: **Manhole**

Distance (ft): **294.0**
Structural Grade: **0**
O&M Grade: **0**
Clock Start/From:
Clock To:
1st Value:
2nd Value:
Value Percent:
Continuous Index:
Within 8" of Joint: **NO**
Remarks: **M-806-032**
