Profile/Photo Observation Report

| Street: | STARBOARD CT | Flow Control: | Not Controlled |

| US MH: | M-806-034 | DS MH: | M-806-033 |

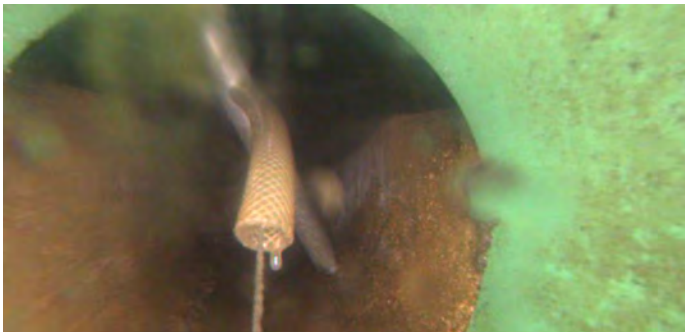
| Code: | MGO |
| Description: | General Observation |

| Distance (ft): | 2.4 |
| Remarks: | rear camera |

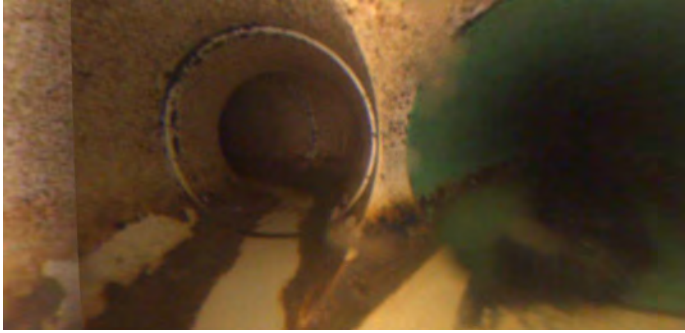
Code: **TFA**
Description: **Tap Factory Active**

Distance (ft): **49.6**
Structural Grade: **0**
O&M Grade: **0**
Clock Start/From: **9**
Clock To:
1st Value: **4.000**
2nd Value:
Value Percent:
Continuous Index:
Within 8" of Joint:
Remarks:

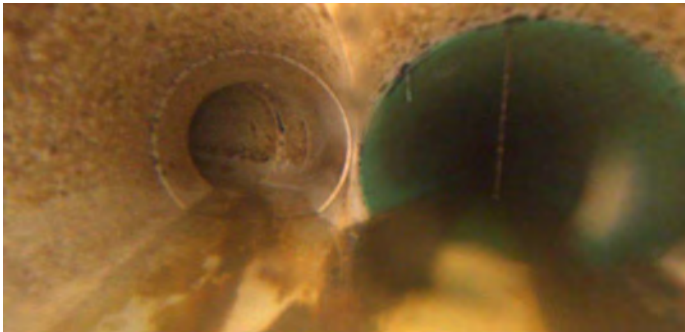
Code: **TFA**
Description: **Tap Factory Active**

Distance (ft): **110.6**
Structural Grade: **0**
O&M Grade: **0**
Clock Start/From: **9**
Clock To:
1st Value: **4.000**
2nd Value:
Value Percent:
Continuous Index:
Within 8" of Joint:
Remarks:

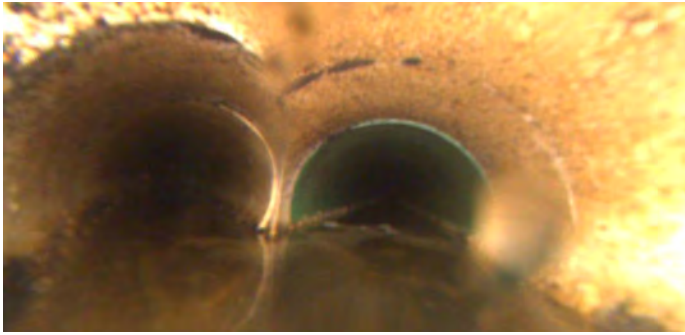
Code: **TFA**
Description: **Tap Factory Active**

Distance (ft): **140.5**
Structural Grade: **0**
O&M Grade: **0**
Clock Start/From: **9**
Clock To:
1st Value: **4.000**
2nd Value:
Value Percent:
Continuous Index:
Within 8" of Joint:
Remarks:

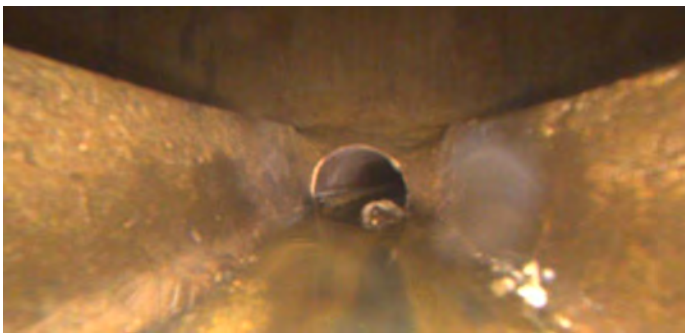
Code: **AMH**
Description: **Manhole**

Distance (ft): **159.1**
Structural Grade: **0**
O&M Grade: **0**
Clock Start/From:
Clock To:
1st Value:
2nd Value:
Value Percent:
Continuous Index:
Within 8" of Joint: **NO**
Remarks: **M-806-033**
