Profile/Photo Observation Report

Street:	Capitol	Flow Control:	Not Controlled
City:	Hobart, IN	Year Renewed:	
Location:	Sidewalk	Tape/Media #:	
Purpose:	Maintenance Related	Dia/Height:	8"
Use:	Sanitary	Material:	PVC
Drain Area:	NA	Lining:	Cured in Place
Category:	NA		
Comment:	flow incorrect.

Location Details:		Direction of Survey:	Downstream
US MH:	M-806-034	DS MH:	M-806-033
		Total Length Surveyed (ft):	159.1

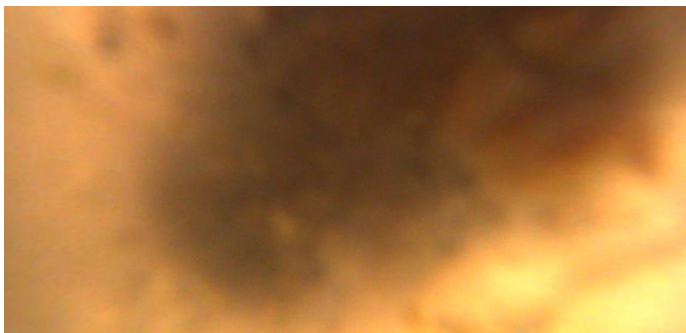
Code: **AMH**
Description: **Manhole**

Distance (ft): **.0**
Structural Grade: **0**
O&M Grade: **0**
Clock Start/From:
Clock To:
1st Value:
2nd Value:
Value Percent:
Continuous Index:
Within 8" of Joint: **NO**
Remarks: **M-806-034**

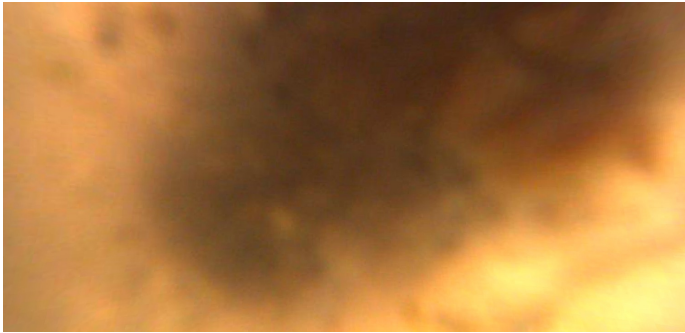
Code:	MWL
Description:	Water Level

Distance (ft):	.0
Structural Grade:	0
O&M Grade:	0
Clock Start/From:	
Clock To:	
1st Value:	
2nd Value:	
Value Percent:	5.000
Continuous Index:	
Within 8" of Joint:	NO
Remarks:

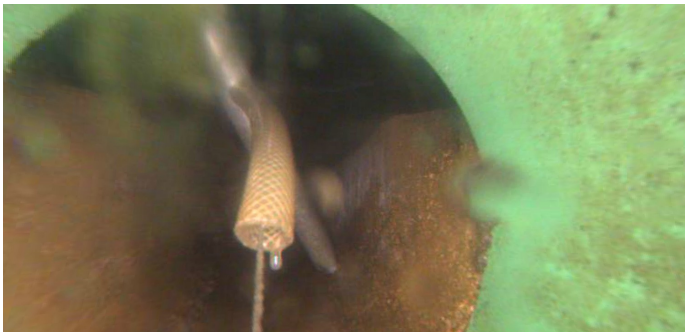
Code:	MGO
Description:	General Observation

Distance (ft):	2.4
Structural Grade:	0
O&M Grade:	0
Clock Start/From:	
Clock To:	
1st Value:	
2nd Value:	
Value Percent:	
Continuous Index:	
Within 8" of Joint:	NO
Remarks:	rear camera

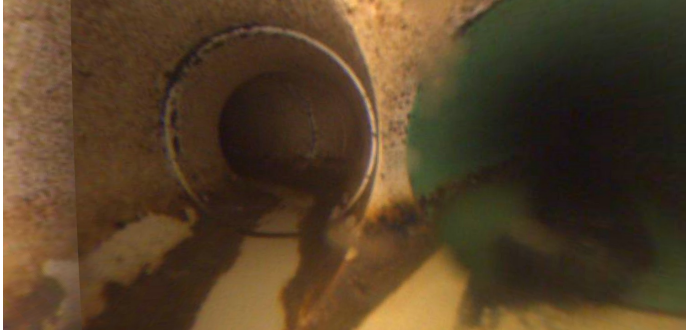
Code: **TFA**
Description: **Tap Factory Active**

Distance (ft): **49.6**
Structural Grade: **0**
O&M Grade: **0**
Clock Start/From: **9**
Clock To:
1st Value: **4.000**
2nd Value:
Value Percent:
Continuous Index:
Within 8" of Joint:
Remarks:

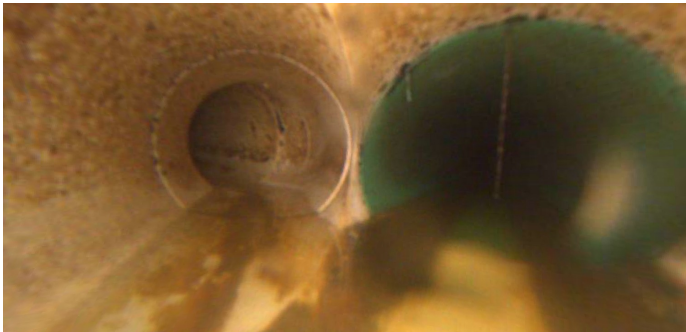
Code: **TFA**
Description: **Tap Factory Active**

Distance (ft): **110.6**
Structural Grade: **0**
O&M Grade: **0**
Clock Start/From: **9**
Clock To:
1st Value: **4.000**
2nd Value:
Value Percent:
Continuous Index:
Within 8" of Joint:
Remarks:

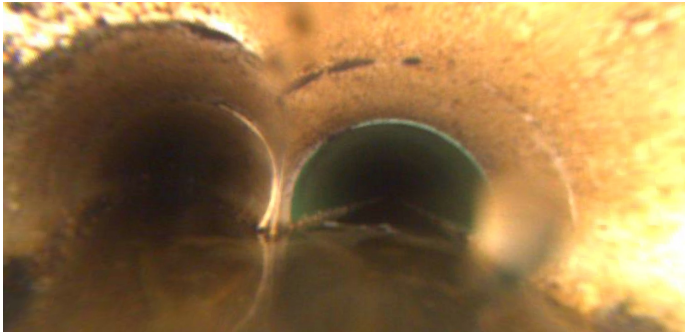
Code: **TFA**
Description: **Tap Factory Active**

Distance (ft): **140.5**
Structural Grade: **0**
O&M Grade: **0**
Clock Start/From: **9**
Clock To:
1st Value: **4.000**
2nd Value:
Value Percent:
Continuous Index:
Within 8" of Joint:
Remarks:

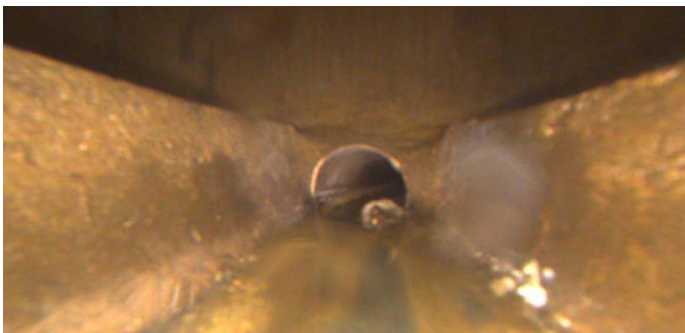
Code: **AMH**
Description: **Manhole**

Distance (ft): **159.1**
Structural Grade: **0**
O&M Grade: **0**
Clock Start/From:
Clock To:
1st Value:
2nd Value:
Value Percent:
Continuous Index:
Within 8" of Joint: **NO**
Remarks: **M-806-033**
