## Profile/Photo Observation Report

Date:	<b>04/13/2018</b>	Weather:		Coding:	<b>PACP 6.0</b>
Pipe Length (ft):	<b>256.6</b>	Owner:	<b>NA</b>	Pre Clean:	<b>Not Known</b>
P.O.#:		Surveyor:	<b>Jen Costello</b>	PSR:	<b>P-806-034-035</b>
Customer:		Clean Date:	<b>01/01/1900</b>	Shape:	<b>C</b>

Location Details:		Direction of Survey:	<b>Upstream</b>
US MH:	<b>M-806-035</b>	DS MH:	<b>M-806-034</b>
		Total Length Surveyed (ft):	<b>254.0</b>

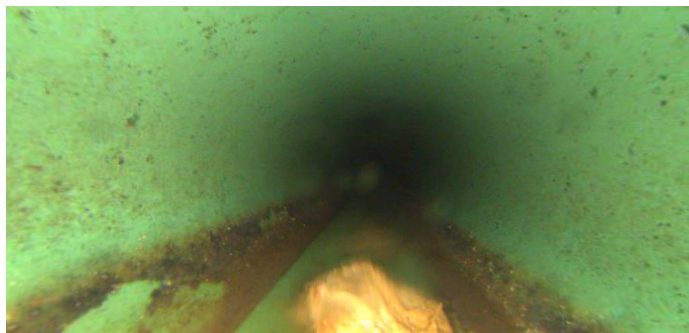
Code: **AMH**  
 Description: **Manhole**

Distance (ft): **.0**  
 Structural Grade: **0**  
 O&M Grade: **0**  
 Clock Start/From:  
 Clock To:  
 1st Value:  
 2nd Value:  
 Value Percent:  
 Continuous Index:  
 Within 8" of Joint: **NO**  
 Remarks: **M-806-034**

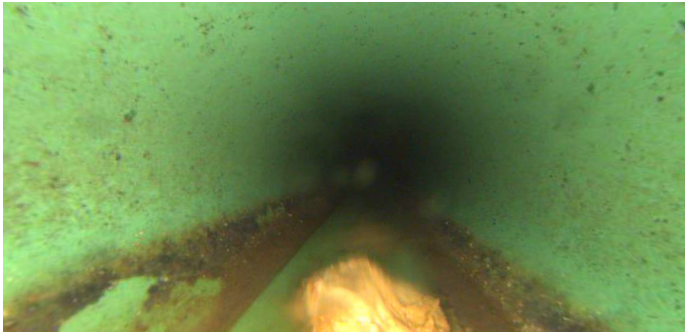
Code:	<b>MWL</b>
Description:	<b>Water Level</b>

Distance (ft):	<b>.0</b>
Structural Grade:	<b>0</b>
O&M Grade:	<b>0</b>
Clock Start/From:	
Clock To:	
1st Value:	
2nd Value:	
Value Percent:	<b>5.000</b>
Continuous Index:	
Within 8" of Joint:	<b>NO</b>
Remarks:

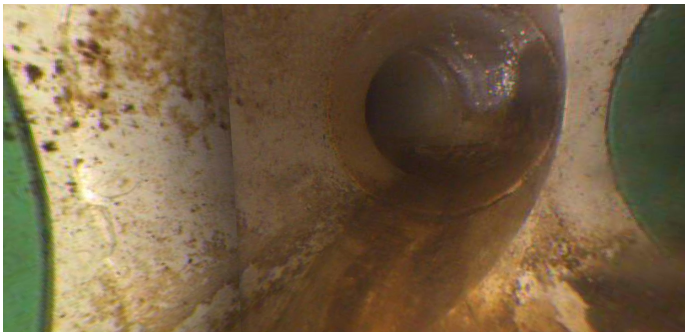
Code:	<b>TFA</b>
Description:	<b>Tap Factory Active</b>

Distance (ft):	<b>29.1</b>
Structural Grade:	<b>0</b>
O&M Grade:	<b>0</b>
Clock Start/From:	<b>3</b>
Clock To:	
1st Value:	<b>4.000</b>
2nd Value:	
Value Percent:	
Continuous Index:	
Within 8" of Joint:	
Remarks:

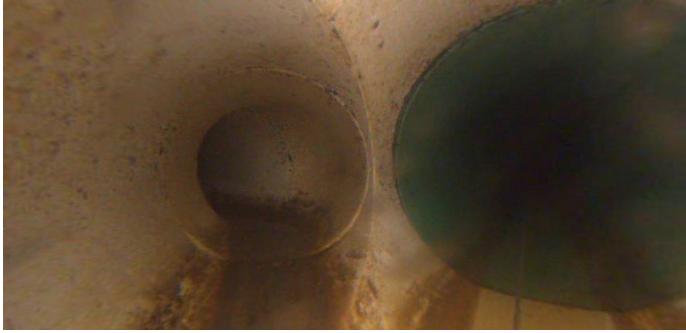
Code: **TFA**  
Description: **Tap Factory Active**

Distance (ft): **105.2**  
Structural Grade: **0**  
O&M Grade: **0**  
Clock Start/From: **3**  
Clock To:  
1st Value: **4.000**  
2nd Value:  
Value Percent:  
Continuous Index:  
Within 8" of Joint:  
Remarks:

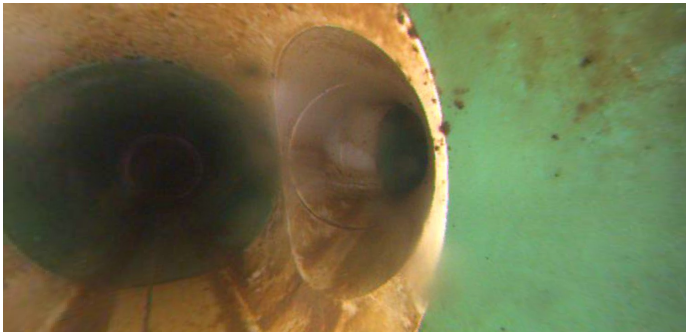
Code: **TF**  
Description: **Tap Factory**

Distance (ft): **108.9**  
Structural Grade: **0**  
O&M Grade: **0**  
Clock Start/From: **9**  
Clock To:  
1st Value: **4.000**  
2nd Value:  
Value Percent:  
Continuous Index:  
Within 8" of Joint:  
Remarks:

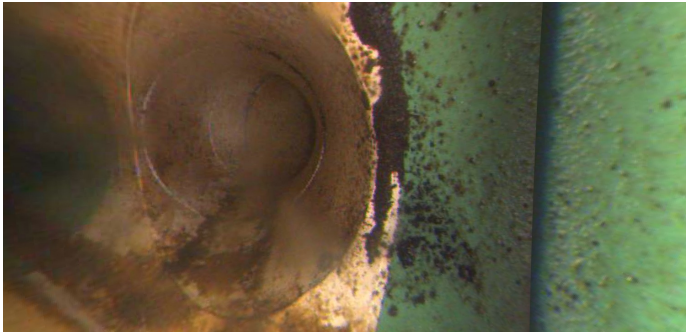
Code: **TF**  
Description: **Tap Factory**

Distance (ft): **194.8**  
Structural Grade: **0**  
O&M Grade: **0**  
Clock Start/From: **9**  
Clock To:  
1st Value: **4.000**  
2nd Value:  
Value Percent:  
Continuous Index:  
Within 8" of Joint:  
Remarks:

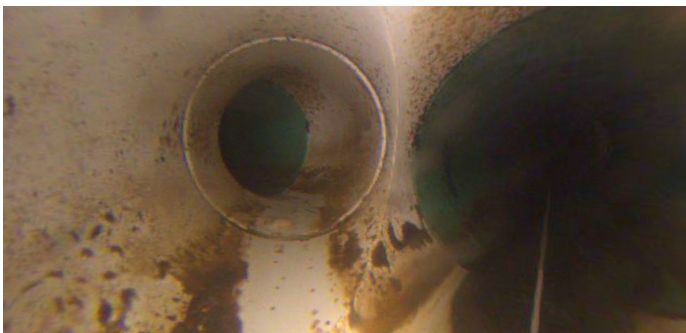
Code: **TF**  
Description: **Tap Factory**

Distance (ft): **198.1**  
Structural Grade: **0**  
O&M Grade: **0**  
Clock Start/From: **3**  
Clock To:  
1st Value: **4.000**  
2nd Value:  
Value Percent:  
Continuous Index:  
Within 8" of Joint:  
Remarks:

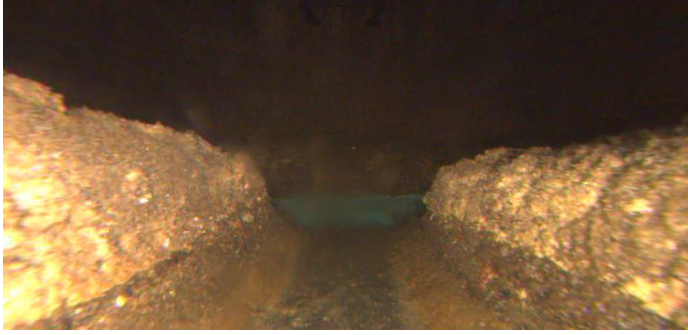
Code:	<b>AMH</b>
Description:	<b>Manhole</b>
Distance (ft):	<b>253.9</b>
Structural Grade:	<b>0</b>
O&M Grade:	<b>0</b>
Clock Start/From:	
Clock To:	
1st Value:	
2nd Value:	
Value Percent:	
Continuous Index:	
Within 8" of Joint:	<b>NO</b>
Remarks:	<b>M-806-035</b>
