Profile/Photo Observation Report

Date:	04/16/2018	Weather:		Coding:	PACP 6.0
Pipe Length (ft):	123.8	Owner:	NA	Pre Clean:	Not Known
P.O.#:		Surveyor:	Selasie Honu	PSR:	P-806-066-040
Customer:		Clean Date:	01/01/1900	Shape:	C

Street:	OFF E 10TH ST	Flow Control:	Not Controlled
City:	Hobart, IN	Year Renewed:	
Location:	Yard	Tape/Media #:	
Purpose:	Maintenance Related	Dia/Height:	8"
Use:	Sanitary	Material:	PVC
Drain Area:	NA	Lining:	Cured in Place
Category:	NA		
Comment:	silt and sediment at 9'.-flow incorrect.		
Location Details:		Direction of Survey:	Downstream
US MH:	M-806-040	DS MH:	M-806-066
		Total Length Surveyed (ft):	10.1

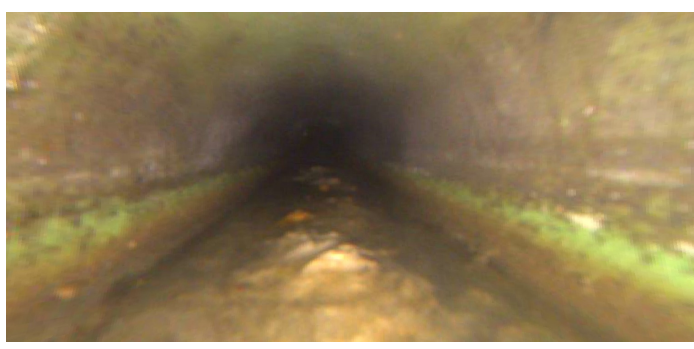
Code: **AMH**
Description: **Manhole**

Distance (ft): **.0**
Structural Grade: **0**
O&M Grade: **0**
Clock Start/From:
Clock To:
1st Value:
2nd Value:
Value Percent:
Continuous Index:
Within 8" of Joint: **NO**
Remarks: **M-806-040**

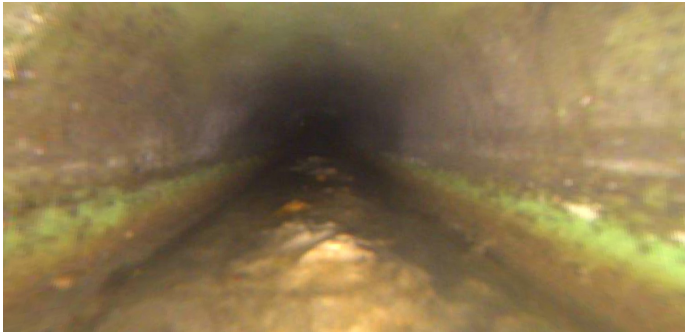
Code:	MWL
Description:	Water Level

Distance (ft):	.0
Structural Grade:	0
O&M Grade:	0
Clock Start/From:	
Clock To:	
1st Value:	
2nd Value:	
Value Percent:	5.000
Continuous Index:	
Within 8" of Joint:	NO
Remarks:

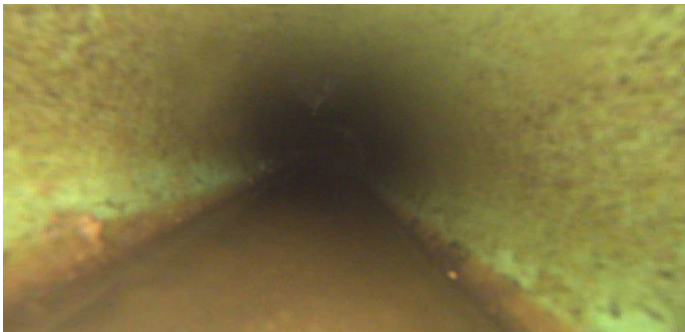
Code:	MSA
Description:	Abandoned Survey

Distance (ft):	10.1
Structural Grade:	0
O&M Grade:	0
Clock Start/From:	
Clock To:	
1st Value:	
2nd Value:	
Value Percent:	
Continuous Index:	
Within 8" of Joint:	NO
Remarks:	camera stopped
