Profile/Photo Observation Report

Street:	Capitol	Flow Control:	Not Controlled
City:	Hobart, IN	Year Renewed:	
Location:	Yard	Tape/Media #:	
Purpose:	Maintenance Related	Dia/Height:	8"
Use:	Sanitary	Material:	PVC
Drain Area:	NA	Lining:	Cured in Place
Category:	NA		
Comment:	silt and sediment at 9'.-flow incorrect.

Location Details:		Direction of Survey:	Downstream
US MH:	M-806-040	DS MH:	M-806-066
		Total Length Surveyed (ft):	10.1

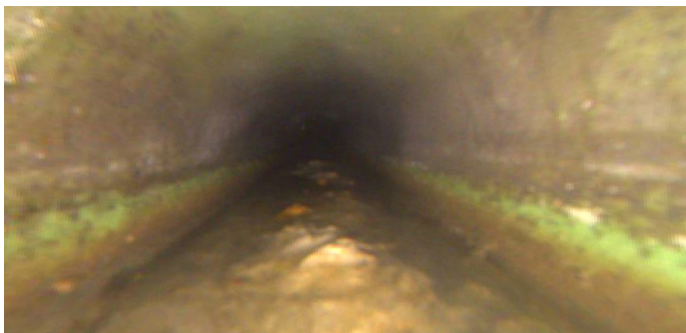
Code: **AMH**
Description: **Manhole**

Distance (ft): **.0**
Structural Grade: **0**
O&M Grade: **0**
Clock Start/From:
Clock To:
1st Value:
2nd Value:
Value Percent:
Continuous Index:
Within 8" of Joint: **NO**
Remarks: **M-806-040**

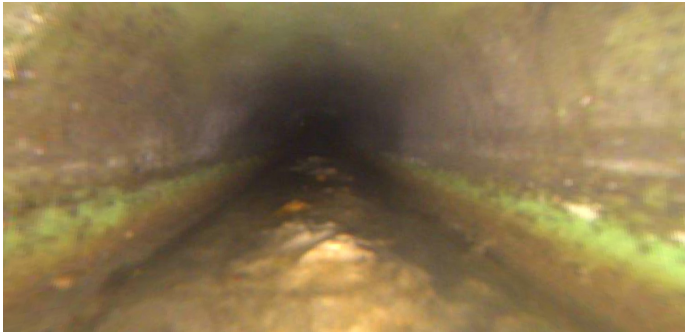
Code:	MWL
Description:	Water Level

Distance (ft):	.0
Structural Grade:	0
O&M Grade:	0
Clock Start/From:	
Clock To:	
1st Value:	
2nd Value:	
Value Percent:	5.000
Continuous Index:	
Within 8" of Joint:	NO
Remarks:

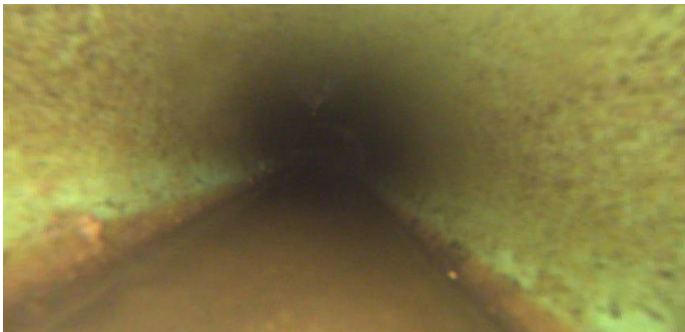
Code:	MSA
Description:	Abandoned Survey

Distance (ft):	10.1
Structural Grade:	0
O&M Grade:	0
Clock Start/From:	
Clock To:	
1st Value:	
2nd Value:	
Value Percent:	
Continuous Index:	
Within 8" of Joint:	NO
Remarks:	camera stopped
