Profile/Photo Observation Report

Date:	04/14/2018	Weather:		Coding:	PACP 6.0
Pipe Length (ft):	110.4	Owner:	NA	Pre Clean:	Not Known
P.O.#:		Surveyor:	Jen Costello	PSR:	P-806-040-041
Customer:		Clean Date:	01/01/1900	Shape:	C

Location Details:		Direction of Survey:	Downstream
US MH:	M-806-041	DS MH:	M-806-040
		Total Length Surveyed (ft):	102.3

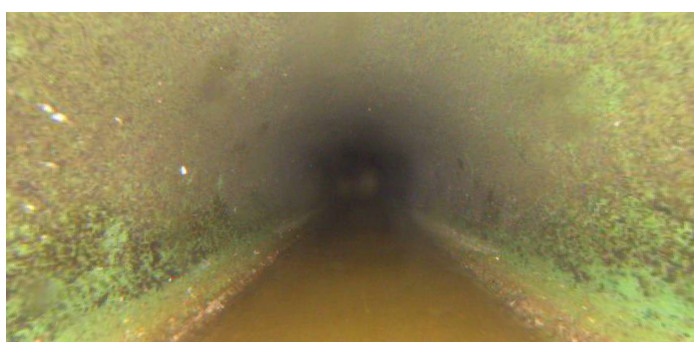
Code: **AMH**
Description: **Manhole**

Distance (ft): **.0**
Structural Grade: **0**
O&M Grade: **0**
Clock Start/From:
Clock To:
1st Value:
2nd Value:
Value Percent:
Continuous Index:
Within 8" of Joint: **NO**
Remarks: **M-806-041**

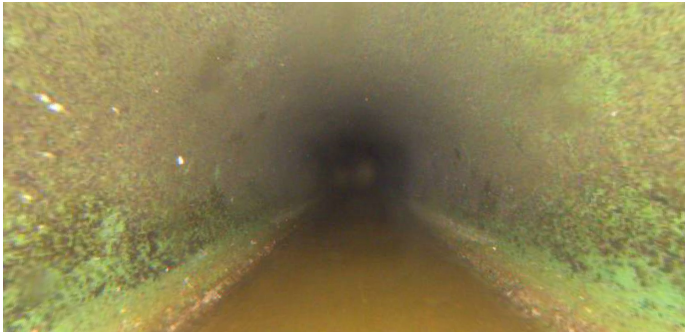
Code:	MWL
Description:	Water Level

Distance (ft):	.0
Structural Grade:	0
O&M Grade:	0
Clock Start/From:	
Clock To:	
1st Value:	
2nd Value:	
Value Percent:	10.000
Continuous Index:	
Within 8" of Joint:	NO
Remarks:

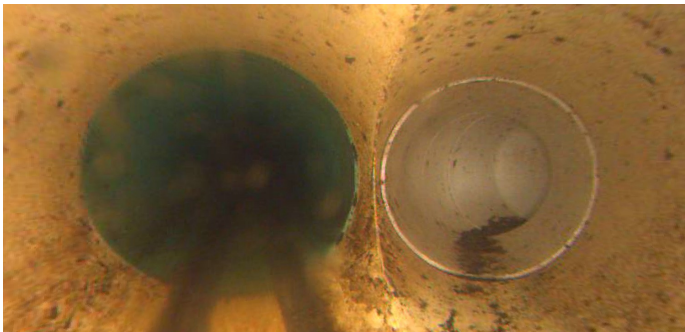
Code:	TFC
Description:	Tap Factory Capped

Distance (ft):	50.9
Structural Grade:	0
O&M Grade:	0
Clock Start/From:	3
Clock To:	
1st Value:	4.000
2nd Value:	
Value Percent:	
Continuous Index:	
Within 8" of Joint:	
Remarks:

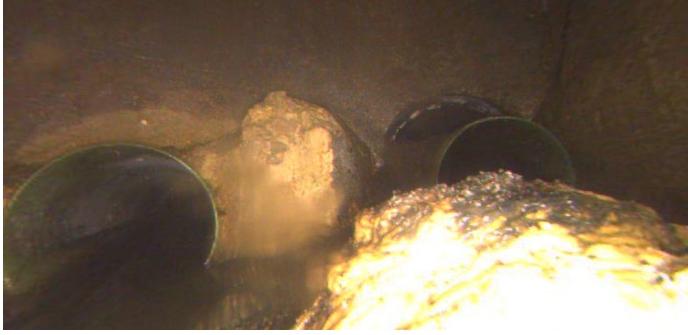
Code: **AMH**
Description: **Manhole**

Distance (ft): **102.3**
Structural Grade: **0**
O&M Grade: **0**
Clock Start/From:
Clock To:
1st Value:
2nd Value:
Value Percent:
Continuous Index:
Within 8" of Joint: **NO**
Remarks: **M-806-040**
