## Profile/Photo Observation Report

Street:	<b>E 10TH ST</b>	Flow Control:	<b>Not Controlled</b>
City:	<b>Hobart, IN</b>	Year Renewed:	
Location:	<b>Yard</b>	Tape/Media #:	
Purpose:	<b>Maintenance Related</b>	Dia/Height:	<b>8"</b>
Use:	<b>Sanitary</b>	Material:	<b>PVC</b>
Drain Area:	<b>NA</b>	Lining:	<b>Cured in Place</b>
Category:	<b>NA</b>		
Comment:	<b>flow incorrect.</b>

Location Details:		Direction of Survey:	<b>Downstream</b>
US MH:	<b>M-806-041</b>	DS MH:	<b>M-806-043</b>
		Total Length Surveyed (ft):	<b>131.5</b>

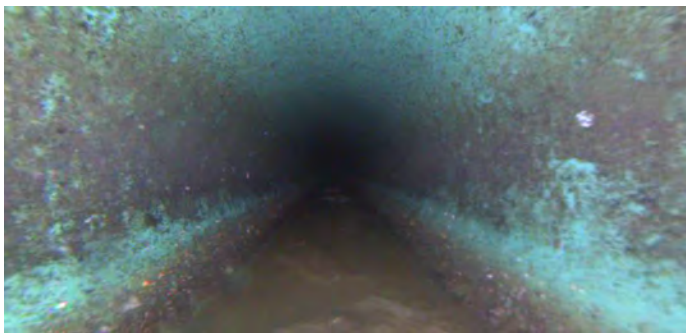
Code: **AMH**  
Description: **Manhole**

Distance (ft): **.0**  
Structural Grade: **0**  
O&M Grade: **0**  
Clock Start/From:  
Clock To:  
1st Value:  
2nd Value:  
Value Percent:  
Continuous Index:  
Within 8" of Joint: **NO**  
Remarks: **M-806-041**

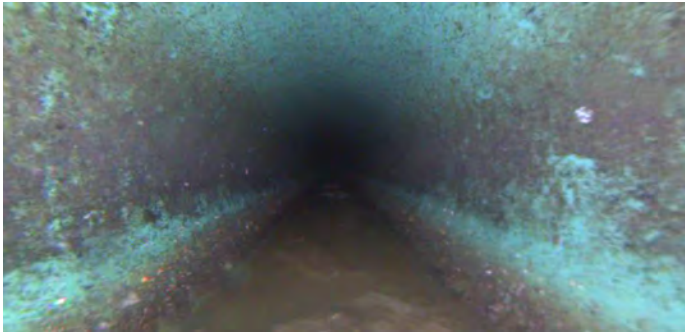
Code:	<b>MWL</b>
Description:	<b>Water Level</b>

Distance (ft):	<b>.0</b>
Structural Grade:	<b>0</b>
O&M Grade:	<b>0</b>
Clock Start/From:	
Clock To:	
1st Value:	
2nd Value:	
Value Percent:	<b>5.000</b>
Continuous Index:	
Within 8" of Joint:	<b>NO</b>
Remarks:

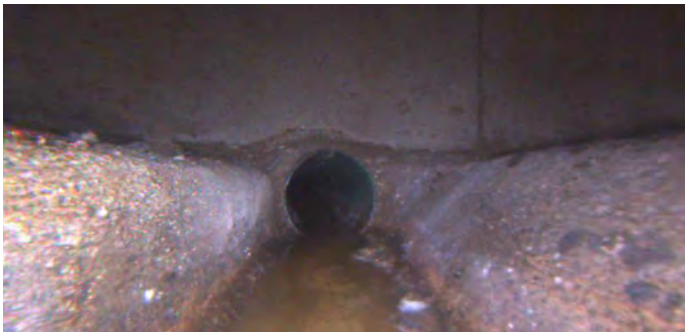
Code:	<b>AMH</b>
Description:	<b>Manhole</b>

Distance (ft):	<b>131.5</b>
Structural Grade:	<b>0</b>
O&M Grade:	<b>0</b>
Clock Start/From:	
Clock To:	
1st Value:	
2nd Value:	
Value Percent:	
Continuous Index:	
Within 8" of Joint:	<b>NO</b>
Remarks:	<b>M-806-043</b>
