Profile/Photo Observation Report

Street:	DEER CROSS TRL	Flow Control:	Not Controlled
City:	Hobart, IN	Year Renewed:	
Location:	Yard	Tape/Media #:	
Purpose:	Maintenance Related	Dia/Height:	8"
Use:	Sanitary	Material:	PVC
Drain Area:	NA	Lining:	Cured in Place
Category:	NA		
Comment:	flow incorrect.

Location Details:		Direction of Survey:	Downstream
US MH:	M-806-045	DS MH:	M-806-053
		Total Length Surveyed (ft):	75.5

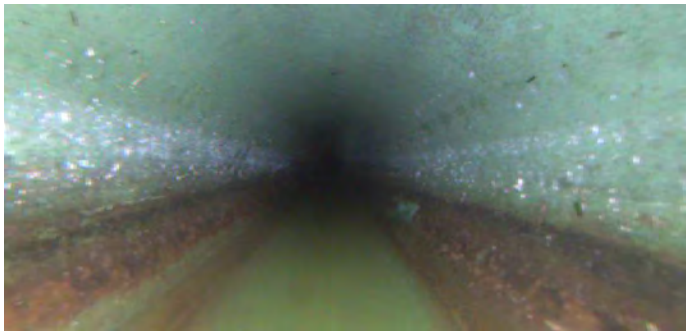
Code: **AMH**
Description: **Manhole**

Distance (ft): **.0**
Structural Grade: **0**
O&M Grade: **0**
Clock Start/From:
Clock To:
1st Value:
2nd Value:
Value Percent:
Continuous Index:
Within 8" of Joint: **NO**
Remarks: **M-806-045**

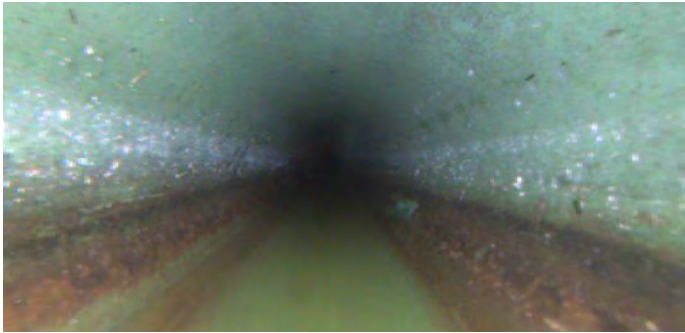
Code:	MWL
Description:	Water Level

Distance (ft):	.0
Structural Grade:	0
O&M Grade:	0
Clock Start/From:	
Clock To:	
1st Value:	
2nd Value:	
Value Percent:	5.000
Continuous Index:	
Within 8" of Joint:	NO
Remarks:

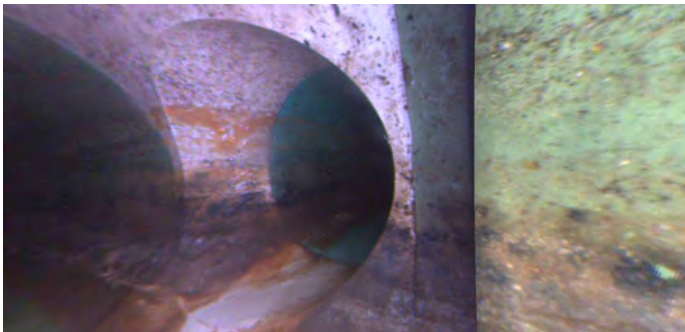
Code:	TF
Description:	Tap Factory

Distance (ft):	27.4
Structural Grade:	0
O&M Grade:	0
Clock Start/From:	9
Clock To:	
1st Value:	4.000
2nd Value:	
Value Percent:	
Continuous Index:	
Within 8" of Joint:	YES
Remarks:

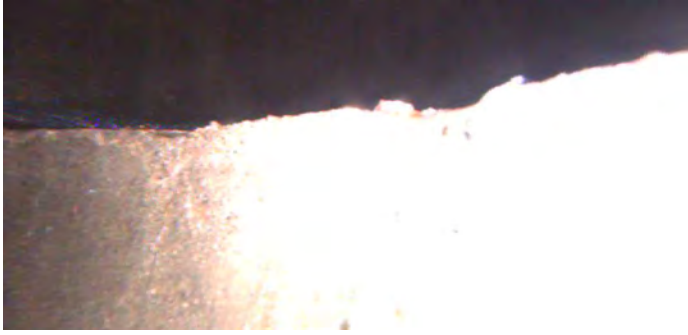
Code:	AMH
Description:	Manhole
Distance (ft):	75.5
Structural Grade:	0
O&M Grade:	0
Clock Start/From:	
Clock To:	
1st Value:	
2nd Value:	
Value Percent:	
Continuous Index:	
Within 8" of Joint:	NO
Remarks:	M-806-053
