## Profile/Photo Observation Report

Street:	<b>DEER CROSS TRL &amp; FAWN CT</b>	Flow Control:	<b>Not Controlled</b>
City:	<b>Hobart, IN</b>	Year Renewed:	
Location:	<b>Yard</b>	Tape/Media #:	
Purpose:	<b>Maintenance Related</b>	Dia/Height:	<b>8"</b>
Use:	<b>Sanitary</b>	Material:	<b>PVC</b>
Drain Area:	<b>NA</b>	Lining:	<b>Cured in Place</b>
Category:	<b>NA</b>		
Comment:	<b>battery at 280'.</b>

Location Details:		Direction of Survey:	<b>Upstream</b>
US MH:	<b>M-806-050</b>	DS MH:	<b>M-806-052</b>
		Total Length Surveyed (ft):	<b>281.6</b>

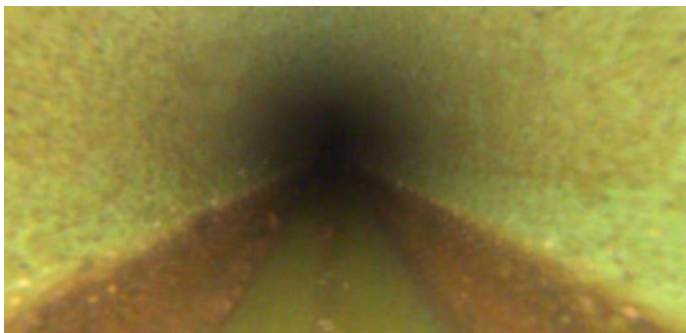
Code: **AMH**  
Description: **Manhole**

Distance (ft): **.0**  
Structural Grade: **0**  
O&M Grade: **0**  
Clock Start/From:  
Clock To:  
1st Value:  
2nd Value:  
Value Percent:  
Continuous Index:  
Within 8" of Joint: **NO**  
Remarks: **M-806-052**

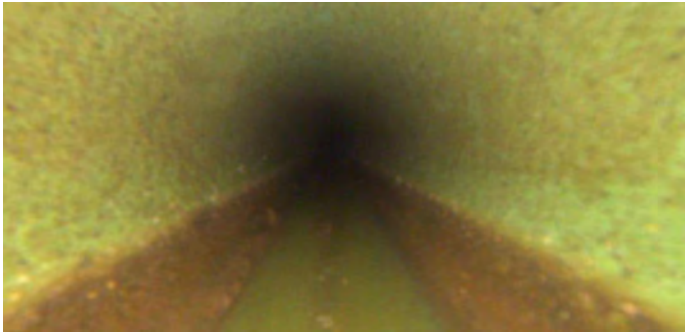
Code:	<b>MWL</b>
Description:	<b>Water Level</b>

Distance (ft):	<b>.0</b>
Structural Grade:	<b>0</b>
O&M Grade:	<b>0</b>
Clock Start/From:	
Clock To:	
1st Value:	
2nd Value:	
Value Percent:	<b>5.000</b>
Continuous Index:	
Within 8" of Joint:	<b>NO</b>
Remarks:

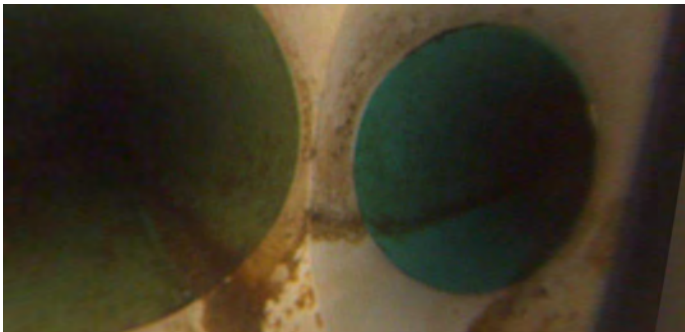
Code:	<b>TF</b>
Description:	<b>Tap Factory</b>

Distance (ft):	<b>68.6</b>
Structural Grade:	<b>0</b>
O&M Grade:	<b>0</b>
Clock Start/From:	<b>3</b>
Clock To:	
1st Value:	<b>4.000</b>
2nd Value:	
Value Percent:	
Continuous Index:	
Within 8" of Joint:	
Remarks:

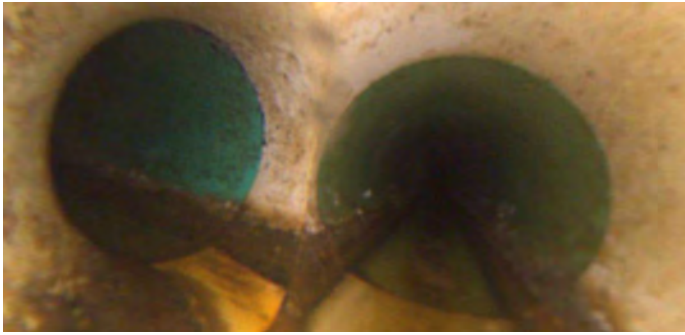
Code: **TFA**  
Description: **Tap Factory Active**

Distance (ft): **78.5**  
Structural Grade: **0**  
O&M Grade: **0**  
Clock Start/From: **9**  
Clock To:  
1st Value: **4.000**  
2nd Value:  
Value Percent:  
Continuous Index:  
Within 8" of Joint:  
Remarks:

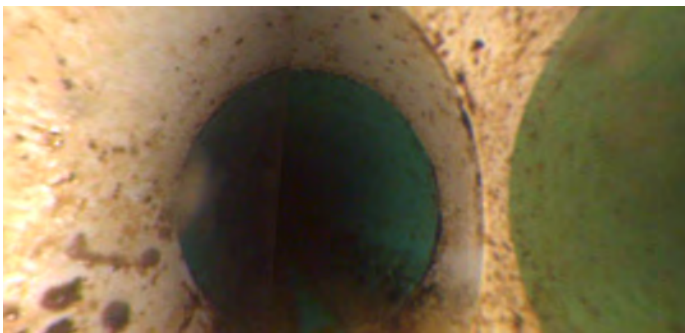
Code: **TFA**  
Description: **Tap Factory Active**

Distance (ft): **169.0**  
Structural Grade: **0**  
O&M Grade: **0**  
Clock Start/From: **9**  
Clock To:  
1st Value: **4.000**  
2nd Value:  
Value Percent:  
Continuous Index:  
Within 8" of Joint:  
Remarks:

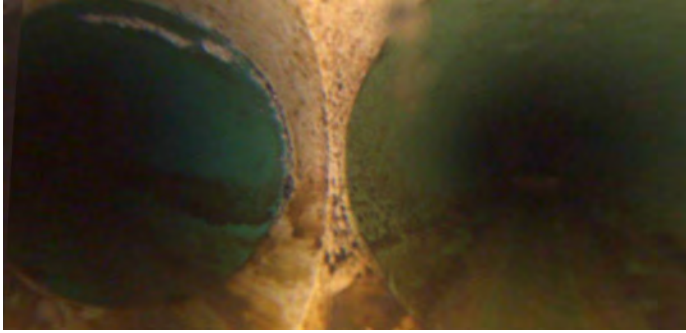
Code: **TF**  
Description: **Tap Factory**

Distance (ft): **246.0**  
Structural Grade: **0**  
O&M Grade: **0**  
Clock Start/From: **9**  
Clock To:  
1st Value: **4.000**  
2nd Value:  
Value Percent:  
Continuous Index:  
Within 8" of Joint:  
Remarks:

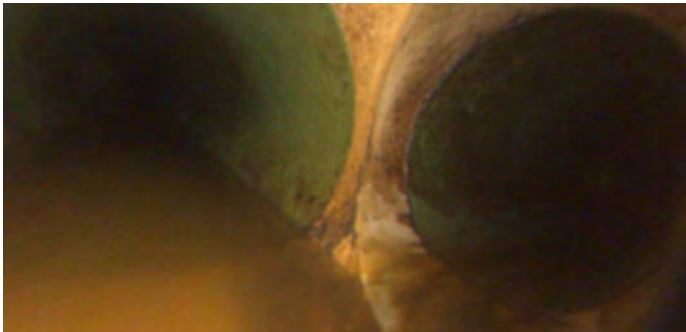
Code: **TF**  
Description: **Tap Factory**

Distance (ft): **266.3**  
Structural Grade: **0**  
O&M Grade: **0**  
Clock Start/From: **3**  
Clock To:  
1st Value: **4.000**  
2nd Value:  
Value Percent:  
Continuous Index:  
Within 8" of Joint:  
Remarks:

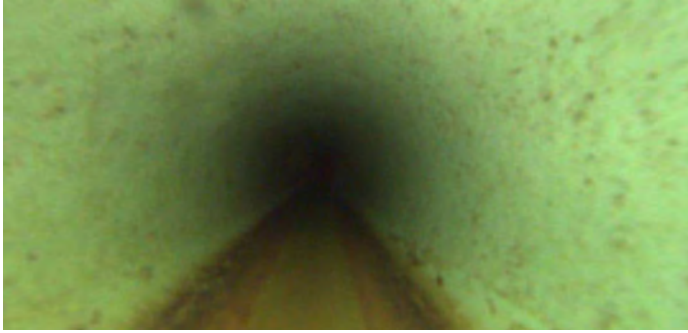
Code:	<b>MSA</b>
Description:	<b>Abandoned Survey</b>
Distance (ft):	<b>281.6</b>
Structural Grade:	<b>0</b>
O&M Grade:	<b>0</b>
Clock Start/From:	
Clock To:	
1st Value:	
2nd Value:	
Value Percent:	
Continuous Index:	
Within 8" of Joint:	<b>NO</b>
Remarks:	<b>unknown</b>
