Profile/Photo Observation Report

Street:	Capitol	Flow Control:	Not Controlled
City:	Hobart, IN	Year Renewed:	
Location:	Yard	Tape/Media #:	
Purpose:	Maintenance Related	Dia/Height:	8"
Use:	Sanitary	Material:	PVC
Drain Area:	NA	Lining:	Cured in Place
Category:	NA		
Comment:	battery at 280'.

Location Details:		Direction of Survey:	Upstream
US MH:	M-806-050	DS MH:	M-806-052
		Total Length Surveyed (ft):	281.6

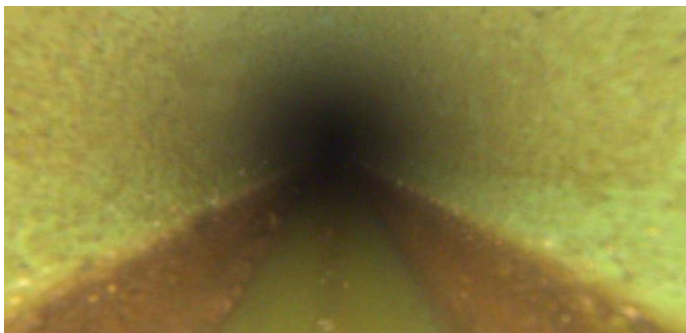
Code: **AMH**
Description: **Manhole**

Distance (ft): **.0**
Structural Grade: **0**
O&M Grade: **0**
Clock Start/From:
Clock To:
1st Value:
2nd Value:
Value Percent:
Continuous Index:
Within 8" of Joint: **NO**
Remarks: **M-806-052**

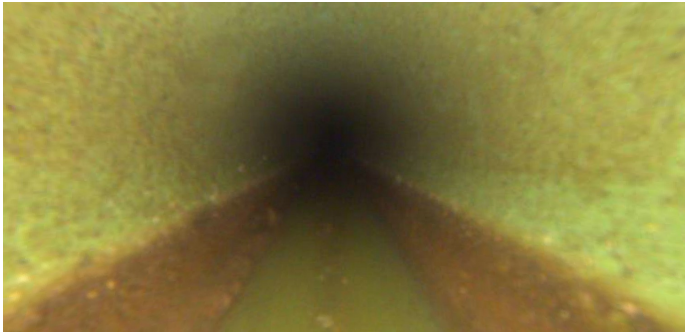
Code:	MWL
Description:	Water Level

Distance (ft):	.0
Structural Grade:	0
O&M Grade:	0
Clock Start/From:	
Clock To:	
1st Value:	
2nd Value:	
Value Percent:	5.000
Continuous Index:	
Within 8" of Joint:	NO
Remarks:

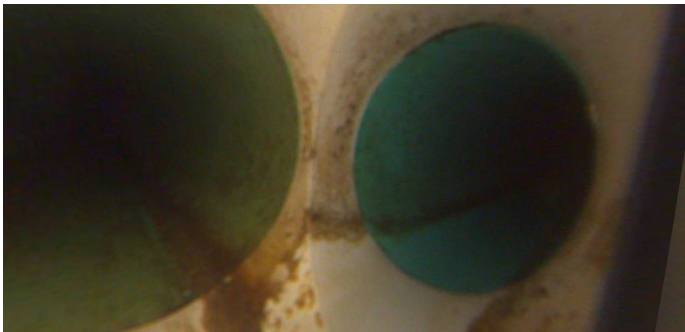
Code:	TF
Description:	Tap Factory

Distance (ft):	68.6
Structural Grade:	0
O&M Grade:	0
Clock Start/From:	3
Clock To:	
1st Value:	4.000
2nd Value:	
Value Percent:	
Continuous Index:	
Within 8" of Joint:	
Remarks:

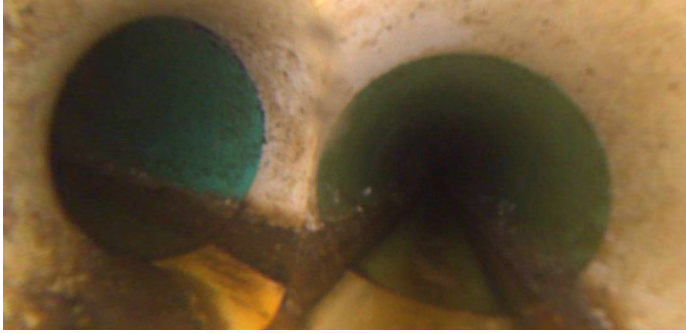
Code: **TFA**
Description: **Tap Factory Active**

Distance (ft): **78.5**
Structural Grade: **0**
O&M Grade: **0**
Clock Start/From: **9**
Clock To:
1st Value: **4.000**
2nd Value:
Value Percent:
Continuous Index:
Within 8" of Joint:
Remarks:

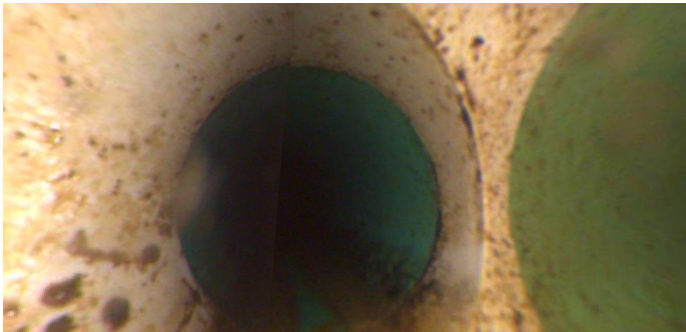
Code: **TFA**
Description: **Tap Factory Active**

Distance (ft): **169.0**
Structural Grade: **0**
O&M Grade: **0**
Clock Start/From: **9**
Clock To:
1st Value: **4.000**
2nd Value:
Value Percent:
Continuous Index:
Within 8" of Joint:
Remarks:

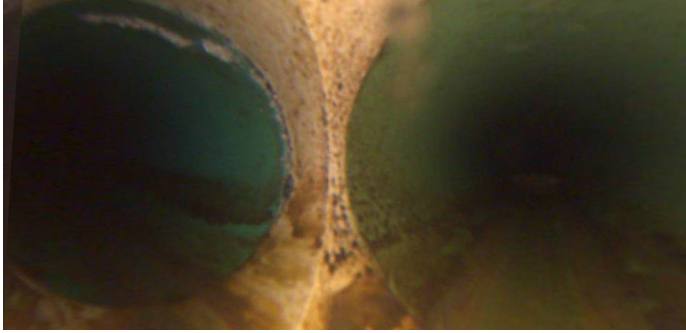
Code: **TF**
Description: **Tap Factory**

Distance (ft): **246.0**
Structural Grade: **0**
O&M Grade: **0**
Clock Start/From: **9**
Clock To:
1st Value: **4.000**
2nd Value:
Value Percent:
Continuous Index:
Within 8" of Joint:
Remarks:

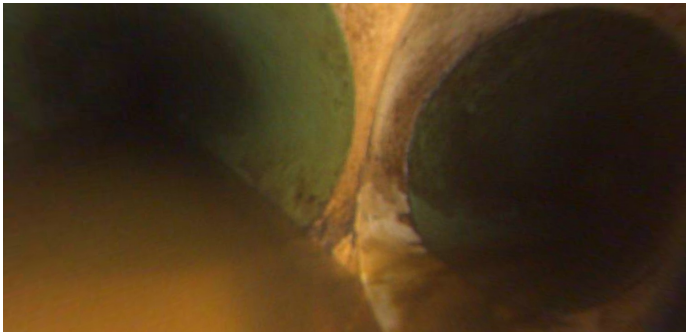
Code: **TF**
Description: **Tap Factory**

Distance (ft): **266.3**
Structural Grade: **0**
O&M Grade: **0**
Clock Start/From: **3**
Clock To:
1st Value: **4.000**
2nd Value:
Value Percent:
Continuous Index:
Within 8" of Joint:
Remarks:

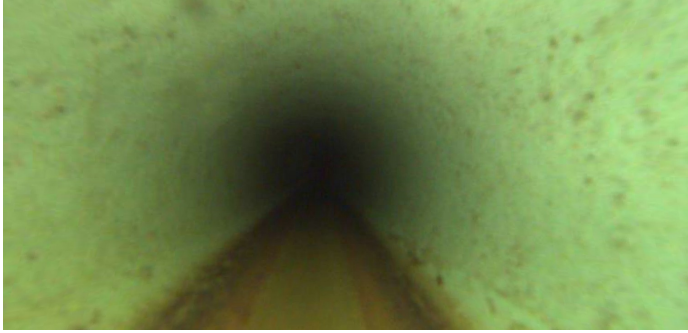
Code:	MSA
Description:	Abandoned Survey
Distance (ft):	281.6
Structural Grade:	0
O&M Grade:	0
Clock Start/From:	
Clock To:	
1st Value:	
2nd Value:	
Value Percent:	
Continuous Index:	
Within 8" of Joint:	NO
Remarks:	unknown
