Profile/Photo Observation Report

Street:	DEER CROSS TRL & FAWN CT	Flow Control:	Not Controlled
City:	Hobart, IN	Year Renewed:	
Location:	Yard	Tape/Media #:	
Purpose:	Maintenance Related	Dia/Height:	8"
Use:	Sanitary	Material:	PVC
Drain Area:	NA	Lining:	Cured in Place
Category:	NA		
Comment:	Reverse setup. user set max at 100'.

Location Details:		Direction of Survey:	Downstream
US MH:	M-806-050	DS MH:	M-806-052
		Total Length Surveyed (ft):	101.6

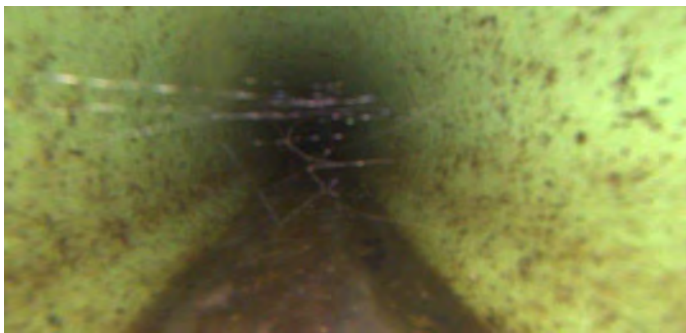
Code: **AMH**
Description: **Manhole**

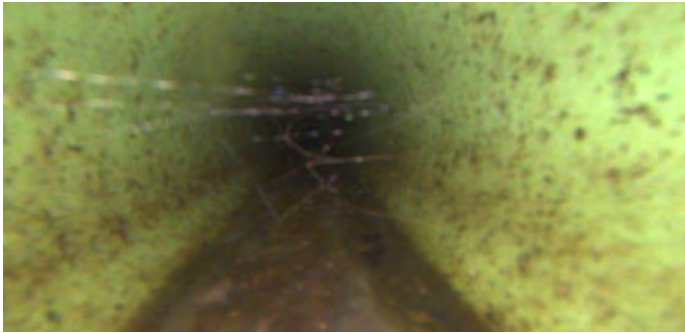
Code:	MWL
Description:	Water Level

Distance (ft):	.0
Structural Grade:	0
O&M Grade:	0
Clock Start/From:	
Clock To:	
1st Value:	
2nd Value:	
Value Percent:	5.000
Continuous Index:	
Within 8" of Joint:	NO
Remarks:

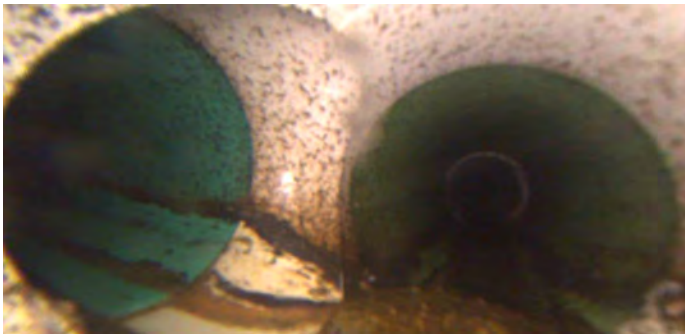
Code:	TFA
Description:	Tap Factory Active

Distance (ft):	5.1
Structural Grade:	0
O&M Grade:	0
Clock Start/From:	9
Clock To:	
1st Value:	4.000
2nd Value:	
Value Percent:	
Continuous Index:	
Within 8" of Joint:	
Remarks:

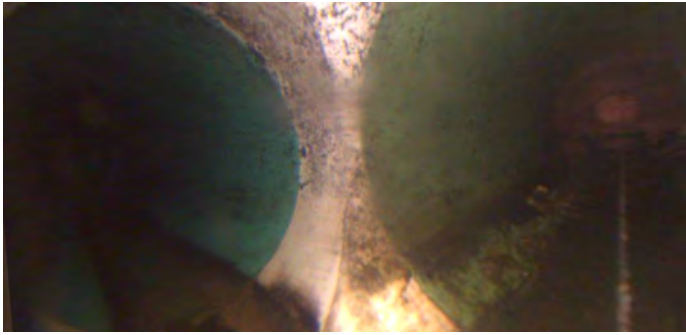
Code: **TFA**
Description: **Tap Factory Active**

Distance (ft): **8.2**
Structural Grade: **0**
O&M Grade: **0**
Clock Start/From: **3**
Clock To:
1st Value: **4.000**
2nd Value:
Value Percent:
Continuous Index:
Within 8" of Joint:
Remarks:

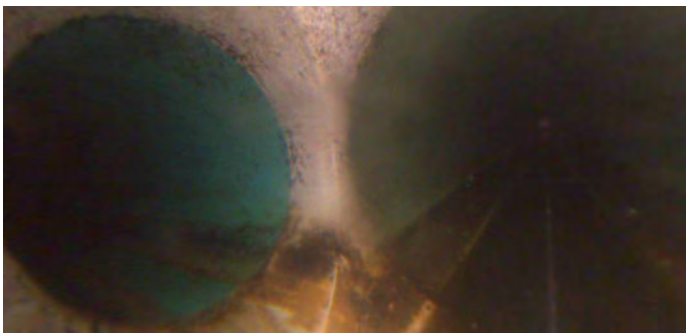
Code: **TFA**
Description: **Tap Factory Active**

Distance (ft): **28.8**
Structural Grade: **0**
O&M Grade: **0**
Clock Start/From: **3**
Clock To:
1st Value: **4.000**
2nd Value:
Value Percent:
Continuous Index:
Within 8" of Joint:
Remarks:

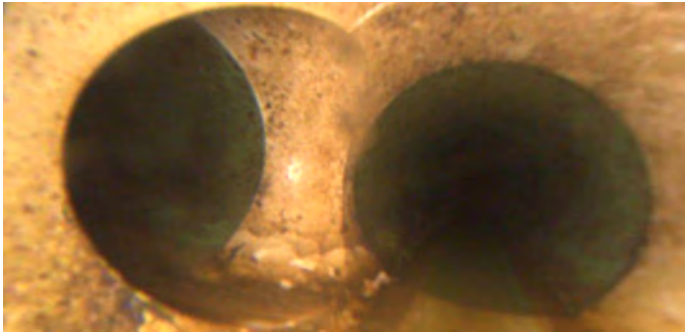
Code: **TF**
Description: **Tap Factory**

Distance (ft): **60.3**
Structural Grade: **0**
O&M Grade: **0**
Clock Start/From: **9**
Clock To:
1st Value: **4.000**
2nd Value:
Value Percent:
Continuous Index:
Within 8" of Joint:
Remarks:

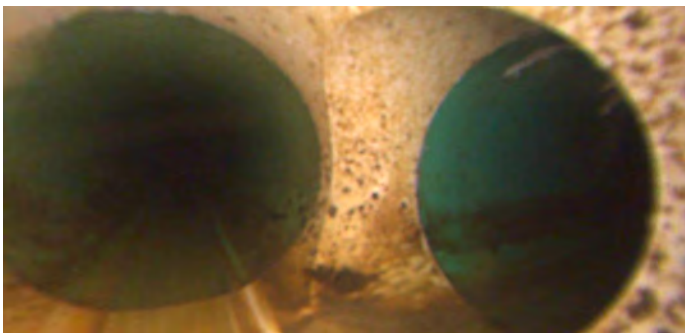
Code: **TF**
Description: **Tap Factory**

Distance (ft): **80.8**
Structural Grade: **0**
O&M Grade: **0**
Clock Start/From: **3**
Clock To:
1st Value: **4.000**
2nd Value:
Value Percent:
Continuous Index:
Within 8" of Joint:
Remarks:

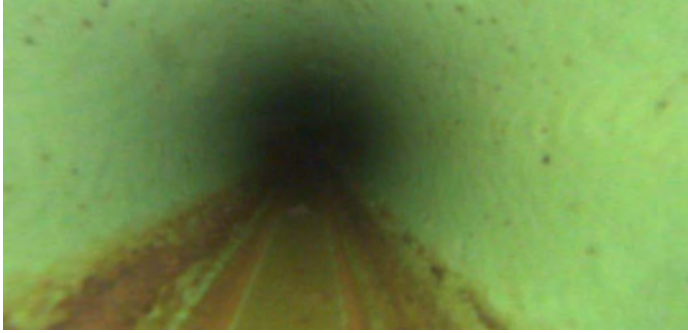
Code:	MSA
Description:	Abandoned Survey
Distance (ft):	101.6
Structural Grade:	0
O&M Grade:	0
Clock Start/From:	
Clock To:	
1st Value:	
2nd Value:	
Value Percent:	
Continuous Index:	
Within 8" of Joint:	NO
Remarks:	unknown
