Profile/Photo Observation Report

Date:	04/12/2018	Weather:		Coding:	PACP 6.0
Pipe Length (ft):	330.0	Owner:	NA	Pre Clean:	Not Known
P.O.#:		Surveyor:	Jen Costello	PSR:	P-806-050-052
Customer:		Clean Date:	01/01/1900	Shape:	C

Street:	Capitol	Flow Control:	Not Controlled
City:	Hobart, IN	Year Renewed:	
Location:	Yard	Tape/Media #:	
Purpose:	Maintenance Related	Dia/Height:	8"
Use:	Sanitary	Material:	PVC
Drain Area:	NA	Lining:	Cured in Place
Category:	NA		
Comment:	Reverse setup. user set max at 100'.

Location Details:		Direction of Survey:	Downstream
US MH:	M-806-050	DS MH:	M-806-052
		Total Length Surveyed (ft):	101.6

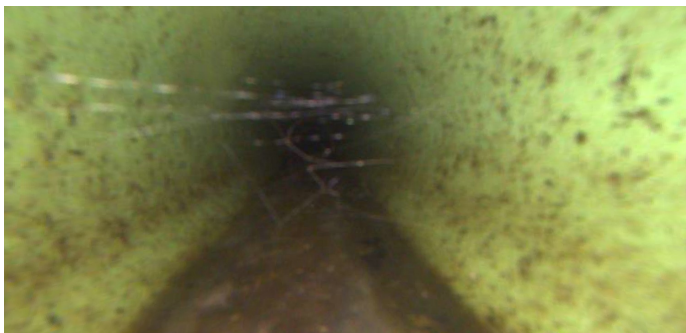
Code: **AMH**
Description: **Manhole**

Distance (ft): **.0**
Structural Grade: **0**
O&M Grade: **0**
Clock Start/From:
Clock To:
1st Value:
2nd Value:
Value Percent:
Continuous Index:
Within 8" of Joint: **NO**
Remarks: **M-806-050**

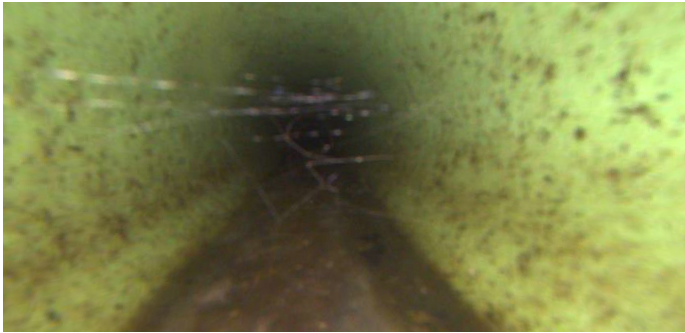
Code:	MWL
Description:	Water Level

Distance (ft):	.0
Structural Grade:	0
O&M Grade:	0
Clock Start/From:	
Clock To:	
1st Value:	
2nd Value:	
Value Percent:	5.000
Continuous Index:	
Within 8" of Joint:	NO
Remarks:

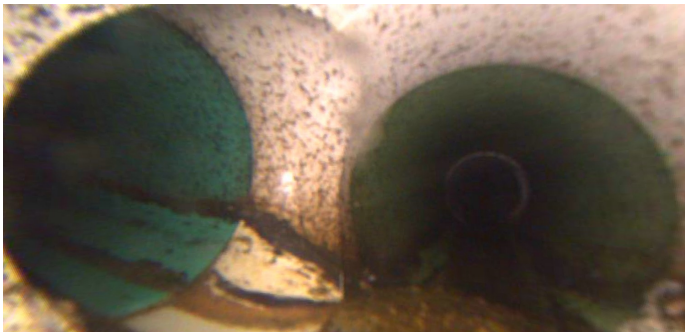
Code:	TFA
Description:	Tap Factory Active

Distance (ft):	5.1
Structural Grade:	0
O&M Grade:	0
Clock Start/From:	9
Clock To:	
1st Value:	4.000
2nd Value:	
Value Percent:	
Continuous Index:	
Within 8" of Joint:	
Remarks:

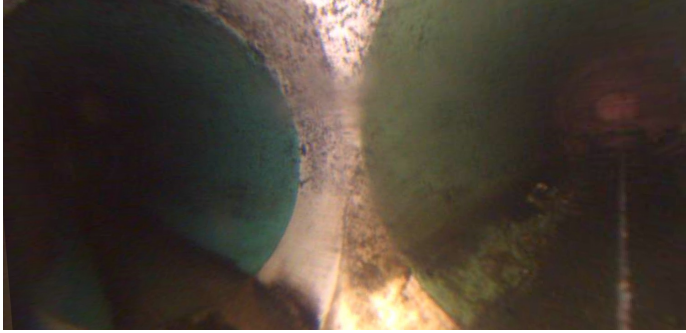
Code: **TFA**
Description: **Tap Factory Active**

Distance (ft): **8.2**
Structural Grade: **0**
O&M Grade: **0**
Clock Start/From: **3**
Clock To:
1st Value: **4.000**
2nd Value:
Value Percent:
Continuous Index:
Within 8" of Joint:
Remarks:

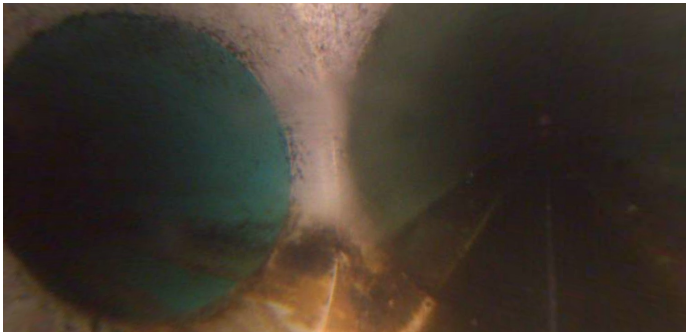
Code: **TFA**
Description: **Tap Factory Active**

Distance (ft): **28.8**
Structural Grade: **0**
O&M Grade: **0**
Clock Start/From: **3**
Clock To:
1st Value: **4.000**
2nd Value:
Value Percent:
Continuous Index:
Within 8" of Joint:
Remarks:

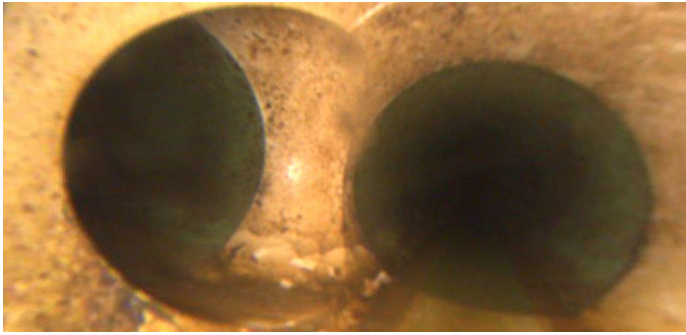
Code: **TF**
Description: **Tap Factory**

Distance (ft): **60.3**
Structural Grade: **0**
O&M Grade: **0**
Clock Start/From: **9**
Clock To:
1st Value: **4.000**
2nd Value:
Value Percent:
Continuous Index:
Within 8" of Joint:
Remarks:

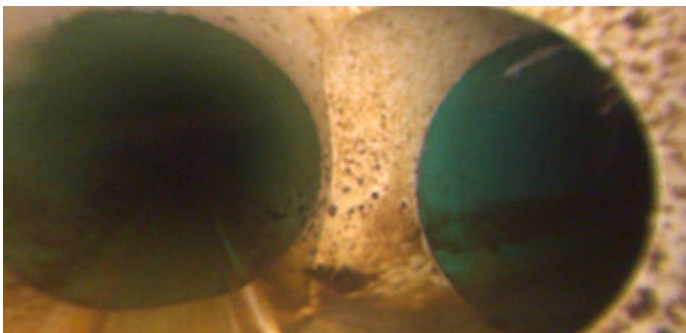
Code: **TF**
Description: **Tap Factory**

Distance (ft): **80.8**
Structural Grade: **0**
O&M Grade: **0**
Clock Start/From: **3**
Clock To:
1st Value: **4.000**
2nd Value:
Value Percent:
Continuous Index:
Within 8" of Joint:
Remarks:

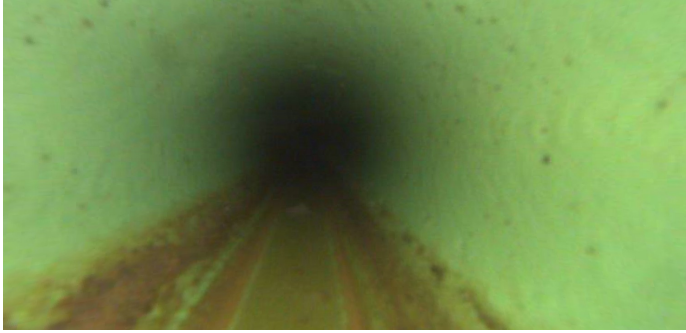
Code:	MSA
Description:	Abandoned Survey
Distance (ft):	101.6
Structural Grade:	0
O&M Grade:	0
Clock Start/From:	
Clock To:	
1st Value:	
2nd Value:	
Value Percent:	
Continuous Index:	
Within 8" of Joint:	NO
Remarks:	unknown
