## Profile/Photo Observation Report

Date:	<b>04/12/2018</b>	Weather:		Coding:	<b>PACP 6.0</b>
Pipe Length (ft):	<b>108.1</b>	Owner:	<b>NA</b>	Pre Clean:	<b>Not Known</b>
P.O.#:		Surveyor:	<b>Jen Costello</b>	PSR:	<b>P-806-051-052</b>
Customer:		Clean Date:	<b>01/01/1900</b>	Shape:	<b>C</b>

Location Details:		Direction of Survey:	<b>Downstream</b>
US MH:	<b>M-806-052</b>	DS MH:	<b>M-806-051</b>
		Total Length Surveyed (ft):	<b>107.2</b>

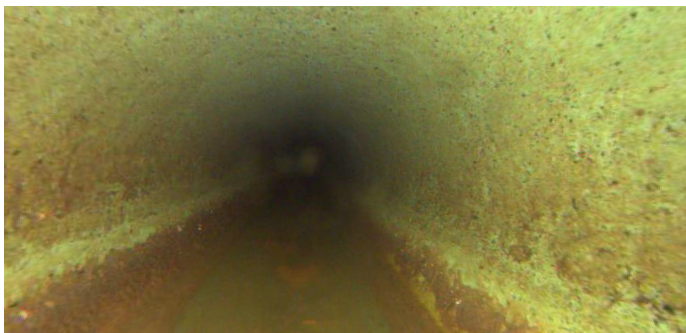
Code: **AMH**  
Description: **Manhole**

Distance (ft): **.0**  
Structural Grade: **0**  
O&M Grade: **0**  
Clock Start/From:  
Clock To:  
1st Value:  
2nd Value:  
Value Percent:  
Continuous Index:  
Within 8" of Joint: **NO**  
Remarks: **M-806-052**

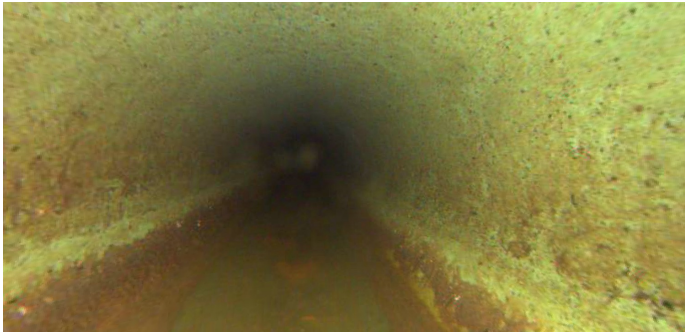
Code:	<b>MWL</b>
Description:	<b>Water Level</b>

Distance (ft):	<b>.0</b>
Structural Grade:	<b>0</b>
O&M Grade:	<b>0</b>
Clock Start/From:	
Clock To:	
1st Value:	
2nd Value:	
Value Percent:	<b>5.000</b>
Continuous Index:	
Within 8" of Joint:	<b>NO</b>
Remarks:

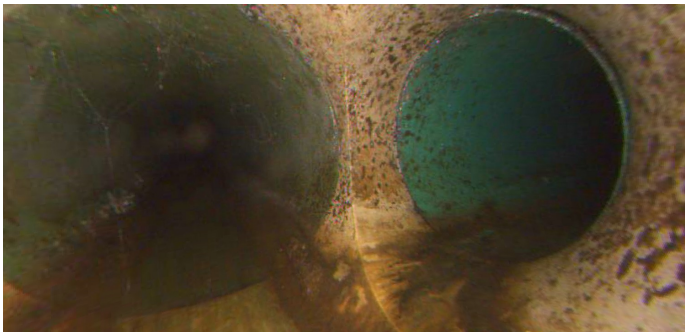
Code:	<b>TFA</b>
Description:	<b>Tap Factory Active</b>

Distance (ft):	<b>51.1</b>
Structural Grade:	<b>0</b>
O&M Grade:	<b>0</b>
Clock Start/From:	<b>3</b>
Clock To:	
1st Value:	<b>4.000</b>
2nd Value:	
Value Percent:	
Continuous Index:	
Within 8" of Joint:	
Remarks:

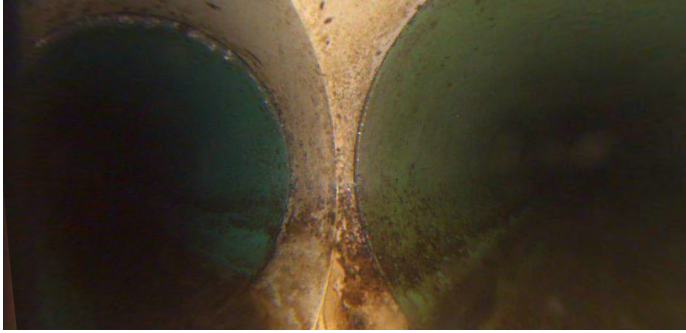
Code: **TFA**  
Description: **Tap Factory Active**

Distance (ft): **94.8**  
Structural Grade: **0**  
O&M Grade: **0**  
Clock Start/From: **9**  
Clock To:  
1st Value: **4.000**  
2nd Value:  
Value Percent:  
Continuous Index:  
Within 8" of Joint:  
Remarks:

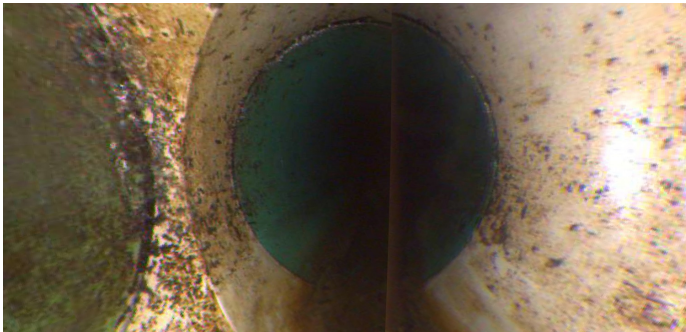
Code: **TF**  
Description: **Tap Factory**

Distance (ft): **100.6**  
Structural Grade: **0**  
O&M Grade: **0**  
Clock Start/From: **3**  
Clock To:  
1st Value: **4.000**  
2nd Value:  
Value Percent:  
Continuous Index:  
Within 8" of Joint:  
Remarks:

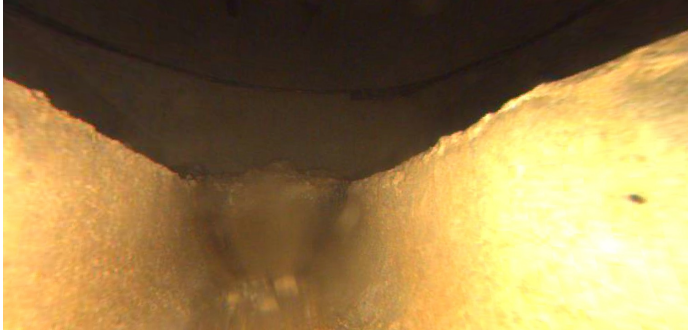
Code:	<b>AMH</b>
Description:	<b>Manhole</b>
Distance (ft):	<b>107.2</b>
Structural Grade:	<b>0</b>
O&M Grade:	<b>0</b>
Clock Start/From:	
Clock To:	
1st Value:	
2nd Value:	
Value Percent:	
Continuous Index:	
Within 8" of Joint:	<b>NO</b>
Remarks:	<b>M-806-051</b>
