Profile/Photo Observation Report

Street:	DEER CROSS TRL & FAWN CT	Flow Control:	Not Controlled
City:	Hobart, IN	Year Renewed:	
Location:	Yard	Tape/Media #:	
Purpose:	Maintenance Related	Dia/Height:	8"
Use:	Sanitary	Material:	PVC
Drain Area:	NA	Lining:	Cured in Place
Category:	NA		
Comment:	flow incorrect.

Location Details:		Direction of Survey:	Upstream
US MH:	M-806-053	DS MH:	M-806-052
		Total Length Surveyed (ft):	123.2

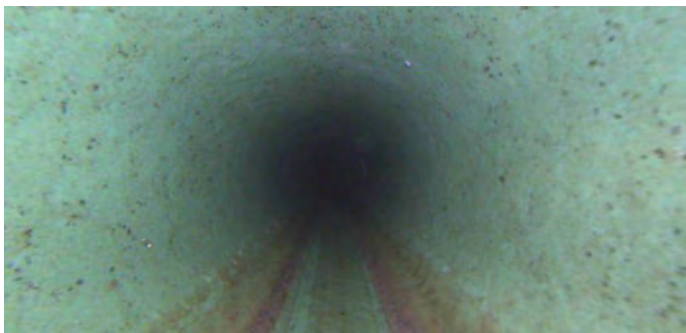
Code: **AMH**
Description: **Manhole**

Distance (ft): **.0**
Structural Grade: **0**
O&M Grade: **0**
Clock Start/From:
Clock To:
1st Value:
2nd Value:
Value Percent:
Continuous Index:
Within 8" of Joint: **NO**
Remarks: **M-806-052**

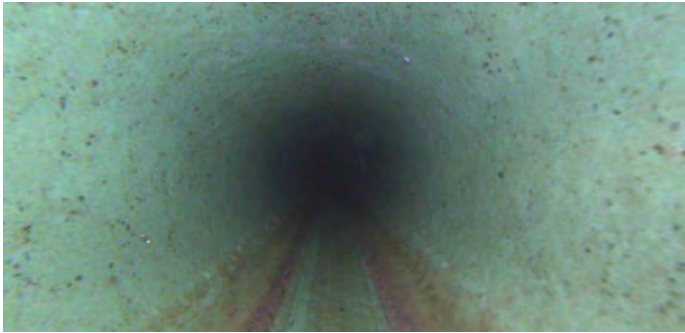
Code:	MWL
Description:	Water Level

Distance (ft):	.0
Structural Grade:	0
O&M Grade:	0
Clock Start/From:	
Clock To:	
1st Value:	
2nd Value:	
Value Percent:	5.000
Continuous Index:	
Within 8" of Joint:	NO
Remarks:

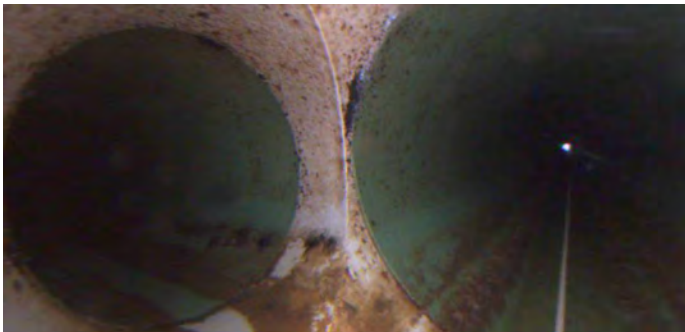
Code:	TFA
Description:	Tap Factory Active

Distance (ft):	26.5
Structural Grade:	0
O&M Grade:	0
Clock Start/From:	3
Clock To:	
1st Value:	4.000
2nd Value:	
Value Percent:	
Continuous Index:	
Within 8" of Joint:	
Remarks:

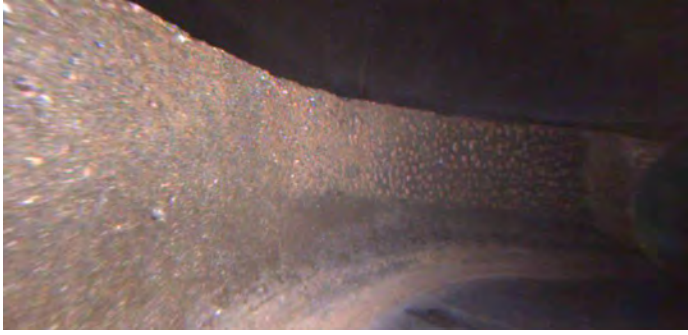
Code:	AMH
Description:	Manhole
Distance (ft):	123.2
Structural Grade:	0
O&M Grade:	0
Clock Start/From:	
Clock To:	
1st Value:	
2nd Value:	
Value Percent:	
Continuous Index:	
Within 8" of Joint:	NO
Remarks:	M-806-053
