Profile/Photo Observation Report

Street:	Capitol	Flow Control:	Not Controlled
City:	Hobart, IN	Year Renewed:	
Location:	Yard	Tape/Media #:	
Purpose:	Maintenance Related	Dia/Height:	8"
Use:	Sanitary	Material:	PVC
Drain Area:	NA	Lining:	Cured in Place
Category:	NA		
Comment:	flow incorrect.

Location Details:		Direction of Survey:	Upstream
US MH:	M-806-053	DS MH:	M-806-052
		Total Length Surveyed (ft):	123.2

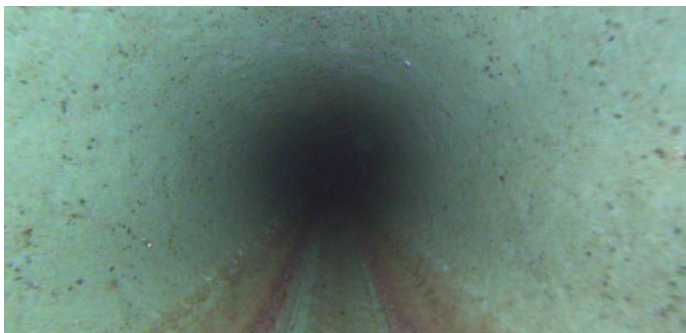
Code: **AMH**
Description: **Manhole**

Distance (ft): **.0**
Structural Grade: **0**
O&M Grade: **0**
Clock Start/From:
Clock To:
1st Value:
2nd Value:
Value Percent:
Continuous Index:
Within 8" of Joint: **NO**
Remarks: **M-806-052**

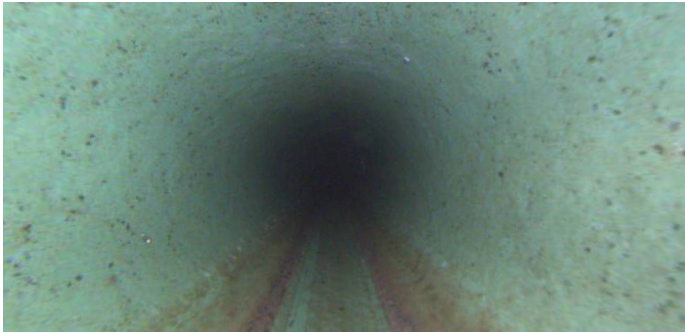
Code:	MWL
Description:	Water Level

Distance (ft):	.0
Structural Grade:	0
O&M Grade:	0
Clock Start/From:	
Clock To:	
1st Value:	
2nd Value:	
Value Percent:	5.000
Continuous Index:	
Within 8" of Joint:	NO
Remarks:

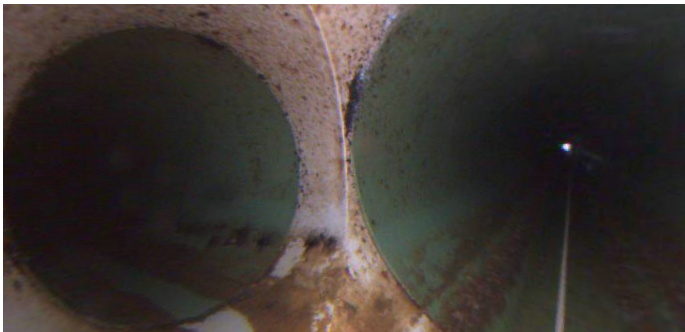
Code:	TFA
Description:	Tap Factory Active

Distance (ft):	26.5
Structural Grade:	0
O&M Grade:	0
Clock Start/From:	3
Clock To:	
1st Value:	4.000
2nd Value:	
Value Percent:	
Continuous Index:	
Within 8" of Joint:	
Remarks:

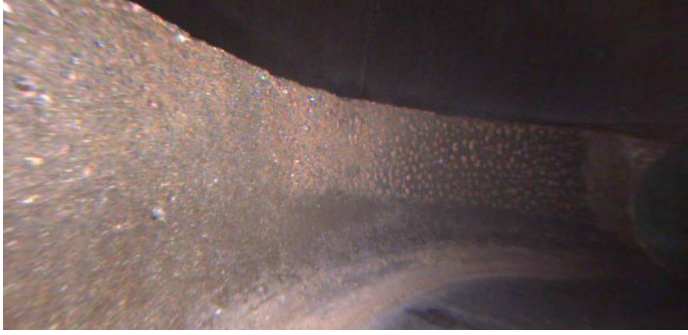
Code:	AMH
Description:	Manhole
Distance (ft):	123.2
Structural Grade:	0
O&M Grade:	0
Clock Start/From:	
Clock To:	
1st Value:	
2nd Value:	
Value Percent:	
Continuous Index:	
Within 8" of Joint:	NO
Remarks:	M-806-053
