Profile/Photo Observation Report

Date:	04/12/2018	Weather:		Coding:	PACP 6.0
Pipe Length (ft):	158.5	Owner:	NA	Pre Clean:	Not Known
P.O.#:		Surveyor:	Jen Costello	PSR:	P-806-054-055
Customer:		Clean Date:	01/01/1900	Shape:	C

Street:	DEER CROSS TRL	Flow Control:	Not Controlled
City:	Hobart, IN	Year Renewed:	
Location:	Sidewalk	Tape/Media #:	
Purpose:	Maintenance Related	Dia/Height:	8"
Use:	Sanitary	Material:	PVC
Drain Area:	NA	Lining:	Cured in Place
Category:	NA		
Comment:	utility line punctured pvc segment at 70'.flow is incorrect.		
Location Details:		Direction of Survey:	Upstream
US MH:	M-806-055	DS MH:	M-806-054
		Total Length Surveyed (ft):	71.3

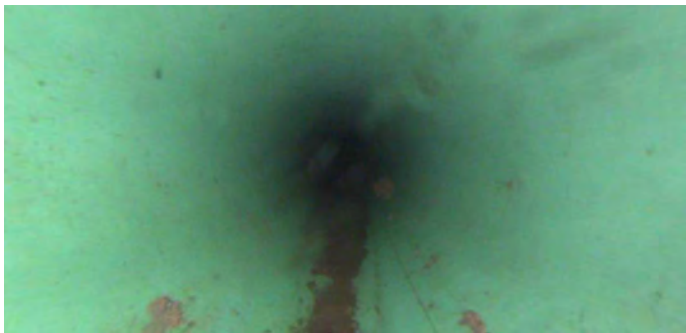
Code: **AMH**
Description: **Manhole**

Distance (ft): **.0**
Structural Grade: **0**
O&M Grade: **0**
Clock Start/From:
Clock To:
1st Value:
2nd Value:
Value Percent:
Continuous Index:
Within 8" of Joint: **NO**
Remarks: **M-806-054**

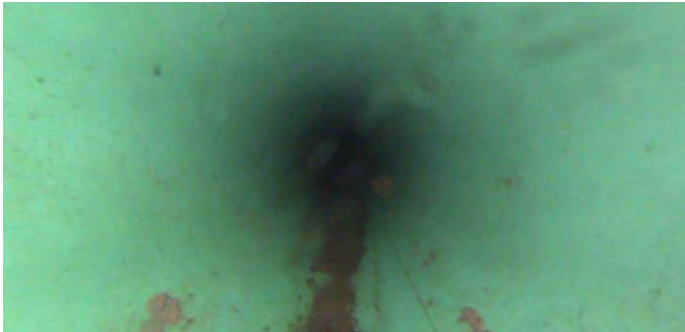
Code:	MWL
Description:	Water Level

Distance (ft):	.0
Structural Grade:	0
O&M Grade:	0
Clock Start/From:	
Clock To:	
1st Value:	
2nd Value:	
Value Percent:	5.000
Continuous Index:	
Within 8" of Joint:	NO
Remarks:

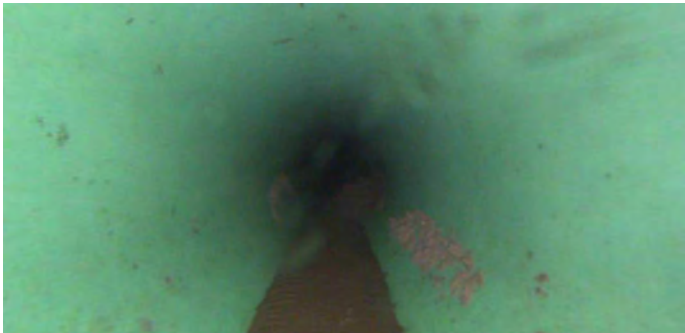
Code:	DSF
Description:	Deposits Settled Fine

Distance (ft):	2.2
Structural Grade:	0
O&M Grade:	2
Clock Start/From:	6
Clock To:	
1st Value:	
2nd Value:	
Value Percent:	5.000
Continuous Index:	S01
Within 8" of Joint:	NO
Remarks:

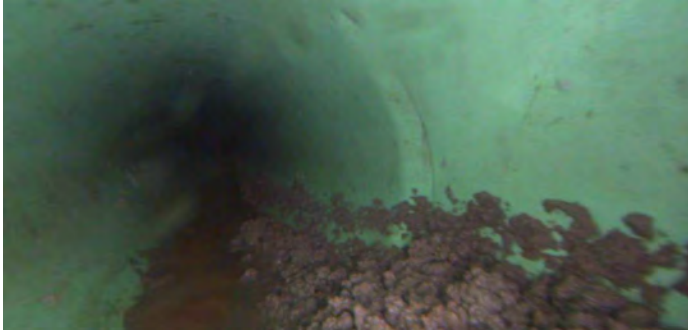
Code:	DAZ
Description:	Deposits Attached Other
Distance (ft):	4.1
Structural Grade:	0
O&M Grade:	2
Clock Start/From:	4
Clock To:	5
1st Value:	
2nd Value:	
Value Percent:	5.000
Continuous Index:	
Within 8" of Joint:	NO
Remarks:

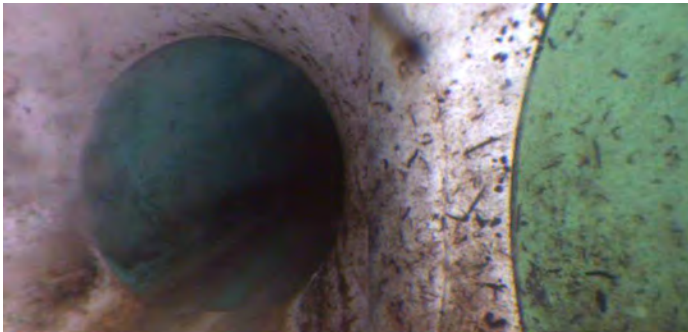
Code:	TFA
Description:	Tap Factory Active
Distance (ft):	11.2
Structural Grade:	0
O&M Grade:	0
Clock Start/From:	9
Clock To:	
1st Value:	4.000
2nd Value:	
Value Percent:	
Continuous Index:	
Within 8" of Joint:	
Remarks:

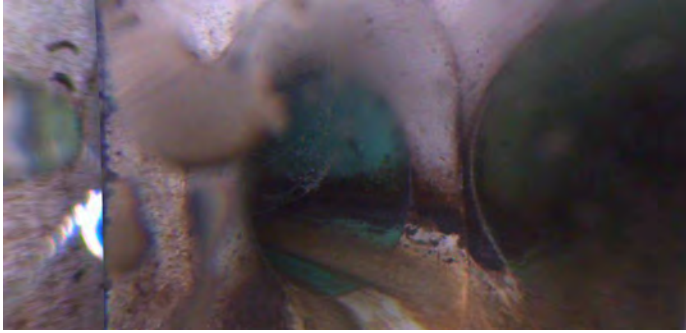
Code: **TFA**
Description: **Tap Factory Active**

Distance (ft): **17.9**
Structural Grade: **0**
O&M Grade: **0**
Clock Start/From: **3**
Clock To:
1st Value: **4.000**
2nd Value:
Value Percent:
Continuous Index:
Within 8" of Joint:
Remarks:

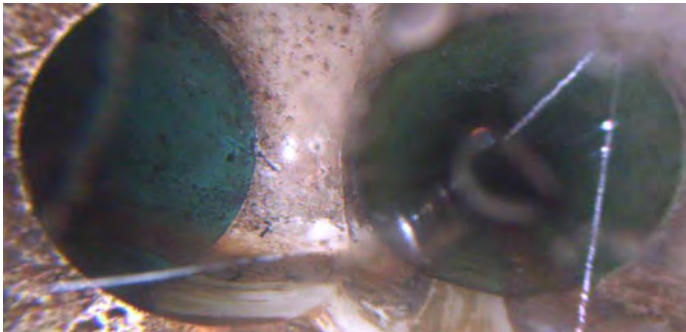
Code: **TFA**
Description: **Tap Factory Active**

Distance (ft): **30.3**
Structural Grade: **0**
O&M Grade: **0**
Clock Start/From: **9**
Clock To:
1st Value: **4.000**
2nd Value:
Value Percent:
Continuous Index:
Within 8" of Joint:
Remarks:

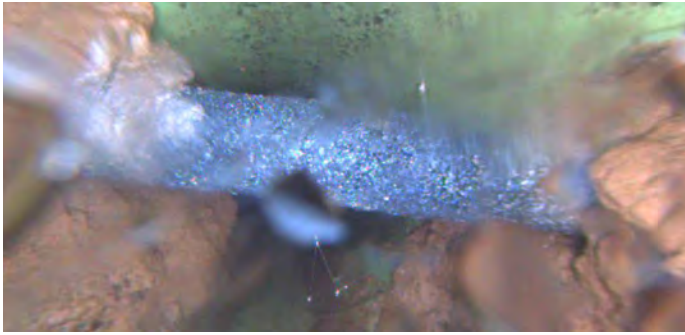
Code: **OBP**
Description: **Obstacle External Pipe or Cable**

Distance (ft): **70.9**
Structural Grade: **0**
O&M Grade: **3**
Clock Start/From: **3**
Clock To: **9**
1st Value:
2nd Value:
Value Percent: **20.000**
Continuous Index:
Within 8" of Joint: **NO**
Remarks:

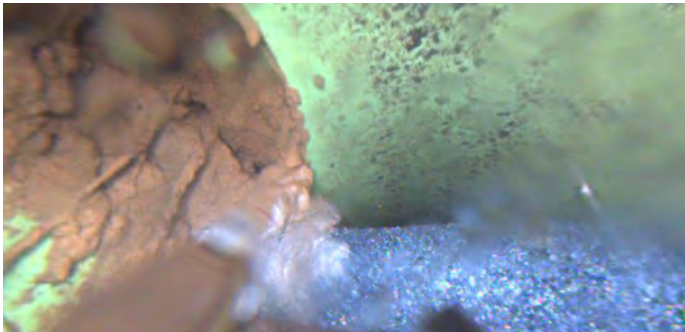
Code: **HVV**
Description: **Hole Void Visible**

Distance (ft): **70.9**
Structural Grade: **5**
O&M Grade: **0**
Clock Start/From: **9**
Clock To: **11**
1st Value:
2nd Value:
Value Percent:
Continuous Index:
Within 8" of Joint:
Remarks:

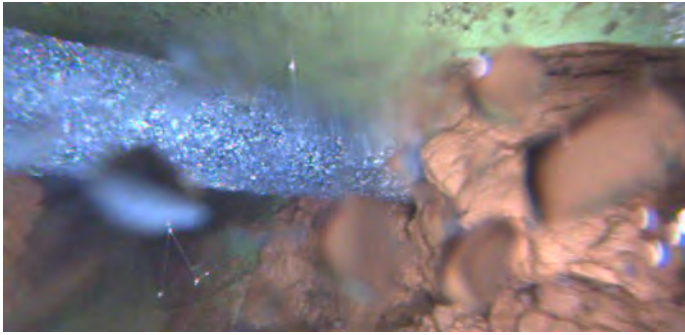
Code: **HSV**
Description: **Hole Soil Visible**

Distance (ft): **70.9**
Structural Grade: **5**
O&M Grade: **0**
Clock Start/From: **1**
Clock To: **4**
1st Value:
2nd Value:
Value Percent:
Continuous Index:
Within 8" of Joint:
Remarks:
