## Profile/Photo Observation Report

| Street: | <b>Capitol</b> | Flow Control: | <b>Not Controlled</b> |
| City: | <b>Hobart, IN</b> | Year Renewed: | |
| US MH: | <b>M-806-055</b> | DS MH: | <b>M-806-054</b> |

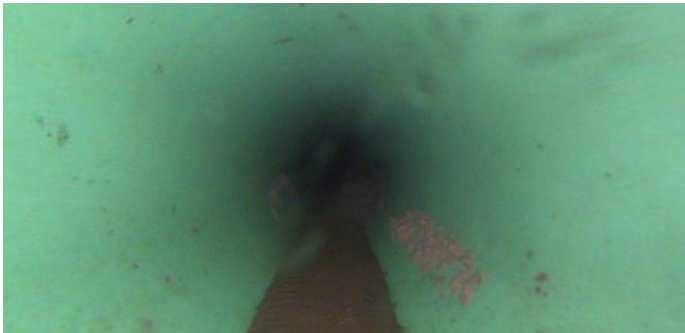
| Code: | <b>DSF</b> |
| Description: | <b>Deposits Settled Fine</b> |

| Distance (ft): | <b>2.2</b> |
| O&M Grade: | <b>2</b> |

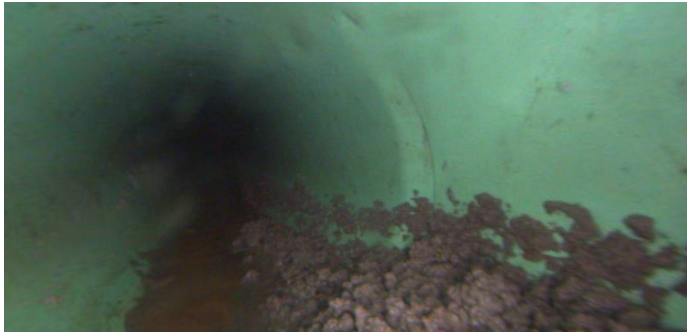
| Code: | <b>DAZ</b> |
| Description: | <b>Deposits Attached Other</b> |
| Distance (ft): | <b>4.1</b> |
| O&M Grade: | <b>2</b> |

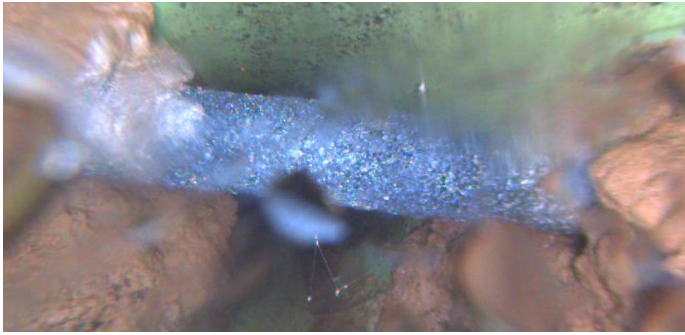
| Comment: | <b>utility line punctured pvc segment at 70'.flow is incorrect.</b> | | |

Code: **OBP**  
Description: **Obstacle External Pipe or Cable**

Distance (ft): **70.9**  
Structural Grade: **0**  
O&M Grade: **3**  
Clock Start/From: **3**  
Clock To: **9**  
1st Value:  
2nd Value:  
Value Percent: **20.000**  
Continuous Index:  
Within 8" of Joint: **NO**  
Remarks:

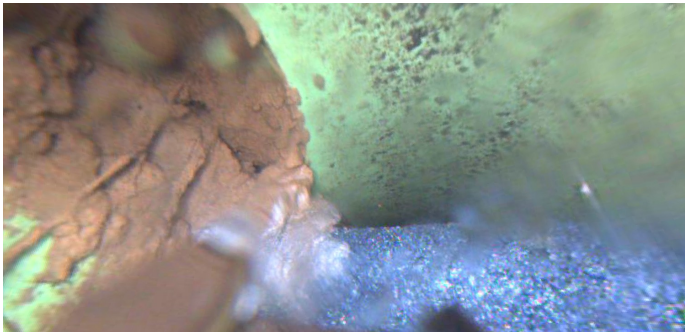
Code: **HVV**  
Description: **Hole Void Visible**

Distance (ft): **70.9**  
Structural Grade: **5**  
O&M Grade: **0**  
Clock Start/From: **9**  
Clock To: **11**  
1st Value:  
2nd Value:  
Value Percent:  
Continuous Index:  
Within 8" of Joint:  
Remarks:

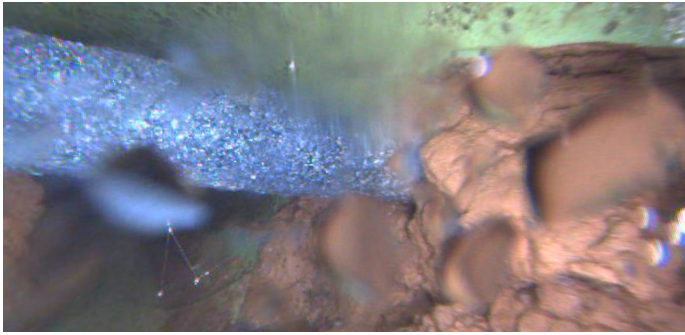
Code: **HSV**  
Description: **Hole Soil Visible**

Distance (ft): **70.9**  
Structural Grade: **5**  
O&M Grade: **0**  
Clock Start/From: **1**  
Clock To: **4**  
1st Value:  
2nd Value:  
Value Percent:  
Continuous Index:  
Within 8" of Joint:  
Remarks:

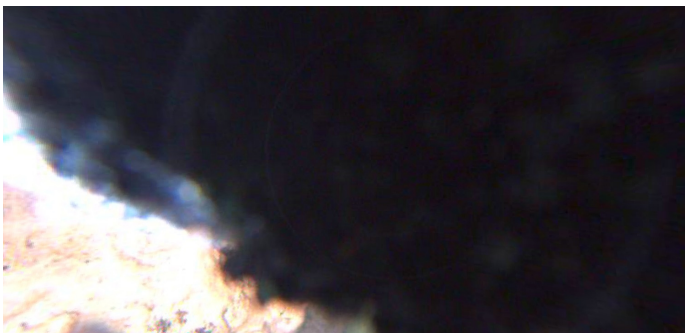
Code: **MSA**  
Description: **Abandoned Survey**

Distance (ft): **71.3**  
Structural Grade: **0**  
O&M Grade: **0**  
Clock Start/From:  
Clock To:  
1st Value:  
2nd Value:  
Value Percent:  
Continuous Index:  
Within 8" of Joint: **NO**  
Remarks: **obp**

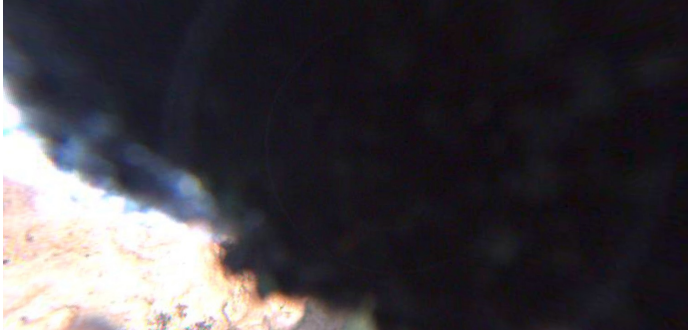
| Code: | <b>DSF</b> |
| Description: | <b>Deposits Settled Fine</b> |
| Distance (ft): | <b>71.3</b> |
| O&M Grade: | <b>2</b> |
