Profile/Photo Observation Report

Street:	DEER CROSS TRAIL	Flow Control:	Not Controlled
City:	Hobart, IN	Year Renewed:	
Location:	Easement/Right of Way	Tape/Media #:	
Purpose:	Sewer System Evaluation Survey (SS	Dia/Height:	8"
Use:	Sanitary Sewage Pipe	Material:	PVC
Drain Area:		Lining:	None
Category:	NA		
Comment:			
Location Details:		Direction of Survey:	Upstream
US MH:	M-806-055	DS MH:	M-806-054
		Total Length Surveyed (ft):	154.9

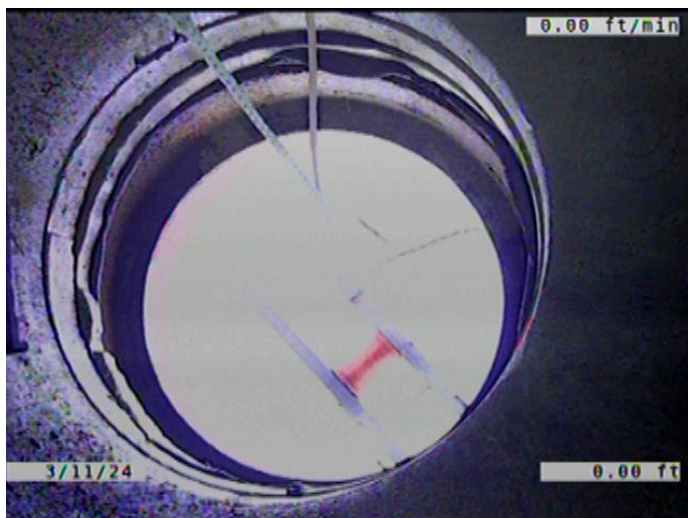
Code: **AMH**
 Description: **Manhole**

Distance (ft): **.0**
 Structural Grade: **0**
 O&M Grade: **0**
 Clock Start/From:
 Clock To:
 1st Value:
 2nd Value:
 Value Percent:
 Continuous Index:
 Within 8" of Joint: **NO**
 Remarks: **M-806-054**

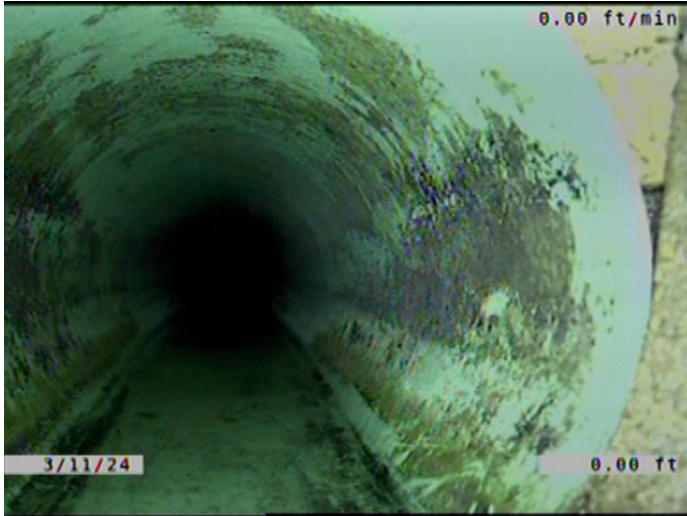
Code:	MWL
Description:	Miscellaneous Water Level
Distance (ft):	.0
Structural Grade:	0
O&M Grade:	0
Clock Start/From:	
Clock To:	
1st Value:	
2nd Value:	
Value Percent:	5.000
Continuous Index:	
Within 8" of Joint:	NO
Remarks:

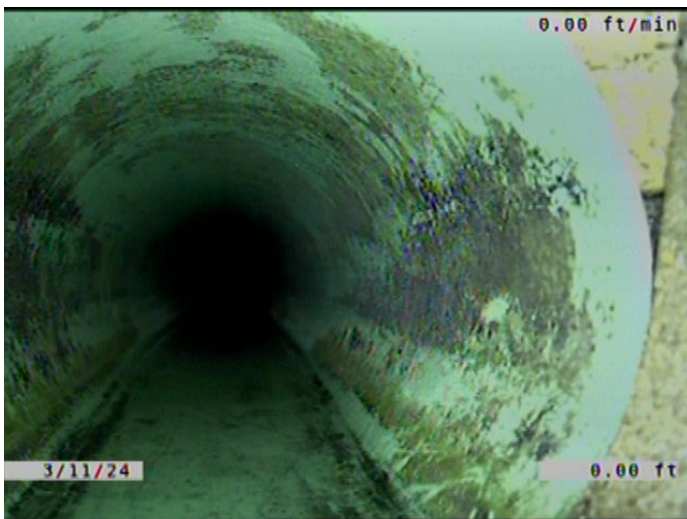
Code:	MWLS
Description:	Miscellaneous Water Level Sag
Distance (ft):	.0
Structural Grade:	2
O&M Grade:	0
Clock Start/From:	
Clock To:	
1st Value:	
2nd Value:	
Value Percent:	15.000
Continuous Index:	S01
Within 8" of Joint:	NO
Remarks:

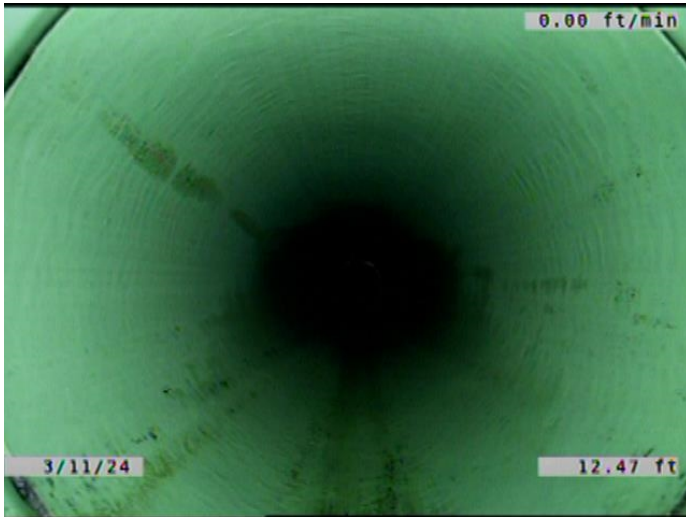
Code: **MWLS**
Description: **Miscellaneous Water Level Sag**

Distance (ft): **12.5**
Structural Grade: **2**
O&M Grade: **0**
Clock Start/From:
Clock To:
1st Value:
2nd Value:
Value Percent: **15.000**
Continuous Index: **F01**
Within 8" of Joint: **NO**
Remarks:

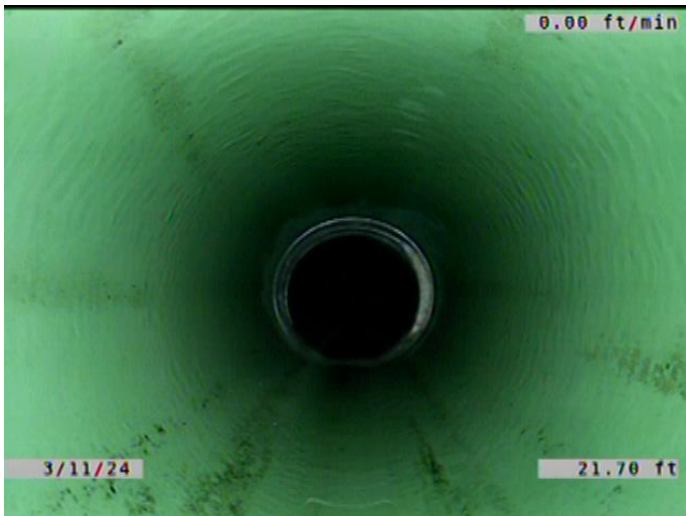
Code: **MWLS**
Description: **Miscellaneous Water Level Sag**

Distance (ft): **21.7**
Structural Grade: **2**
O&M Grade: **0**
Clock Start/From:
Clock To:
1st Value:
2nd Value:
Value Percent: **5.000**
Continuous Index: **S02**
Within 8" of Joint: **NO**
Remarks:

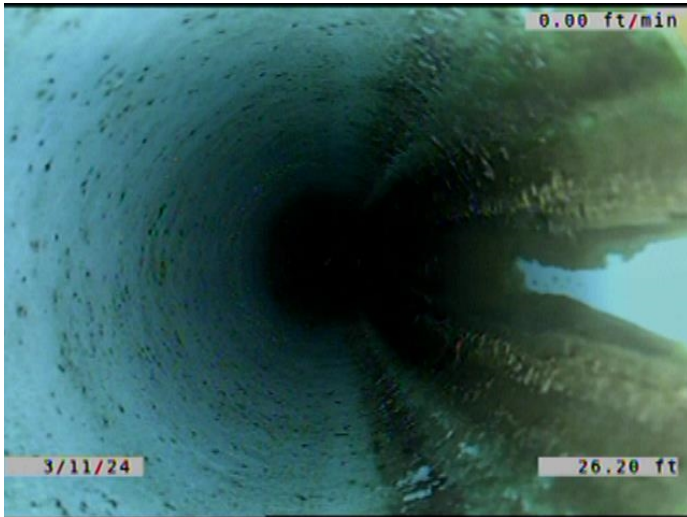
Code: **TF**
Description: **Tap Factory**

Distance (ft): **26.2**
Structural Grade: **0**
O&M Grade: **0**
Clock Start/From: **3**
Clock To:
1st Value: **6.000**
2nd Value:
Value Percent:
Continuous Index:
Within 8" of Joint: **YES**
Remarks:

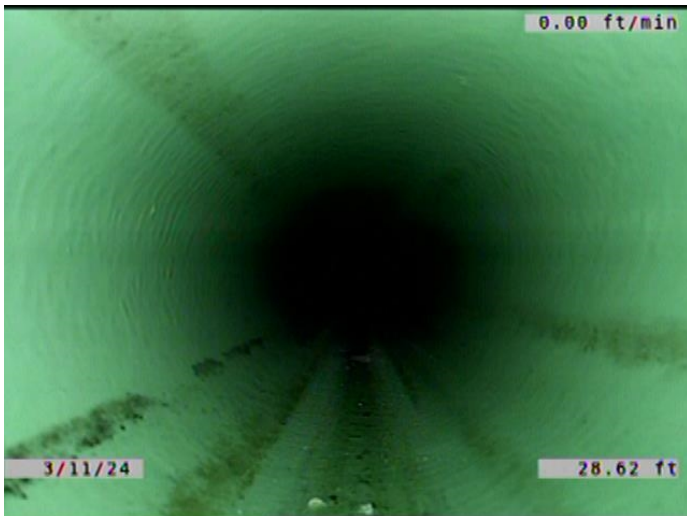
Code: **MWLS**
Description: **Miscellaneous Water Level Sag**

Distance (ft): **28.6**
Structural Grade: **2**
O&M Grade: **0**
Clock Start/From:
Clock To:
1st Value:
2nd Value:
Value Percent: **5.000**
Continuous Index: **F02**
Within 8" of Joint: **NO**
Remarks:

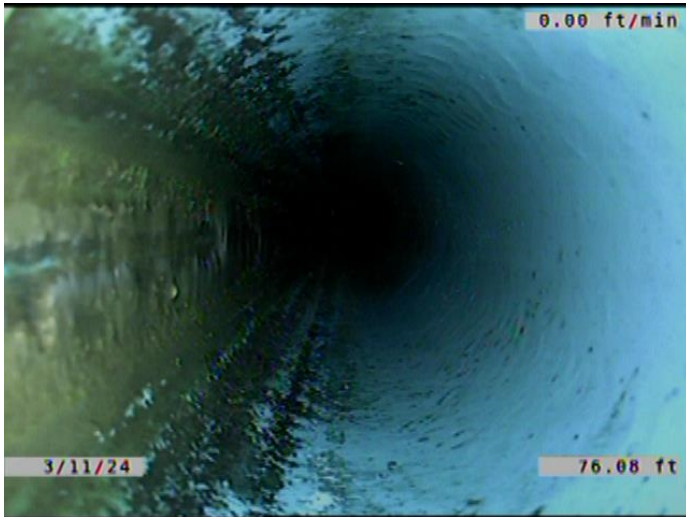
Code: **TF**
Description: **Tap Factory**

Distance (ft): **76.1**
Structural Grade: **0**
O&M Grade: **0**
Clock Start/From: **9**
Clock To:
1st Value: **6.000**
2nd Value:
Value Percent:
Continuous Index:
Within 8" of Joint: **YES**
Remarks:

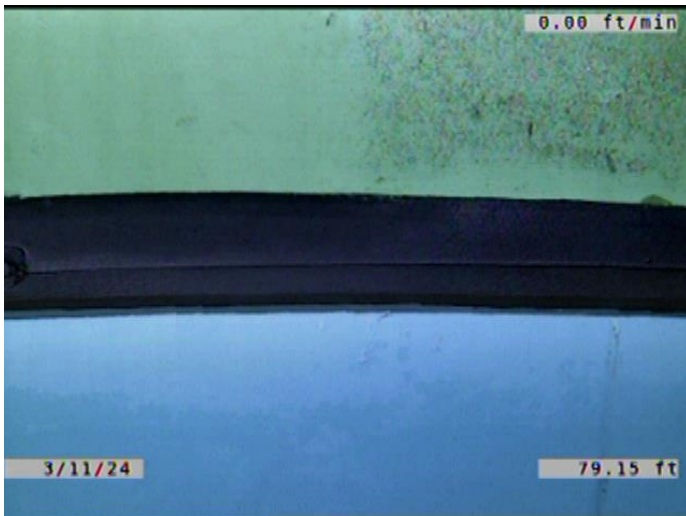
Code: **RPR**
Description: **Point Repair Replacement**

Distance (ft): **79.1**
Structural Grade: **0**
O&M Grade: **0**
Clock Start/From:
Clock To:
1st Value:
2nd Value:
Value Percent:
Continuous Index: **S03**
Within 8" of Joint: **YES**
Remarks: **REPAIR MADE BY H&G ON 2-17-24.
WATER COMPANY BORED THROUGH**

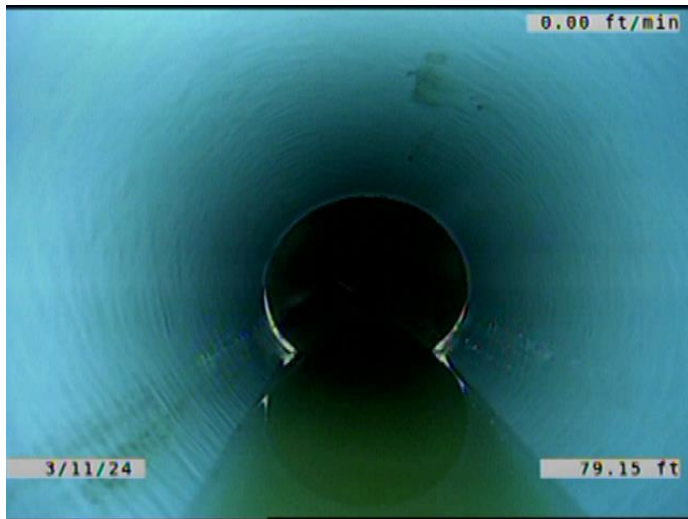
Code: **MWLS**
Description: **Miscellaneous Water Level Sag**

Distance (ft): **79.2**
Structural Grade: **2**
O&M Grade: **0**
Clock Start/From:
Clock To:
1st Value:
2nd Value:
Value Percent: **10.000**
Continuous Index: **S04**
Within 8" of Joint: **NO**
Remarks:

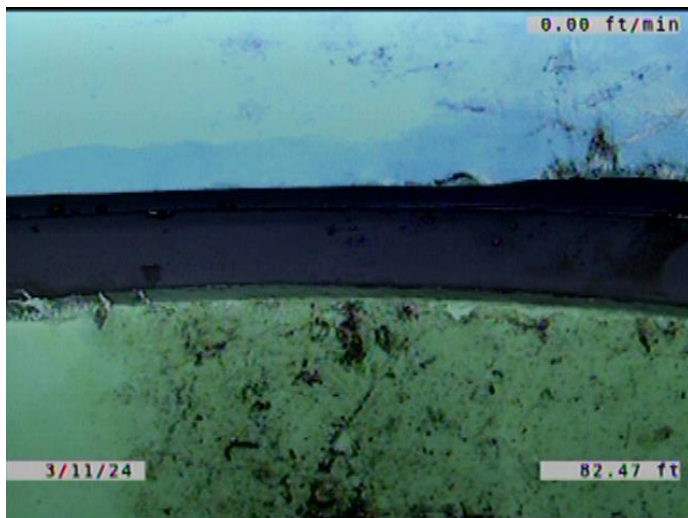
Code: **RPR**
Description: **Point Repair Replacement**

Distance (ft): **82.5**
Structural Grade: **0**
O&M Grade: **0**
Clock Start/From:
Clock To:
1st Value:
2nd Value:
Value Percent:
Continuous Index: **F03**
Within 8" of Joint: **YES**
Remarks: **REPAIR MADE BY H&G ON 2-17-24.
WATER COMPANY BORED THROUGH**

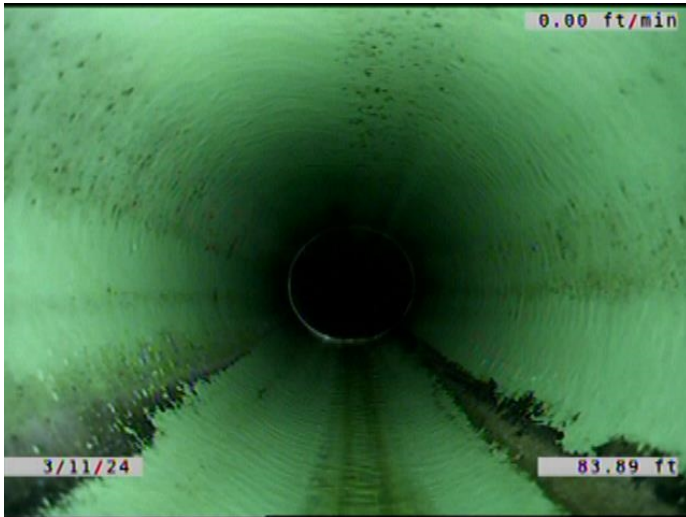
Code:	MWLS
Description:	Miscellaneous Water Level Sag
Distance (ft):	83.9
Structural Grade:	2
O&M Grade:	0
Clock Start/From:	
Clock To:	
1st Value:	
2nd Value:	
Value Percent:	10.000
Continuous Index:	F04
Within 8" of Joint:	NO
Remarks:

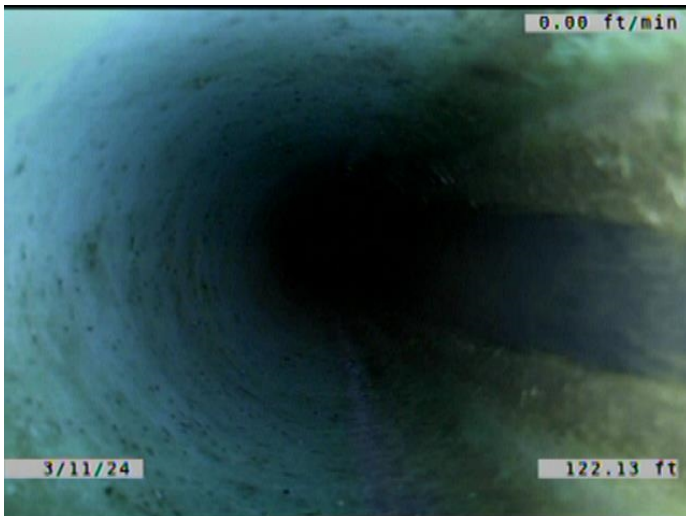
Code:	TF
Description:	Tap Factory
Distance (ft):	122.1
Structural Grade:	0
O&M Grade:	0
Clock Start/From:	3
Clock To:	
1st Value:	6.000
2nd Value:	
Value Percent:	
Continuous Index:	
Within 8" of Joint:	YES
Remarks:

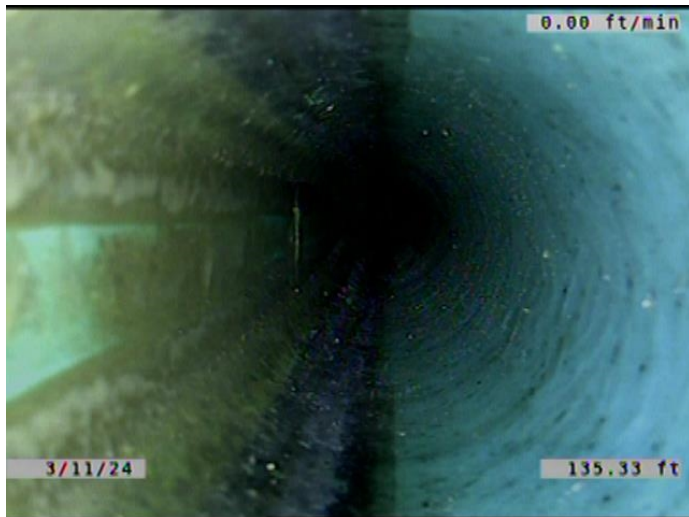
Code: **TF**
Description: **Tap Factory**

Distance (ft): **135.3**
Structural Grade: **0**
O&M Grade: **0**
Clock Start/From: **9**
Clock To:
1st Value: **6.000**
2nd Value:
Value Percent:
Continuous Index:
Within 8" of Joint: **YES**
Remarks:

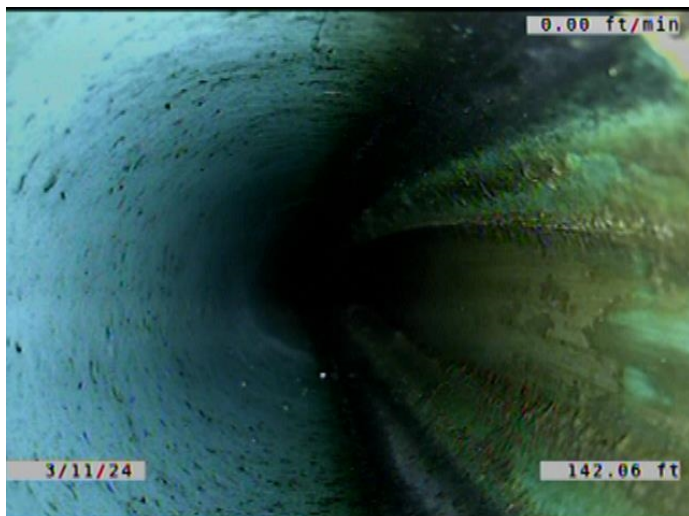
Code: **TF**
Description: **Tap Factory**

Distance (ft): **142.1**
Structural Grade: **0**
O&M Grade: **0**
Clock Start/From: **3**
Clock To:
1st Value: **6.000**
2nd Value:
Value Percent:
Continuous Index:
Within 8" of Joint: **YES**
Remarks:

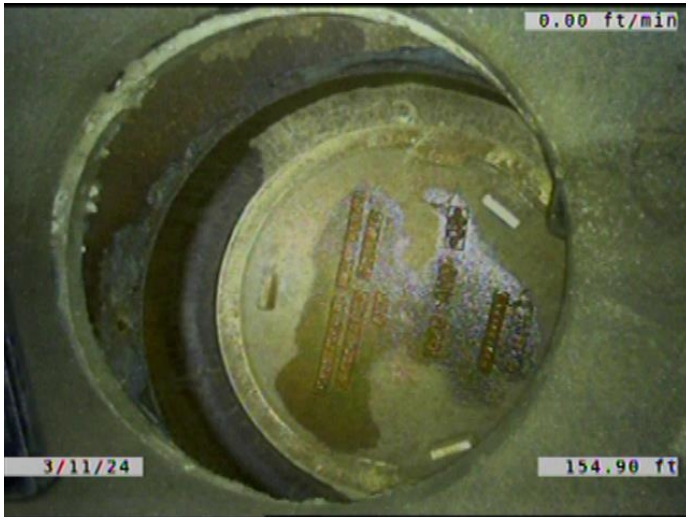
Code:	AMH
Description:	Manhole
Distance (ft):	154.9
Structural Grade:	0
O&M Grade:	0
Clock Start/From:	
Clock To:	
1st Value:	
2nd Value:	
Value Percent:	
Continuous Index:	
Within 8" of Joint:	NO
Remarks:	M-806-055
