Profile/Photo Observation Report

| Street: | Capitol | Flow Control: | Not Controlled |
| City: | Hobart, IN | Year Renewed: | |

| US MH: | M-806-056 | DS MH: | M-806-057 |

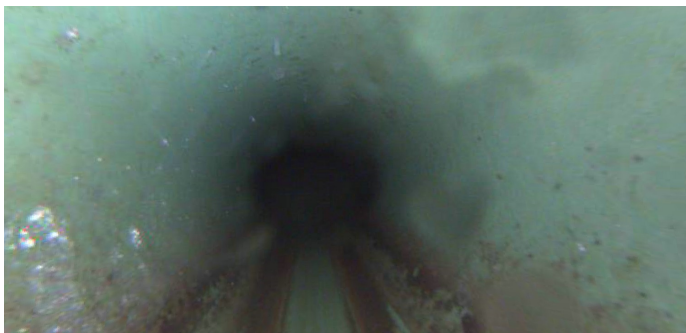
Code: **AMH**
Description: **Manhole**

Distance (ft): **.0**
Structural Grade: **0**
O&M Grade: **0**
Clock Start/From:
Clock To:
1st Value:
2nd Value:
Value Percent:
Continuous Index:
Within 8" of Joint: **NO**
Remarks: **M-806-057**

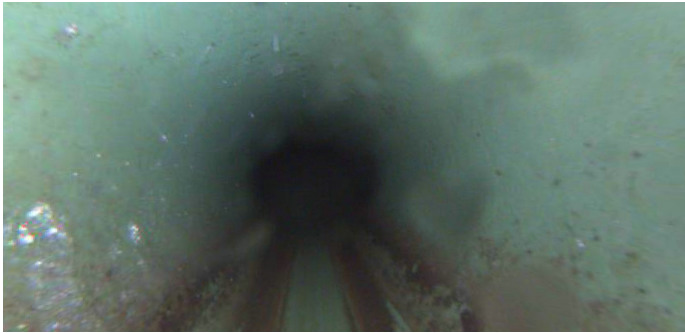
| Code: | MWL |
| Description: | Water Level |

| Value Percent: | 5.000 |

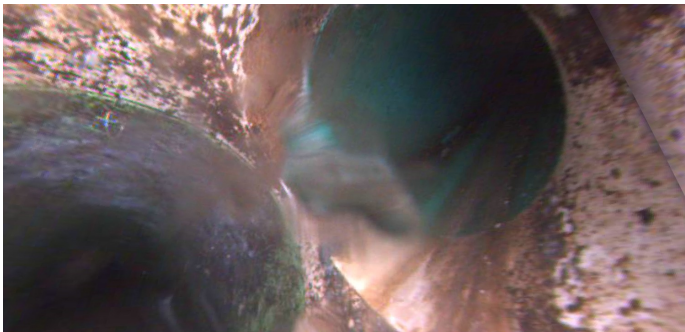
| Code: | TF |
| Description: | Tap Factory |

| Distance (ft): | 47.2 |

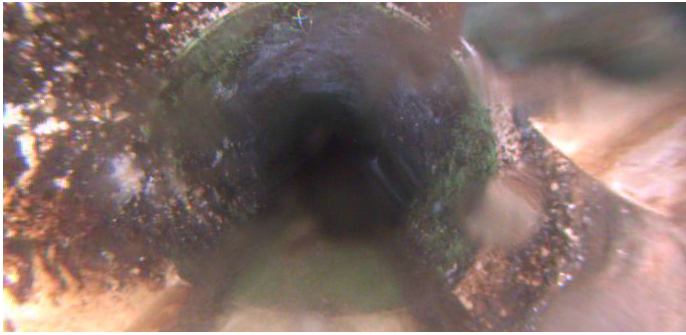
| | Position | Code | Observation | Video (sec) | Grade |
|--|---|---|---|---|---|
| | 47.2 | DAGS | Deposits Attached Grease | 139 | M 2 |

Code: **DAGS**
Description: **Deposits Attached Grease**

Distance (ft): **47.2**
Structural Grade: **0**
O&M Grade: **2**
Clock Start/From: **8**
Clock To: **4**
1st Value:
2nd Value:
Value Percent: **5.000**
Continuous Index:
Within 8" of Joint: **NO**
Remarks:

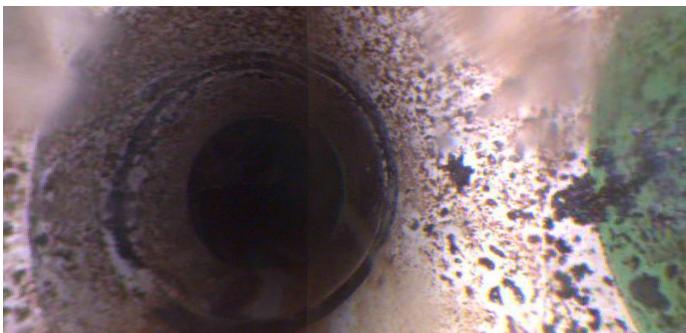
Code: **TF**
Description: **Tap Factory**

Distance (ft): **106.2**
Structural Grade: **0**
O&M Grade: **0**
Clock Start/From: **3**
Clock To:
1st Value: **4.000**
2nd Value:
Value Percent:
Continuous Index:
Within 8" of Joint:
Remarks:

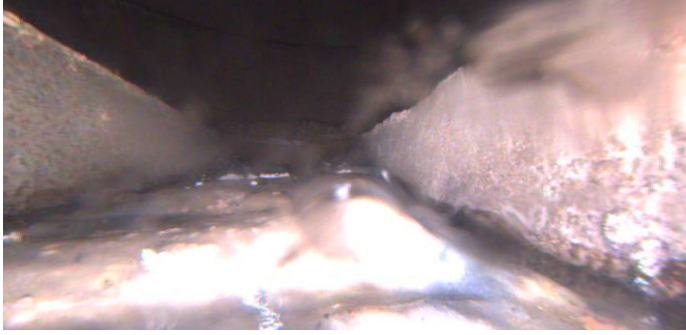
Code: **AMH**
Description: **Manhole**

Distance (ft): **113.3**
Structural Grade: **0**
O&M Grade: **0**
Clock Start/From:
Clock To:
1st Value:
2nd Value:
Value Percent:
Continuous Index:
Within 8" of Joint: **NO**
Remarks: **M-806-056**
