## Profile/Photo Observation Report

Street:	<b>Capitol</b>	Flow Control:	<b>Not Controlled</b>
City:	<b>Hobart, IN</b>	Year Renewed:	
Location:	<b>Sidewalk</b>	Tape/Media #:	
Purpose:	<b>Maintenance Related</b>	Dia/Height:	<b>8"</b>
Use:	<b>Sanitary</b>	Material:	<b>PVC</b>
Drain Area:	<b>NA</b>	Lining:	<b>Cured in Place</b>
Category:	<b>NA</b>		
Comment:

Location Details:		Direction of Survey:	<b>Downstream</b>
US MH:	<b>M-806-057</b>	DS MH:	<b>M-806-055</b>
		Total Length Surveyed (ft):	<b>77.2</b>

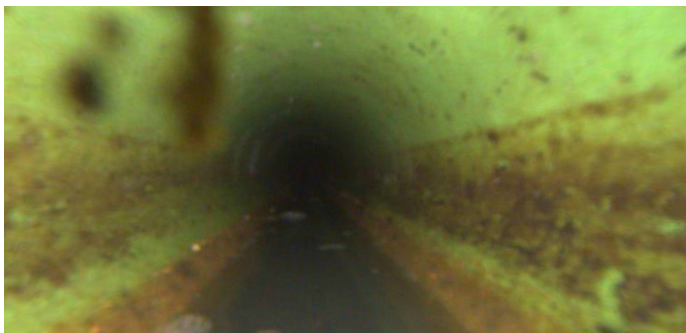
Code: **AMH**  
Description: **Manhole**

Distance (ft): **.0**  
Structural Grade: **0**  
O&M Grade: **0**  
Clock Start/From:  
Clock To:  
1st Value:  
2nd Value:  
Value Percent:  
Continuous Index:  
Within 8" of Joint: **NO**  
Remarks: **M-806-057**

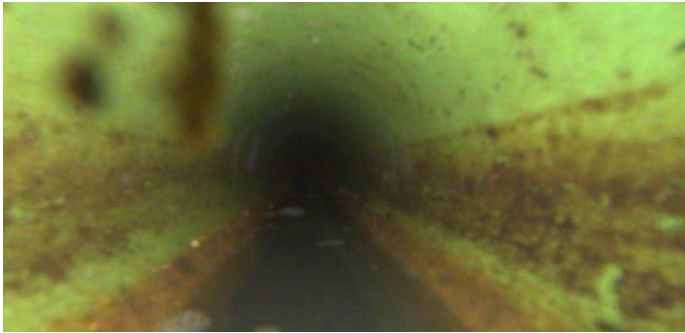
Code:	<b>MWL</b>
Description:	<b>Water Level</b>

Distance (ft):	<b>.0</b>
Structural Grade:	<b>0</b>
O&M Grade:	<b>0</b>
Clock Start/From:	
Clock To:	
1st Value:	
2nd Value:	
Value Percent:	<b>5.000</b>
Continuous Index:	
Within 8" of Joint:	<b>NO</b>
Remarks:

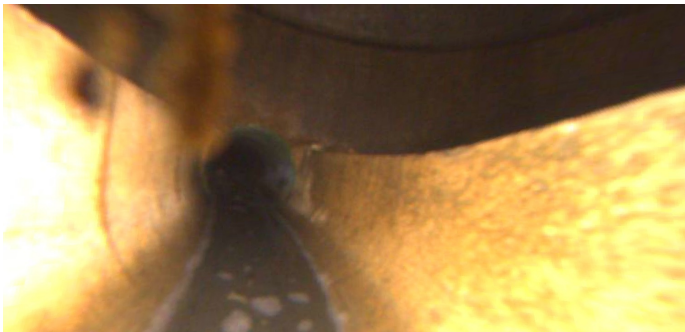
Code:	<b>AMH</b>
Description:	<b>Manhole</b>

Distance (ft):	<b>77.2</b>
Structural Grade:	<b>0</b>
O&M Grade:	<b>0</b>
Clock Start/From:	
Clock To:	
1st Value:	
2nd Value:	
Value Percent:	
Continuous Index:	
Within 8" of Joint:	<b>NO</b>
Remarks:	<b>M-806-055</b>
