## Profile/Photo Observation Report

Street:	<b>OFF E 10TH ST</b>	Flow Control:	<b>Not Controlled</b>
City:	<b>Hobart, IN</b>	Year Renewed:	
Location:	<b>Yard</b>	Tape/Media #:	
Purpose:	<b>Maintenance Related</b>	Dia/Height:	<b>8"</b>
Use:	<b>Sanitary</b>	Material:	<b>PVC</b>
Drain Area:	<b>NA</b>	Lining:	<b>Cured in Place</b>
Category:	<b>NA</b>		
Comment:

Location Details:		Direction of Survey:	<b>Downstream</b>
US MH:	<b>M-806-058</b>	DS MH:	<b>M-806-066</b>
		Total Length Surveyed (ft):	<b>242.5</b>

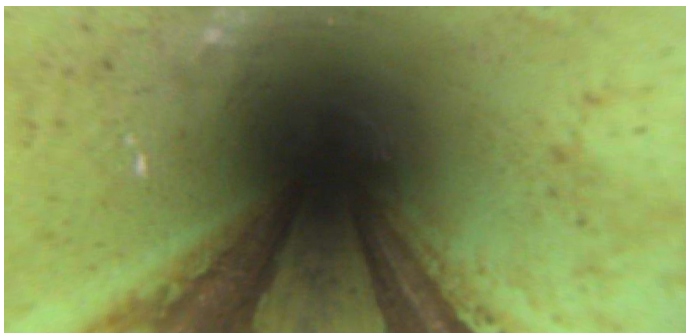
Code: **AMH**  
Description: **Manhole**

Distance (ft): **.0**  
Structural Grade: **0**  
O&M Grade: **0**  
Clock Start/From:  
Clock To:  
1st Value:  
2nd Value:  
Value Percent:  
Continuous Index:  
Within 8" of Joint: **NO**  
Remarks: **M-806-058**

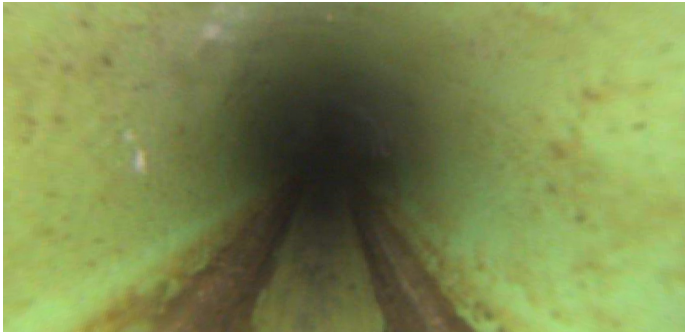
Code:	<b>MWL</b>
Description:	<b>Water Level</b>

Distance (ft):	<b>.0</b>
Structural Grade:	<b>0</b>
O&M Grade:	<b>0</b>
Clock Start/From:	
Clock To:	
1st Value:	
2nd Value:	
Value Percent:	<b>5.000</b>
Continuous Index:	
Within 8" of Joint:	<b>NO</b>
Remarks:

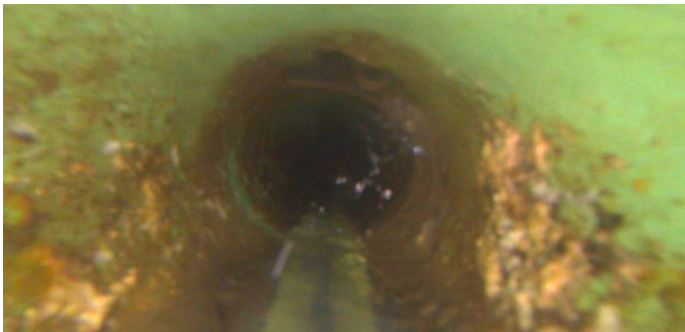
Code:	<b>DAGS</b>
Description:	<b>Deposits Attached Grease</b>

Distance (ft):	<b>70.0</b>
Structural Grade:	<b>0</b>
O&M Grade:	<b>2</b>
Clock Start/From:	<b>8</b>
Clock To:	<b>4</b>
1st Value:	
2nd Value:	
Value Percent:	<b>5.000</b>
Continuous Index:	
Within 8" of Joint:	<b>NO</b>
Remarks:

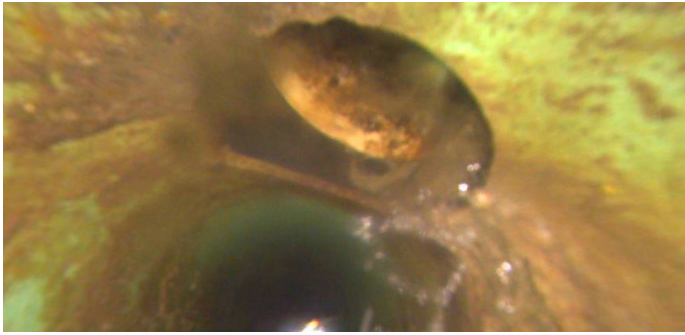
Code: **TBA**  
Description: **Tap Break-in Active**

Distance (ft): **70.7**  
Structural Grade: **0**  
O&M Grade: **0**  
Clock Start/From: **1**  
Clock To:  
1st Value: **4.000**  
2nd Value:  
Value Percent:  
Continuous Index:  
Within 8" of Joint:  
Remarks:

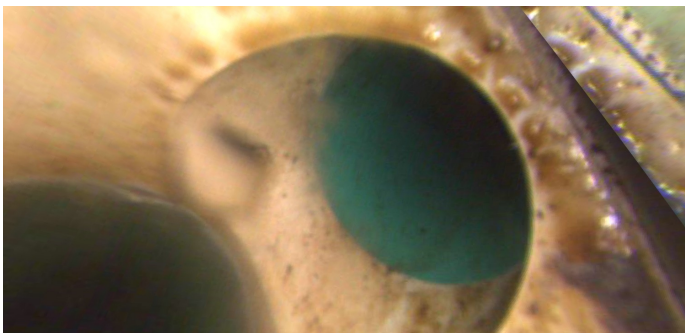
Code: **TF**  
Description: **Tap Factory**

Distance (ft): **111.0**  
Structural Grade: **0**  
O&M Grade: **0**  
Clock Start/From: **2**  
Clock To:  
1st Value: **4.000**  
2nd Value:  
Value Percent:  
Continuous Index:  
Within 8" of Joint:  
Remarks:

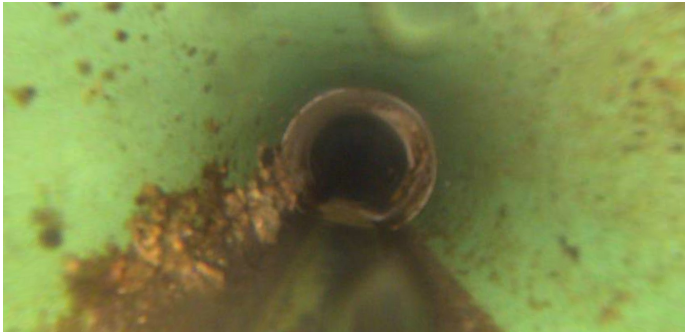
Code: **DAGS**  
Description: **Deposits Attached Grease**

Distance (ft): **206.5**  
Structural Grade: **0**  
O&M Grade: **2**  
Clock Start/From: **7**  
Clock To: **9**  
1st Value:  
2nd Value:  
Value Percent: **10.000**  
Continuous Index:  
Within 8" of Joint: **NO**  
Remarks:

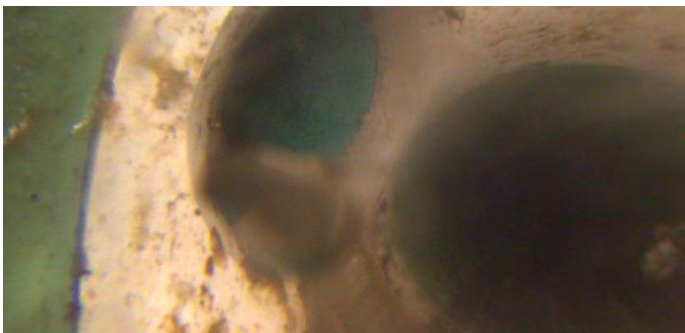
Code: **TF**  
Description: **Tap Factory**

Distance (ft): **208.4**  
Structural Grade: **0**  
O&M Grade: **0**  
Clock Start/From: **2**  
Clock To:  
1st Value: **4.000**  
2nd Value:  
Value Percent:  
Continuous Index:  
Within 8" of Joint:  
Remarks:
