## Profile/Photo Observation Report

Street:	<b>Capitol</b>	Flow Control:	<b>Not Controlled</b>
City:	<b>Hobart, IN</b>	Year Renewed:	
Location:	<b>Yard</b>	Tape/Media #:	
Purpose:	<b>Maintenance Related</b>	Dia/Height:	<b>8"</b>
Use:	<b>Sanitary</b>	Material:	<b>PVC</b>
Drain Area:	<b>NA</b>	Lining:	<b>Cured in Place</b>
Category:	<b>NA</b>		
Comment:

Location Details:		Direction of Survey:	<b>Downstream</b>
US MH:	<b>M-806-058</b>	DS MH:	<b>M-806-066</b>
		Total Length Surveyed (ft):	<b>242.5</b>

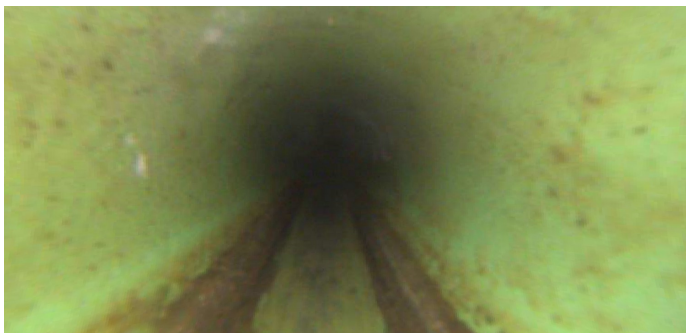
Code: **AMH**  
Description: **Manhole**

Distance (ft): **.0**  
Structural Grade: **0**  
O&M Grade: **0**  
Clock Start/From:  
Clock To:  
1st Value:  
2nd Value:  
Value Percent:  
Continuous Index:  
Within 8" of Joint: **NO**  
Remarks: **M-806-058**

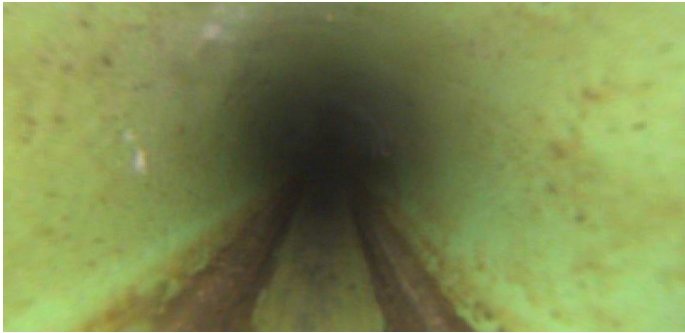
Code:	<b>MWL</b>
Description:	<b>Water Level</b>

Distance (ft):	<b>.0</b>
Structural Grade:	<b>0</b>
O&M Grade:	<b>0</b>
Clock Start/From:	
Clock To:	
1st Value:	
2nd Value:	
Value Percent:	<b>5.000</b>
Continuous Index:	
Within 8" of Joint:	<b>NO</b>
Remarks:

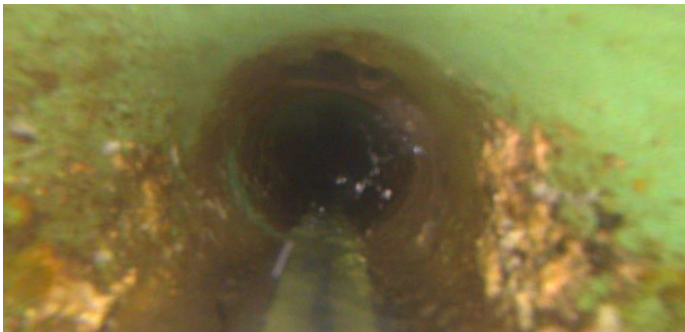
Code:	<b>DAGS</b>
Description:	<b>Deposits Attached Grease</b>

Distance (ft):	<b>70.0</b>
Structural Grade:	<b>0</b>
O&M Grade:	<b>2</b>
Clock Start/From:	<b>8</b>
Clock To:	<b>4</b>
1st Value:	
2nd Value:	
Value Percent:	<b>5.000</b>
Continuous Index:	
Within 8" of Joint:	<b>NO</b>
Remarks:

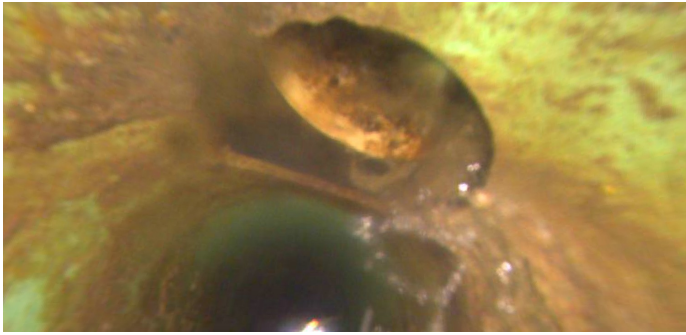
Code: **TBA**  
Description: **Tap Break-in Active**

Distance (ft): **70.7**  
Structural Grade: **0**  
O&M Grade: **0**  
Clock Start/From: **1**  
Clock To:  
1st Value: **4.000**  
2nd Value:  
Value Percent:  
Continuous Index:  
Within 8" of Joint:  
Remarks:

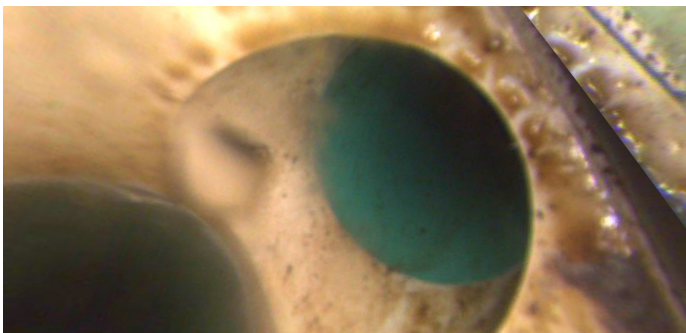
Code: **TF**  
Description: **Tap Factory**

Distance (ft): **111.0**  
Structural Grade: **0**  
O&M Grade: **0**  
Clock Start/From: **2**  
Clock To:  
1st Value: **4.000**  
2nd Value:  
Value Percent:  
Continuous Index:  
Within 8" of Joint:  
Remarks:

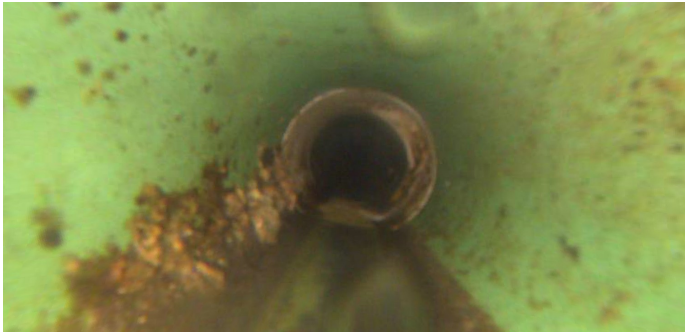
Code: **DAGS**  
Description: **Deposits Attached Grease**

Distance (ft): **206.5**  
Structural Grade: **0**  
O&M Grade: **2**  
Clock Start/From: **7**  
Clock To: **9**  
1st Value:  
2nd Value:  
Value Percent: **10.000**  
Continuous Index:  
Within 8" of Joint: **NO**  
Remarks:

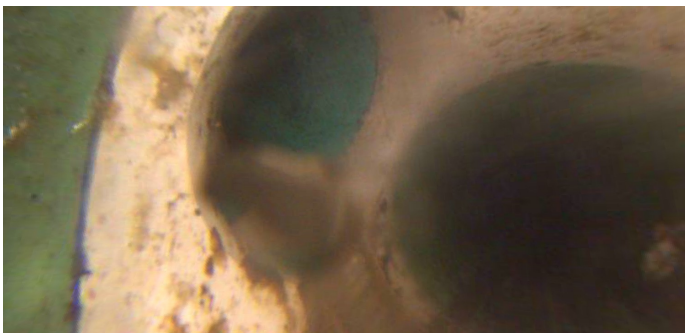
Code: **TF**  
Description: **Tap Factory**

Distance (ft): **208.4**  
Structural Grade: **0**  
O&M Grade: **0**  
Clock Start/From: **2**  
Clock To:  
1st Value: **4.000**  
2nd Value:  
Value Percent:  
Continuous Index:  
Within 8" of Joint:  
Remarks:
