Profile/Photo Observation Report

Date:	04/17/2018	Weather:		Coding:	PACP 6.0
Pipe Length (ft):	128.0	Owner:	NA	Pre Clean:	Not Known
P.O.#:		Surveyor:	Byrd Fitzgerald	PSR:	P-806-059-060
Customer:		Clean Date:	01/01/1900	Shape:	C

Street:	E 10TH ST	Flow Control:	Not Controlled
City:	Hobart, IN	Year Renewed:	
Location:	Sidewalk	Tape/Media #:	
Purpose:	Maintenance Related	Dia/Height:	8"
Use:	Sanitary	Material:	PVC
Drain Area:	NA	Lining:	Cured in Place
Category:	NA		
Comment:	heavy debris at 26'. flow incorrect.		
Location Details:		Direction of Survey:	Upstream
US MH:	M-806-060	DS MH:	M-806-059
		Total Length Surveyed (ft):	27.2

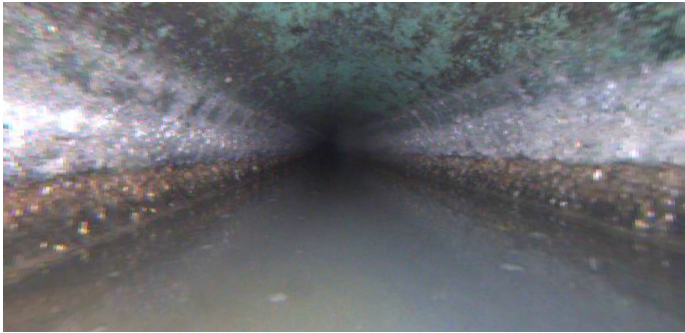
Code:	MWL
Description:	Water Level

Distance (ft):	.0
Structural Grade:	0
O&M Grade:	0
Clock Start/From:	
Clock To:	
1st Value:	
2nd Value:	
Value Percent:	30.000
Continuous Index:	
Within 8" of Joint:	NO
Remarks:

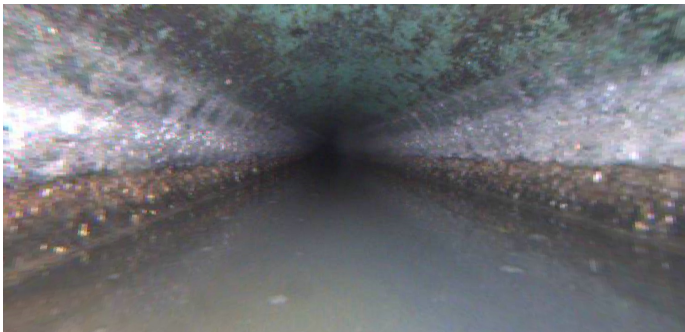
Code:	DAGS
Description:	Deposits Attached Grease

Distance (ft):	.0
Structural Grade:	0
O&M Grade:	2
Clock Start/From:	8
Clock To:	4
1st Value:	
2nd Value:	
Value Percent:	5.000
Continuous Index:	S01
Within 8" of Joint:	NO
Remarks:

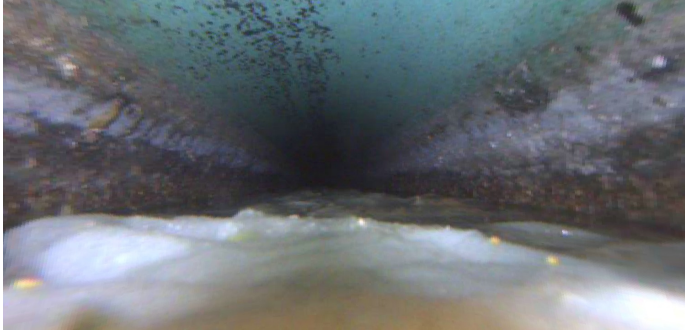
Code: **DSZ**
Description: **Deposits Settled Other**

Distance (ft): **8.0**
Structural Grade: **0**
O&M Grade: **2**
Clock Start/From: **6**
Clock To:
1st Value:
2nd Value:
Value Percent: **5.000**
Continuous Index: **S02**
Within 8" of Joint: **NO**
Remarks: **tissue**

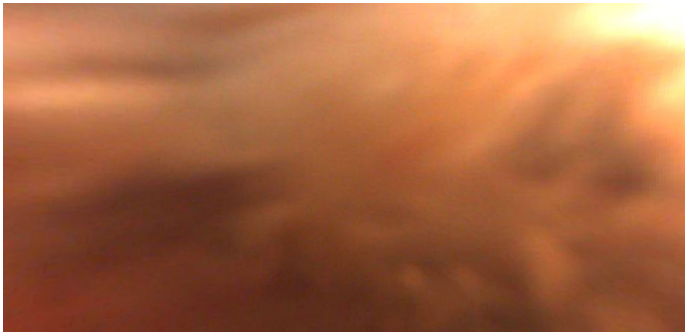
Code: **MCU**
Description: **Camera Underwater**

Distance (ft): **13.7**
Structural Grade: **0**
O&M Grade: **4**
Clock Start/From:
Clock To:
1st Value:
2nd Value:
Value Percent:
Continuous Index: **S03**
Within 8" of Joint: **NO**
Remarks: **front and rear**
