Profile/Photo Observation Report

Date:	04/17/2018	Weather:		Coding:	PACP 6.0
Pipe Length (ft):	128.0	Owner:	NA	Pre Clean:	Not Known
P.O.#:		Surveyor:	Byrd Fitzgerald	PSR:	P-806-059-060
Customer:		Clean Date:	01/01/1900	Shape:	C

Street:	Capitol	Flow Control:	Not Controlled
City:	Hobart, IN	Year Renewed:	
Location:	Sidewalk	Tape/Media #:	
Purpose:	Maintenance Related	Dia/Height:	8"
Use:	Sanitary	Material:	PVC
Drain Area:	NA	Lining:	Cured in Place
Category:	NA		
Comment:	heavy debris at 26'. flow incorrect.		
Location Details:		Direction of Survey:	Upstream
US MH:	M-806-060	DS MH:	M-806-059
		Total Length Surveyed (ft):	27.2

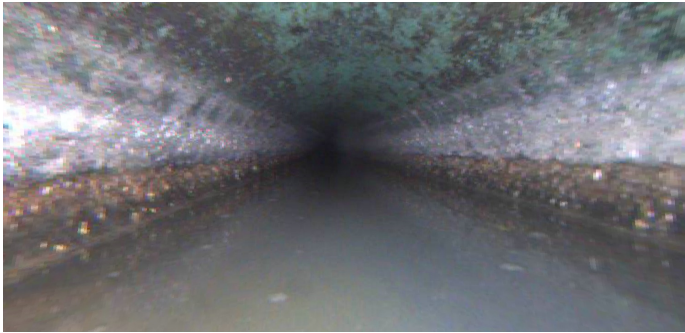
Code:	MWL
Description:	Water Level

Distance (ft):	.0
Structural Grade:	0
O&M Grade:	0
Clock Start/From:	
Clock To:	
1st Value:	
2nd Value:	
Value Percent:	30.000
Continuous Index:	
Within 8" of Joint:	NO
Remarks:

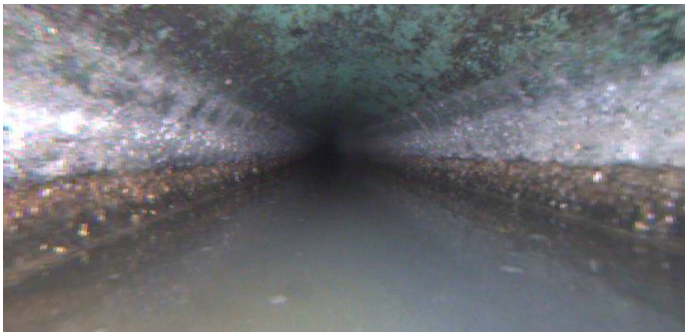
Code:	DAGS
Description:	Deposits Attached Grease

Distance (ft):	.0
Structural Grade:	0
O&M Grade:	2
Clock Start/From:	8
Clock To:	4
1st Value:	
2nd Value:	
Value Percent:	5.000
Continuous Index:	S01
Within 8" of Joint:	NO
Remarks:

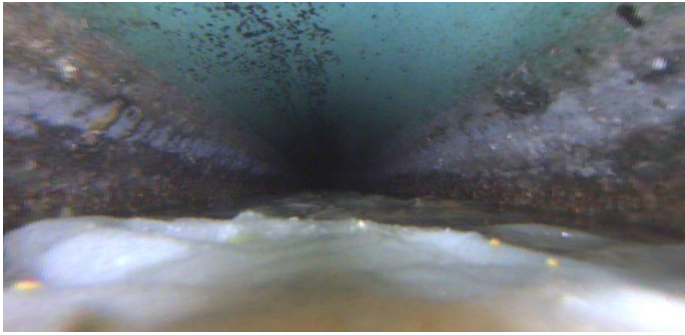
Code: **DSZ**
Description: **Deposits Settled Other**

Distance (ft): **8.0**
Structural Grade: **0**
O&M Grade: **2**
Clock Start/From: **6**
Clock To:
1st Value:
2nd Value:
Value Percent: **5.000**
Continuous Index: **S02**
Within 8" of Joint: **NO**
Remarks: **tissue**

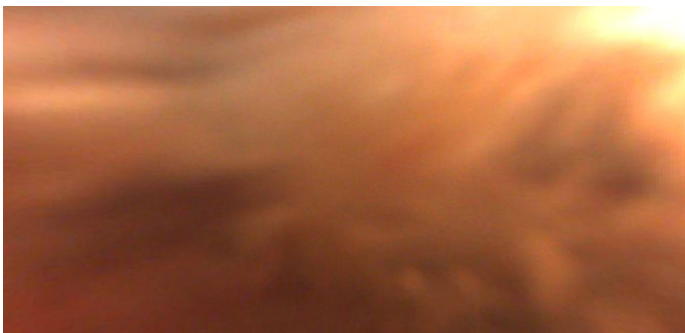
Code: **MCU**
Description: **Camera Underwater**

Distance (ft): **13.7**
Structural Grade: **0**
O&M Grade: **4**
Clock Start/From:
Clock To:
1st Value:
2nd Value:
Value Percent:
Continuous Index: **S03**
Within 8" of Joint: **NO**
Remarks: **front and rear**
