## Profile/Photo Observation Report

| Customer: | <b>City of Hobart</b> | Clean Date: | | Shape: | <b>C</b> |

| Street: | <b>East 10th Street</b> | Flow Control: | <b>Not Controlled</b> |
| US MH: | <b>M-806-061</b> | DS MH: | <b>M-806-047</b> |

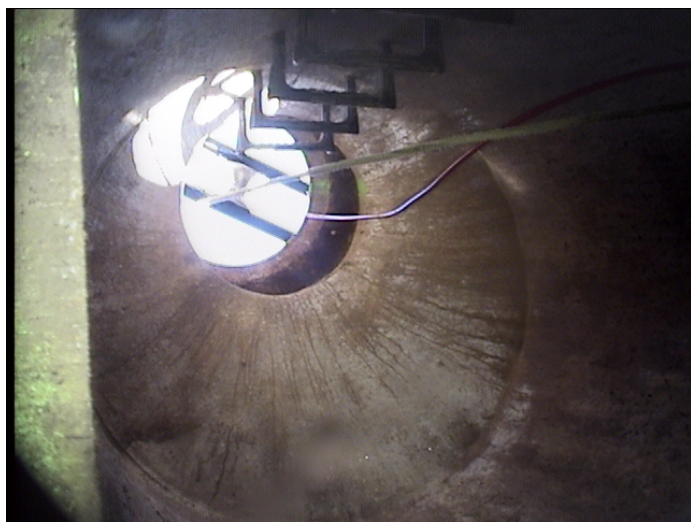
Code: **AMH**  
Description: **Manhole**

Distance (ft): **.0**  
Structural Grade: **0**  
O&M Grade: **0**  
Clock Start/From:  
Clock To:  
1st Value:  
2nd Value:  
Value Percent:  
Continuous Index:  
Within 8" of Joint: **NO**  
Remarks: **M-806-047**

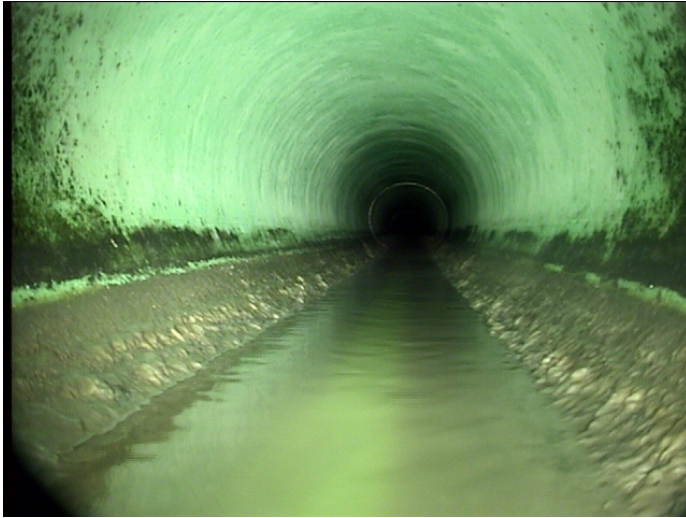
| Code: | <b>MWL</b> |
| Description: | <b>Water Level</b> |
| Distance (ft): | <b>.0</b> |
| Value Percent: | <b>5.000</b> |

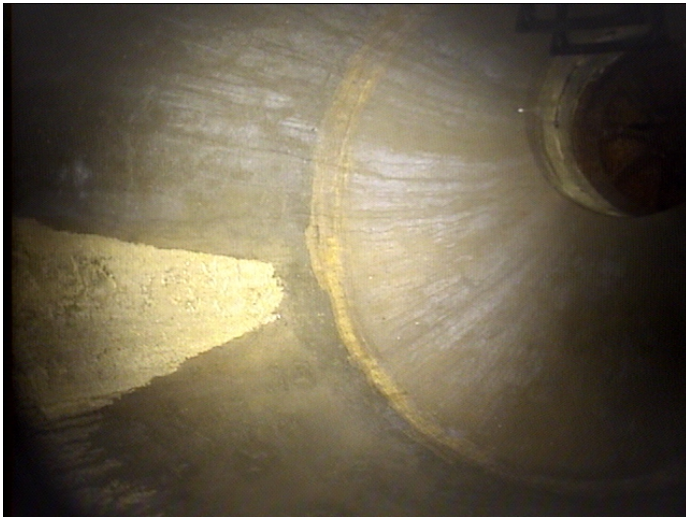
| Code: | <b>AMH</b> |
| Description: | <b>Manhole</b> |
| Distance (ft): | <b>344.4</b> |
| Remarks: | <b>M-806-061</b> |
