Profile/Photo Observation Report

Date:	04/17/2018	Weather:		Coding:	PACP 6.0
Pipe Length (ft):	53.1	Owner:	NA	Pre Clean:	Not Known
P.O.#:		Surveyor:	Byrd Fitzgerald	PSR:	P-806-060-061
Customer:		Clean Date:	01/01/1900	Shape:	C

Street:	E 10TH ST	Flow Control:	Not Controlled
City:	Hobart, IN	Year Renewed:	
Location:	Sidewalk	Tape/Media #:	
Purpose:	Maintenance Related	Dia/Height:	10"
Use:	Sanitary	Material:	PVC
Drain Area:	NA	Lining:	Cured in Place
Category:	NA		
Comment:

Location Details:		Direction of Survey:	Downstream
US MH:	M-806-061	DS MH:	M-806-060
		Total Length Surveyed (ft):	48.7

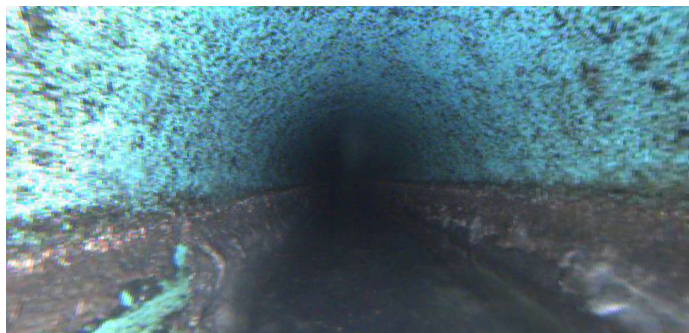
Code: **AMH**
Description: **Manhole**

Distance (ft): **.0**
Structural Grade: **0**
O&M Grade: **0**
Clock Start/From:
Clock To:
1st Value:
2nd Value:
Value Percent:
Continuous Index:
Within 8" of Joint: **NO**
Remarks: **M-806-061**

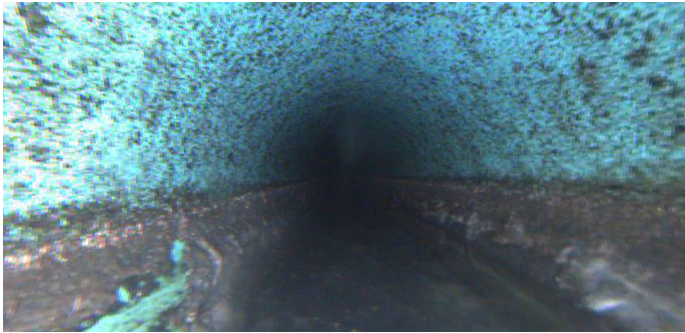
Code:	MWL
Description:	Water Level

Distance (ft):	.0
Structural Grade:	0
O&M Grade:	0
Clock Start/From:	
Clock To:	
1st Value:	
2nd Value:	
Value Percent:	5.000
Continuous Index:	
Within 8" of Joint:	NO
Remarks:

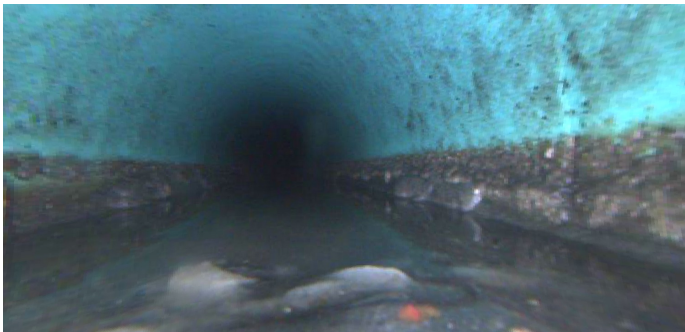
Code:	DSZ
Description:	Deposits Settled Other

Distance (ft):	12.0
Structural Grade:	0
O&M Grade:	2
Clock Start/From:	6
Clock To:	
1st Value:	
2nd Value:	
Value Percent:	5.000
Continuous Index:	
Within 8" of Joint:	NO
Remarks:	tissue

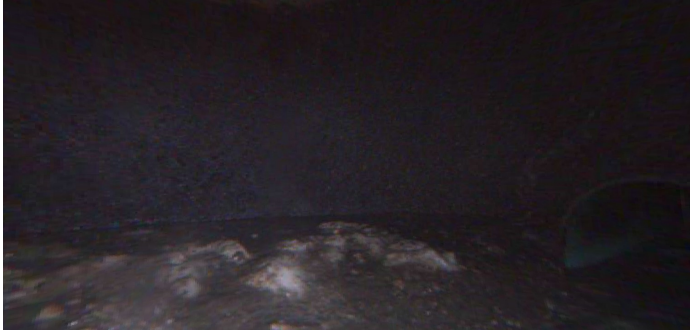
Code:	AMH
Description:	Manhole
Distance (ft):	48.7
Structural Grade:	0
O&M Grade:	0
Clock Start/From:	
Clock To:	
1st Value:	
2nd Value:	
Value Percent:	
Continuous Index:	
Within 8" of Joint:	NO
Remarks:	M-806-060
