Profile/Photo Observation Report

Street:	Capitol	Flow Control:	Not Controlled
City:	Hobart, IN	Year Renewed:	
Location:	Sidewalk	Tape/Media #:	
Purpose:	Maintenance Related	Dia/Height:	10"
Use:	Sanitary	Material:	PVC
Drain Area:	NA	Lining:	Cured in Place
Category:	NA		
Comment:

Location Details:		Direction of Survey:	Downstream
US MH:	M-806-061	DS MH:	M-806-060
		Total Length Surveyed (ft):	48.7

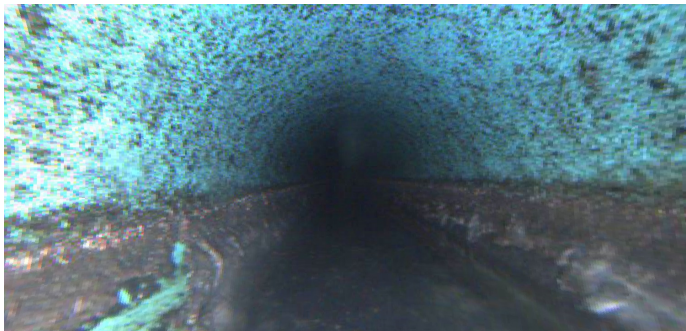
Code: **AMH**
Description: **Manhole**

Distance (ft): **.0**
Structural Grade: **0**
O&M Grade: **0**
Clock Start/From:
Clock To:
1st Value:
2nd Value:
Value Percent:
Continuous Index:
Within 8" of Joint: **NO**
Remarks: **M-806-061**

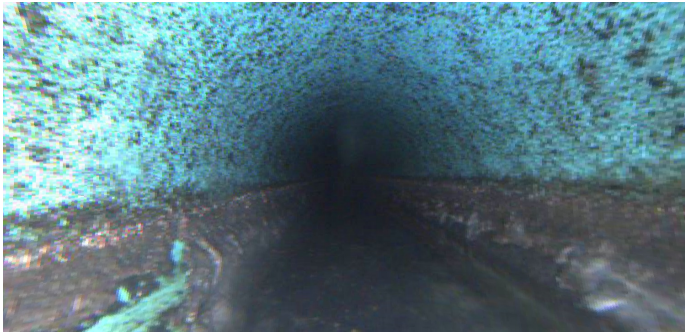
Code:	MWL
Description:	Water Level

Distance (ft):	.0
Structural Grade:	0
O&M Grade:	0
Clock Start/From:	
Clock To:	
1st Value:	
2nd Value:	
Value Percent:	5.000
Continuous Index:	
Within 8" of Joint:	NO
Remarks:

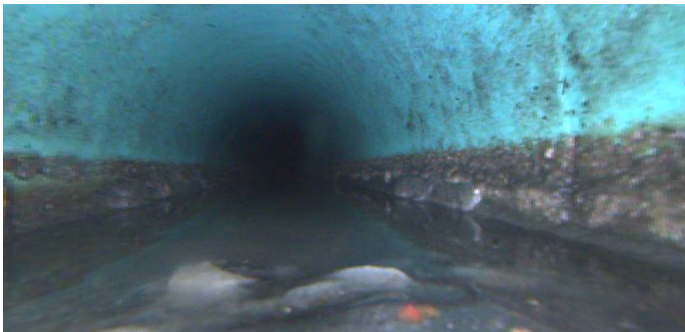
Code:	DSZ
Description:	Deposits Settled Other

Distance (ft):	12.0
Structural Grade:	0
O&M Grade:	2
Clock Start/From:	6
Clock To:	
1st Value:	
2nd Value:	
Value Percent:	5.000
Continuous Index:	
Within 8" of Joint:	NO
Remarks:	tissue

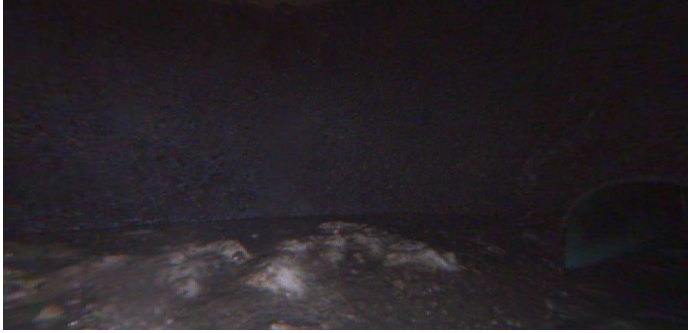
Code:	AMH
Description:	Manhole
Distance (ft):	48.7
Structural Grade:	0
O&M Grade:	0
Clock Start/From:	
Clock To:	
1st Value:	
2nd Value:	
Value Percent:	
Continuous Index:	
Within 8" of Joint:	NO
Remarks:	M-806-060
