Profile/Photo Observation Report

| Street: | Capitol | Flow Control: | Not Controlled |
| City: | Hobart, IN | Year Renewed: | |

| US MH: | M-807-002 | DS MH: | M-807-001 |

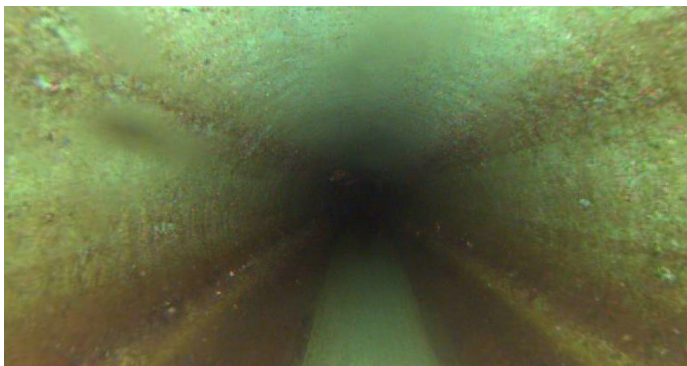
Code: **AMH**
 Description: **Manhole**

Distance (ft): **.0**
 Structural Grade: **0**
 O&M Grade: **0**
 Clock Start/From:
 Clock To:
 1st Value:
 2nd Value:
 Value Percent:
 Continuous Index:
 Within 8" of Joint: **NO**
 Remarks: **M-807-002**

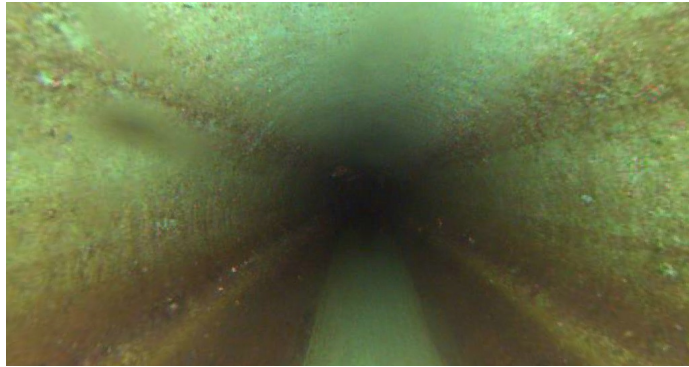
| Code: | MWL |
| Description: | Water Level |
| Distance (ft): | .0 |
| Value Percent: | 10.000 |

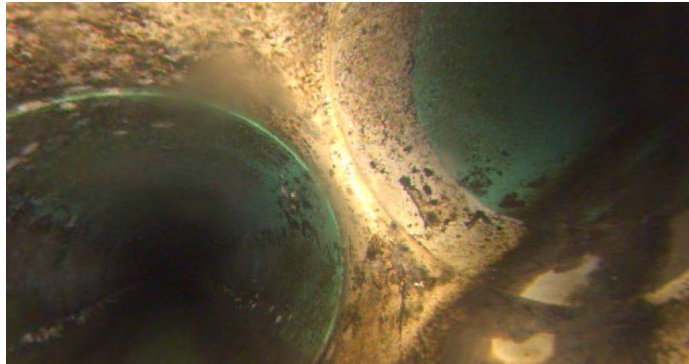
| Code: | TF |
| Description: | Tap Factory |
| Distance (ft): | 7.1 |
| Clock Start/From: | 2 |
| 1st Value: | 4.000 |

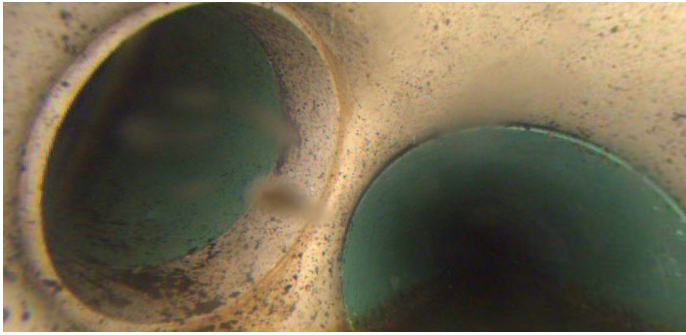
Code: **TF**
Description: **Tap Factory**

Distance (ft): **45.0**
Structural Grade: **0**
O&M Grade: **0**
Clock Start/From: **10**
Clock To:
1st Value: **4.000**
2nd Value:
Value Percent:
Continuous Index:
Within 8" of Joint:
Remarks:

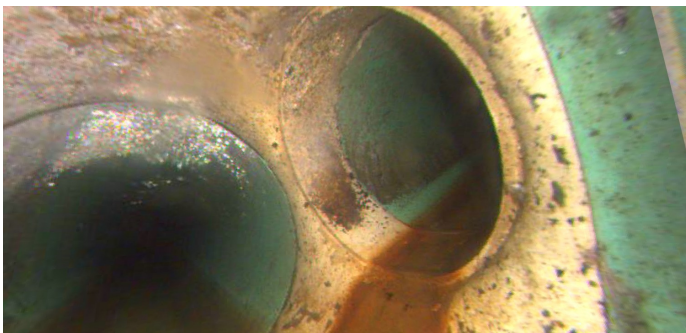
Code: **TFA**
Description: **Tap Factory Active**

Distance (ft): **101.4**
Structural Grade: **0**
O&M Grade: **0**
Clock Start/From: **3**
Clock To:
1st Value: **4.000**
2nd Value:
Value Percent:
Continuous Index:
Within 8" of Joint:
Remarks:

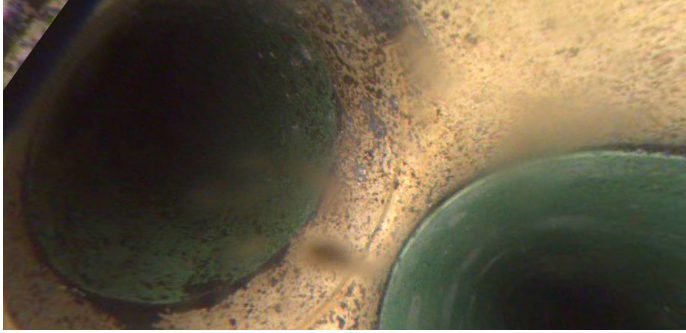
Code: **TF**
Description: **Tap Factory**

Distance (ft): **146.8**
Structural Grade: **0**
O&M Grade: **0**
Clock Start/From: **10**
Clock To:
1st Value: **4.000**
2nd Value:
Value Percent:
Continuous Index:
Within 8" of Joint:
Remarks:

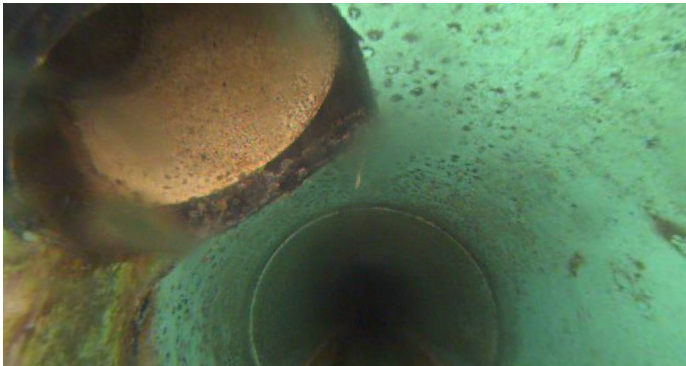
Code: **TS**
Description: **Tap Saddle**

Distance (ft): **209.1**
Structural Grade: **0**
O&M Grade: **0**
Clock Start/From: **10**
Clock To:
1st Value: **4.000**
2nd Value:
Value Percent:
Continuous Index:
Within 8" of Joint:
Remarks:

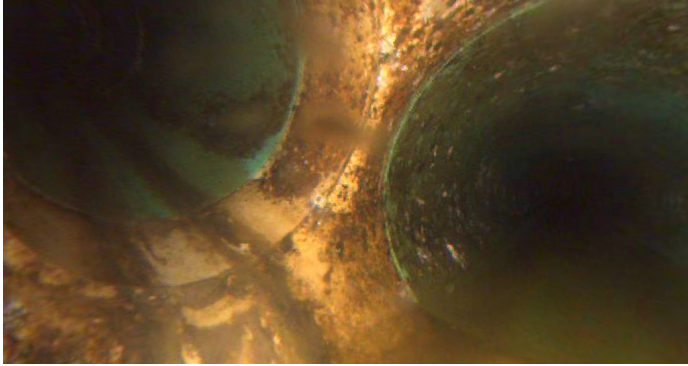
Code: **TF**
Description: **Tap Factory**

Distance (ft): **285.6**
Structural Grade: **0**
O&M Grade: **0**
Clock Start/From: **9**
Clock To:
1st Value: **4.000**
2nd Value:
Value Percent:
Continuous Index:
Within 8" of Joint:
Remarks:

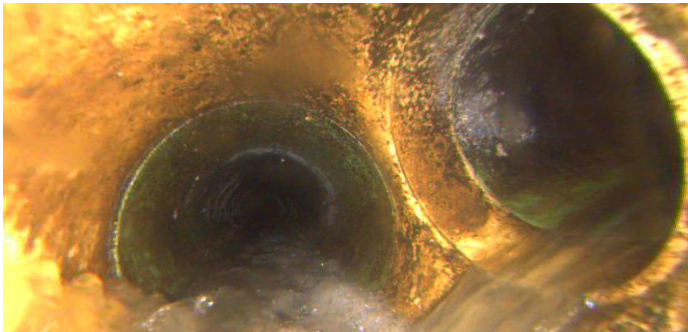
Code: **TFA**
Description: **Tap Factory Active**

Distance (ft): **334.5**
Structural Grade: **0**
O&M Grade: **0**
Clock Start/From: **3**
Clock To:
1st Value: **4.000**
2nd Value:
Value Percent:
Continuous Index:
Within 8" of Joint:
Remarks:

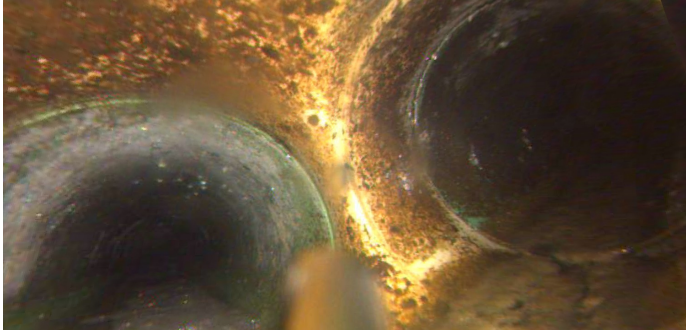
Code: **TF**
Description: **Tap Factory**

Distance (ft): **340.9**
Structural Grade: **0**
O&M Grade: **0**
Clock Start/From: **3**
Clock To:
1st Value: **4.000**
2nd Value:
Value Percent:
Continuous Index:
Within 8" of Joint:
Remarks:

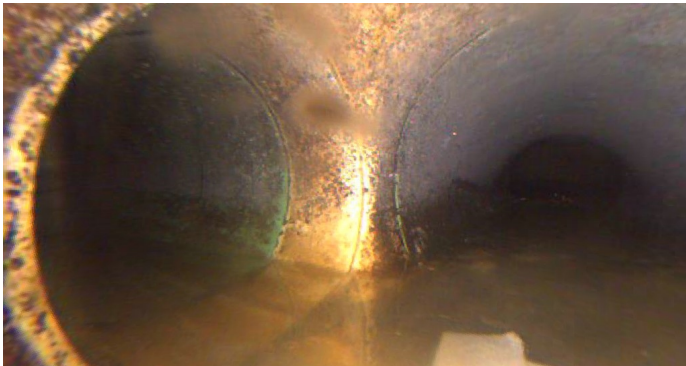
Code: **TF**
Description: **Tap Factory**

Distance (ft): **374.9**
Structural Grade: **0**
O&M Grade: **0**
Clock Start/From: **7**
Clock To:
1st Value: **4.000**
2nd Value:
Value Percent:
Continuous Index:
Within 8" of Joint:
Remarks:

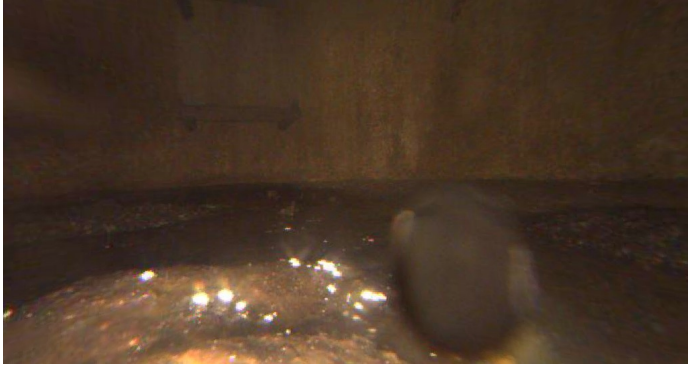
| Code: | AMH |
| Description: | Manhole |
| Distance (ft): | 378.1 |
| Remarks: | M-807-001 |
