Profile/Photo Observation Report

Street:	E 12TH ST	Flow Control:	Not Controlled
City:	Hobart, IN	Year Renewed:	
Location:	Light Highway	Tape/Media #:	
Purpose:	Maintenance Related	Dia/Height:	10"
Use:	Sanitary	Material:	PVC
Drain Area:	NA	Lining:	Cured in Place
Category:	NA		
Comment:	unknown at 92'. flow incorrect.

Location Details:		Direction of Survey:	Upstream
US MH:	M-807-003	DS MH:	M-807-002
		Total Length Surveyed (ft):	93.5

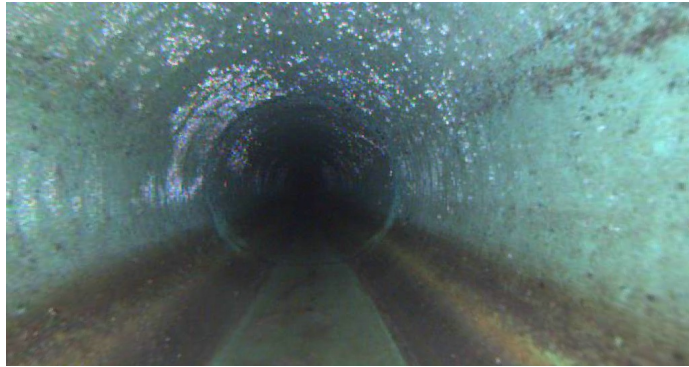
Code:	MWL
Description:	Water Level
Distance (ft):	.0
Structural Grade:	0
O&M Grade:	0
Clock Start/From:	
Clock To:	
1st Value:	
2nd Value:	
Value Percent:	10.000
Continuous Index:	
Within 8" of Joint:	NO
Remarks:

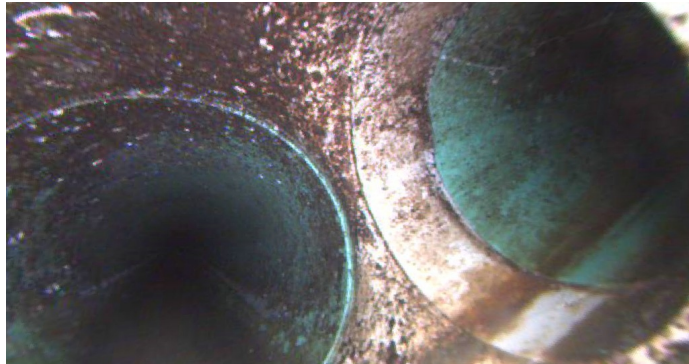
Code:	TF
Description:	Tap Factory
Distance (ft):	19.4
Structural Grade:	0
O&M Grade:	0
Clock Start/From:	3
Clock To:	
1st Value:	4.000
2nd Value:	
Value Percent:	
Continuous Index:	
Within 8" of Joint:	
Remarks:

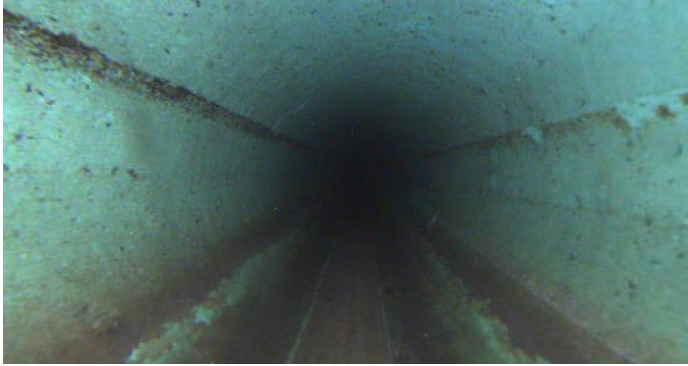
Code:	MSA
Description:	Abandoned Survey
Distance (ft):	93.5
Structural Grade:	0
O&M Grade:	0
Clock Start/From:	
Clock To:	
1st Value:	
2nd Value:	
Value Percent:	
Continuous Index:	
Within 8" of Joint:	NO
Remarks:	No blockage
