Profile/Photo Observation Report

Street:	Capitol	Flow Control:	Not Controlled
City:	Hobart, IN	Year Renewed:	
Location:	Light Highway	Tape/Media #:	
Purpose:	Maintenance Related	Dia/Height:	10"
Use:	Sanitary	Material:	PVC
Drain Area:	NA	Lining:	Cured in Place
Category:	NA		
Comment:	unknown at 92'. flow incorrect.

Location Details:		Direction of Survey:	Upstream
US MH:	M-807-003	DS MH:	M-807-002
		Total Length Surveyed (ft):	93.5

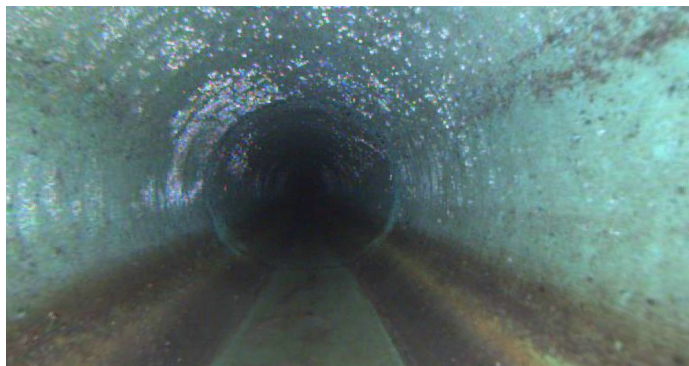
Code: **AMH**
Description: **Manhole**

Distance (ft): **.0**
Structural Grade: **0**
O&M Grade: **0**
Clock Start/From:
Clock To:
1st Value:
2nd Value:
Value Percent:
Continuous Index:
Within 8" of Joint: **NO**
Remarks: **M-807-002**

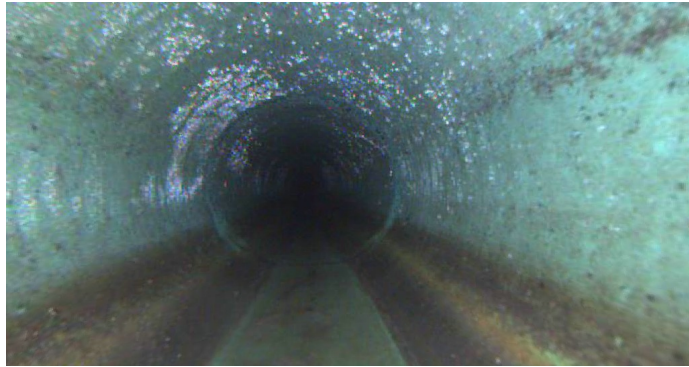
Code:	MWL
Description:	Water Level
Distance (ft):	.0
Structural Grade:	0
O&M Grade:	0
Clock Start/From:	
Clock To:	
1st Value:	
2nd Value:	
Value Percent:	10.000
Continuous Index:	
Within 8" of Joint:	NO
Remarks:

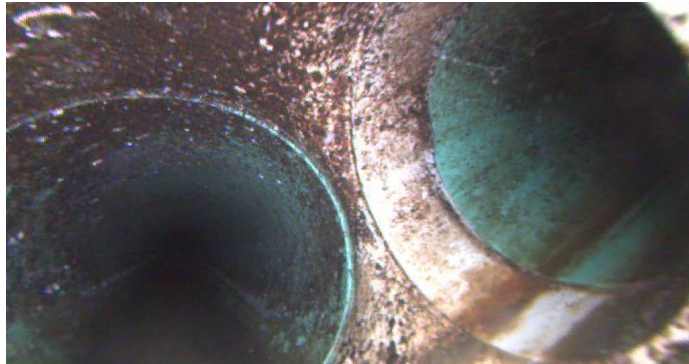
Code:	TF
Description:	Tap Factory
Distance (ft):	19.4
Structural Grade:	0
O&M Grade:	0
Clock Start/From:	3
Clock To:	
1st Value:	4.000
2nd Value:	
Value Percent:	
Continuous Index:	
Within 8" of Joint:	
Remarks:

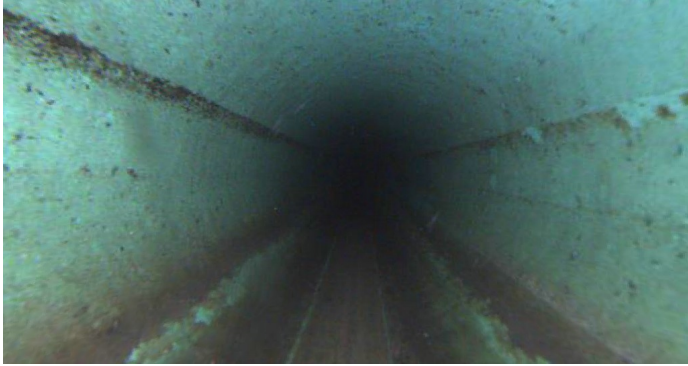
Code:	MSA
Description:	Abandoned Survey
Distance (ft):	93.5
Structural Grade:	0
O&M Grade:	0
Clock Start/From:	
Clock To:	
1st Value:	
2nd Value:	
Value Percent:	
Continuous Index:	
Within 8" of Joint:	NO
Remarks:	No blockage
