## Profile/Photo Observation Report

Date:	<b>04/10/2018</b>	Weather:		Coding:	<b>PACP 6.0</b>
Pipe Length (ft):	<b>365.0</b>	Owner:	<b>NA</b>	Pre Clean:	<b>Not Known</b>
P.O.#:		Surveyor:	<b>Mark Ruby</b>	PSR:	<b>P-807-003-004</b>
Customer:		Clean Date:	<b>01/01/1900</b>	Shape:	<b>C</b>

Street:	<b>Capitol</b>	Flow Control:	<b>Not Controlled</b>
City:	<b>Hobart, IN</b>	Year Renewed:	
Location:	<b>Light Highway</b>	Tape/Media #:	
Purpose:	<b>Maintenance Related</b>	Dia/Height:	<b>10"</b>
Use:	<b>Sanitary</b>	Material:	<b>PVC</b>
Drain Area:	<b>NA</b>	Lining:	<b>Cured in Place</b>
Category:	<b>NA</b>		
Comment:	<b>flow incorrect.</b>

Location Details:		Direction of Survey:	<b>Downstream</b>
US MH:	<b>M-807-004</b>	DS MH:	<b>M-807-003</b>
		Total Length Surveyed (ft):	<b>366.2</b>

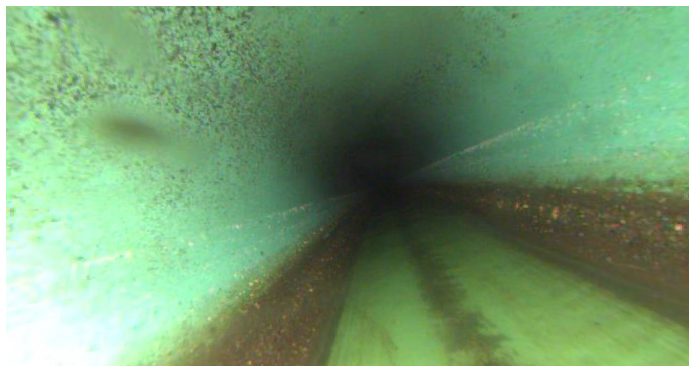
Code: **AMH**  
 Description: **Manhole**

Distance (ft): **.0**  
 Structural Grade: **0**  
 O&M Grade: **0**  
 Clock Start/From:  
 Clock To:  
 1st Value:  
 2nd Value:  
 Value Percent:  
 Continuous Index:  
 Within 8" of Joint: **NO**  
 Remarks: **M-807-004**

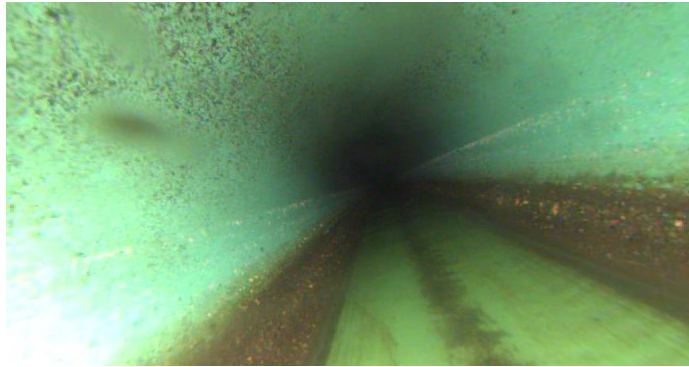
Code: **MWL**  
Description: **Water Level**

Distance (ft): **.0**  
Structural Grade: **0**  
O&M Grade: **0**  
Clock Start/From:  
Clock To:  
1st Value:  
2nd Value:  
Value Percent: **10.000**  
Continuous Index:  
Within 8" of Joint: **NO**  
Remarks:

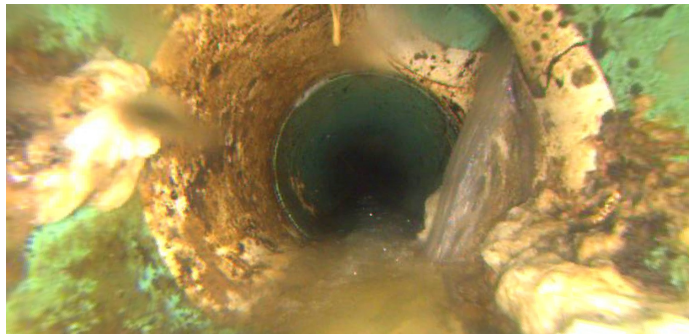
Code: **DAGS**  
Description: **Deposits Attached Grease**

Distance (ft): **41.9**  
Structural Grade: **0**  
O&M Grade: **2**  
Clock Start/From: **8**  
Clock To: **4**  
1st Value:  
2nd Value:  
Value Percent: **5.000**  
Continuous Index:  
Within 8" of Joint: **NO**  
Remarks:

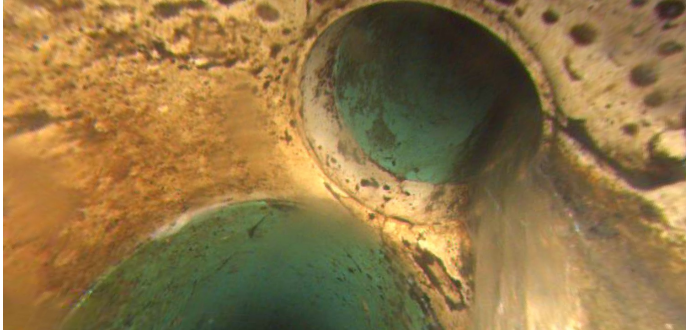
Code: **TFA**  
Description: **Tap Factory Active**

Distance (ft): **42.4**  
Structural Grade: **0**  
O&M Grade: **0**  
Clock Start/From: **1**  
Clock To:  
1st Value: **4.000**  
2nd Value:  
Value Percent:  
Continuous Index:  
Within 8" of Joint:  
Remarks:

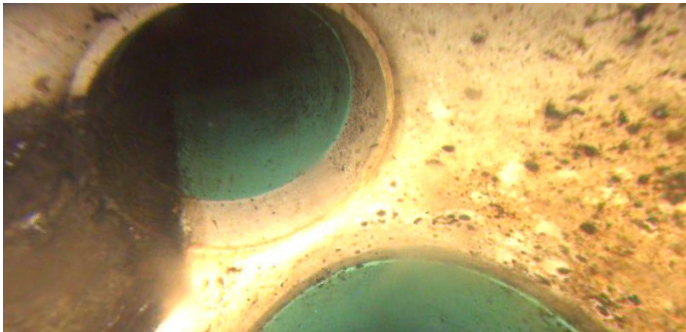
Code: **TFA**  
Description: **Tap Factory Active**

Distance (ft): **55.7**  
Structural Grade: **0**  
O&M Grade: **0**  
Clock Start/From: **11**  
Clock To:  
1st Value: **4.000**  
2nd Value:  
Value Percent:  
Continuous Index:  
Within 8" of Joint:  
Remarks:

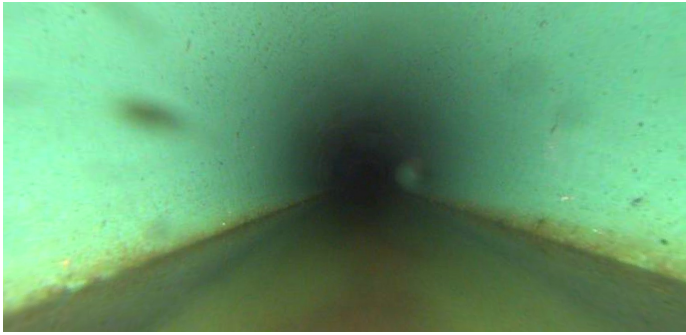
Code: **MWL**  
Description: **Water Level**

Distance (ft): **87.2**  
Structural Grade: **0**  
O&M Grade: **0**  
Clock Start/From:  
Clock To:  
1st Value:  
2nd Value:  
Value Percent: **30.000**  
Continuous Index:  
Within 8" of Joint: **NO**  
Remarks:

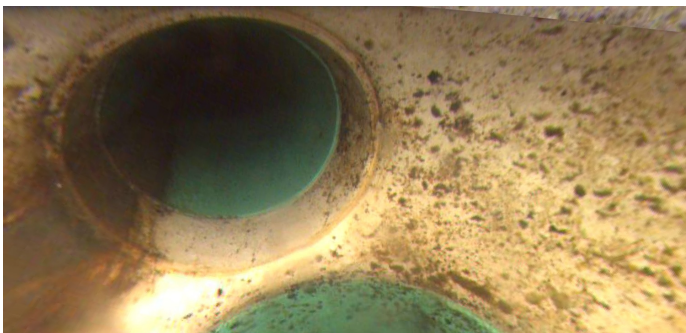
Code: **TF**  
Description: **Tap Factory**

Distance (ft): **154.7**  
Structural Grade: **0**  
O&M Grade: **0**  
Clock Start/From: **11**  
Clock To:  
1st Value: **4.000**  
2nd Value:  
Value Percent:  
Continuous Index:  
Within 8" of Joint:  
Remarks:

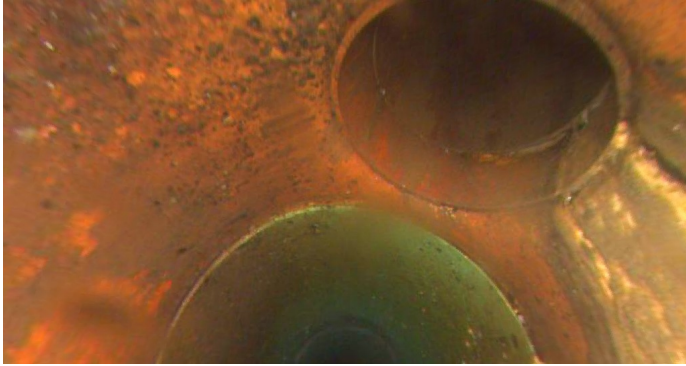
Code: **TF**  
Description: **Tap Factory**

Distance (ft): **194.8**  
Structural Grade: **0**  
O&M Grade: **0**  
Clock Start/From: **1**  
Clock To:  
1st Value: **4.000**  
2nd Value:  
Value Percent:  
Continuous Index:  
Within 8" of Joint:  
Remarks:

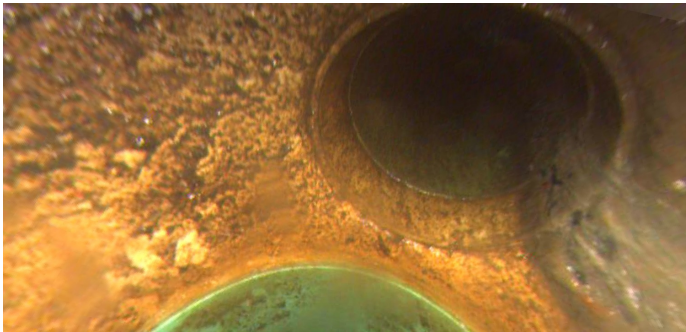
Code: **TF**  
Description: **Tap Factory**

Distance (ft): **225.6**  
Structural Grade: **0**  
O&M Grade: **0**  
Clock Start/From: **1**  
Clock To:  
1st Value: **4.000**  
2nd Value:  
Value Percent:  
Continuous Index:  
Within 8" of Joint:  
Remarks:

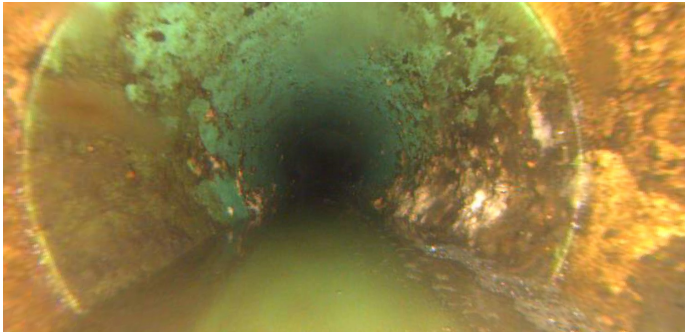
Code: **DAGS**  
Description: **Deposits Attached Grease**

Distance (ft): **225.8**  
Structural Grade: **0**  
O&M Grade: **2**  
Clock Start/From: **3**  
Clock To: **4**  
1st Value:  
2nd Value:  
Value Percent: **5.000**  
Continuous Index:  
Within 8" of Joint: **NO**  
Remarks:

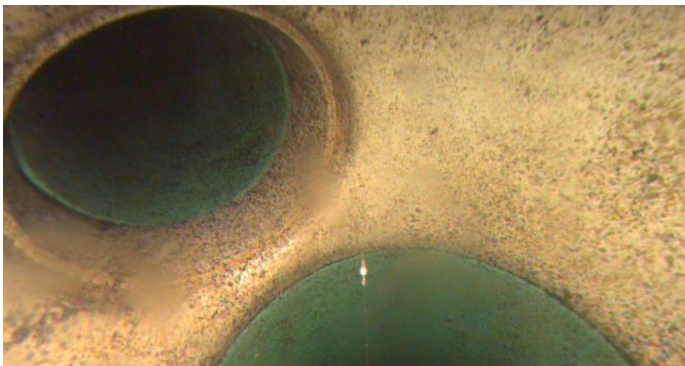
Code: **TF**  
Description: **Tap Factory**

Distance (ft): **255.3**  
Structural Grade: **0**  
O&M Grade: **0**  
Clock Start/From: **10**  
Clock To:  
1st Value: **4.000**  
2nd Value:  
Value Percent:  
Continuous Index:  
Within 8" of Joint:  
Remarks:

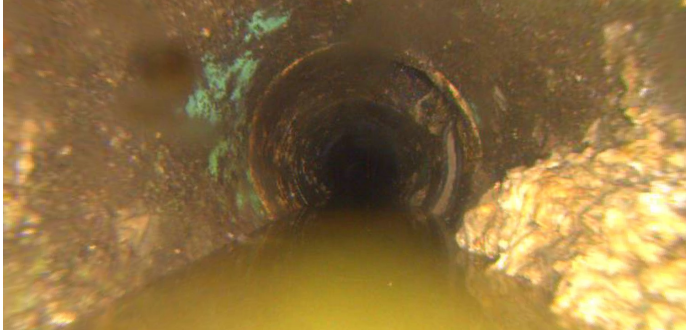
Code: **DAGS**  
Description: **Deposits Attached Grease**

Distance (ft): **331.9**  
Structural Grade: **0**  
O&M Grade: **2**  
Clock Start/From: **3**  
Clock To: **4**  
1st Value:  
2nd Value:  
Value Percent: **10.000**  
Continuous Index:  
Within 8" of Joint: **NO**  
Remarks:

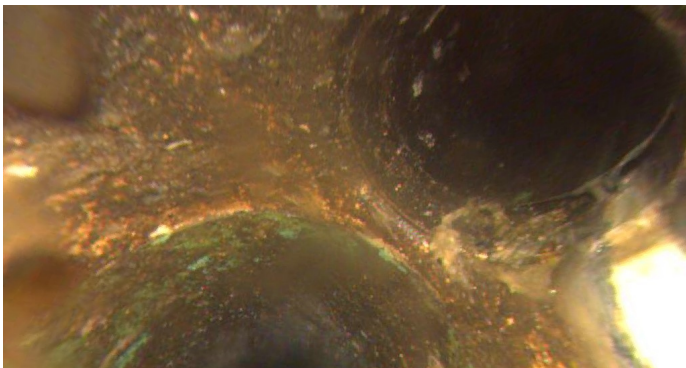
Code: **TF**  
Description: **Tap Factory**

Distance (ft): **333.0**  
Structural Grade: **0**  
O&M Grade: **0**  
Clock Start/From: **2**  
Clock To:  
1st Value: **4.000**  
2nd Value:  
Value Percent:  
Continuous Index:  
Within 8" of Joint:  
Remarks:

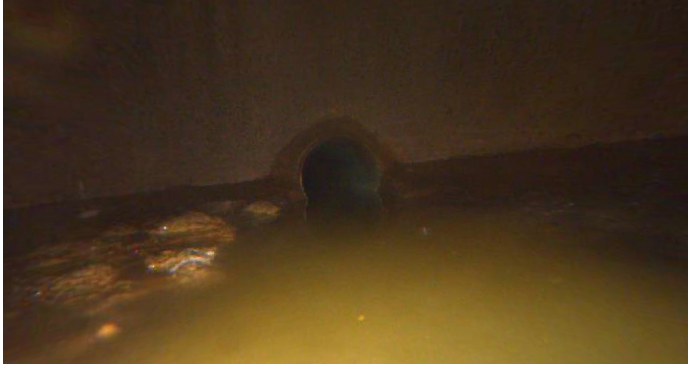
Code:	<b>AMH</b>
Description:	<b>Manhole</b>
Distance (ft):	<b>366.2</b>
Structural Grade:	<b>0</b>
O&M Grade:	<b>0</b>
Clock Start/From:	
Clock To:	
1st Value:	
2nd Value:	
Value Percent:	
Continuous Index:	
Within 8" of Joint:	<b>NO</b>
Remarks:	<b>M-807-003</b>
