## Profile/Photo Observation Report

Street:	<b>S HOBART RD</b>	Flow Control:	<b>Not Controlled</b>
City:	<b>Hobart, IN</b>	Year Renewed:	
Location:	<b>Light Highway</b>	Tape/Media #:	
Purpose:	<b>Maintenance Related</b>	Dia/Height:	<b>12"</b>
Use:	<b>Sanitary</b>	Material:	<b>PVC</b>
Drain Area:	<b>NA</b>	Lining:	<b>Cured in Place</b>
Category:	<b>NA</b>		
Comment:	<b>silt at 12'.</b>

Location Details:		Direction of Survey:	<b>Upstream</b>
US MH:	<b>M-807-009</b>	DS MH:	<b>M-807-012</b>
		Total Length Surveyed (ft):	<b>13.2</b>

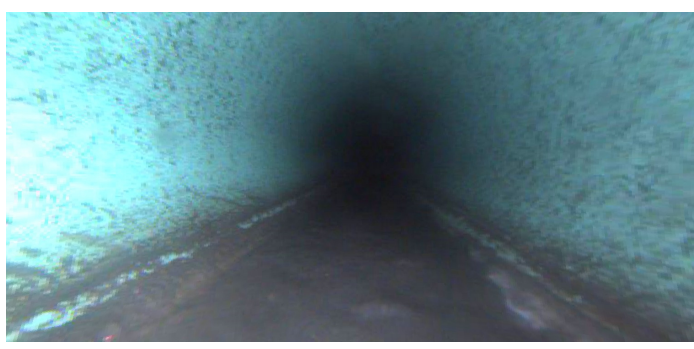
Code: **AMH**  
Description: **Manhole**

Distance (ft): **.0**  
Structural Grade: **0**  
O&M Grade: **0**  
Clock Start/From:  
Clock To:  
1st Value:  
2nd Value:  
Value Percent:  
Continuous Index:  
Within 8" of Joint: **NO**  
Remarks: **M-807-012**

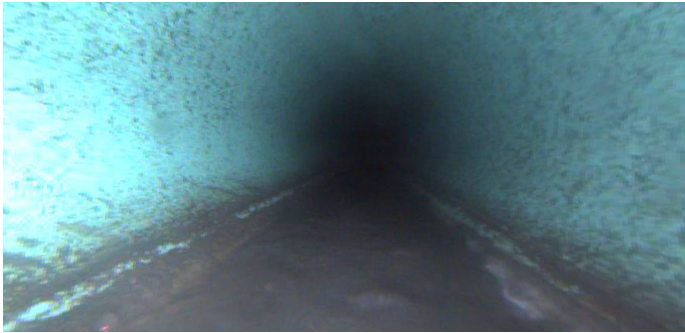
Code:	<b>MWL</b>
Description:	<b>Water Level</b>

Distance (ft):	<b>.0</b>
Structural Grade:	<b>0</b>
O&M Grade:	<b>0</b>
Clock Start/From:	
Clock To:	
1st Value:	
2nd Value:	
Value Percent:	<b>5.000</b>
Continuous Index:	
Within 8" of Joint:	<b>NO</b>
Remarks:
